Aviation Investigation Final Report

Location:	Jackson, Wyoming	Incident Number:	DCA08IA044
Date & Time:	February 25, 2008, 21:16 Local	Registration:	N442UA
Aircraft:	Airbus Industrie A320	Aircraft Damage:	Minor
Defining Event:	Sys/Comp malf/fail (non-power)	Injuries:	1 Minor, 124 None
Flight Conducted Under:	Part 121: Air carrier - Scheduled

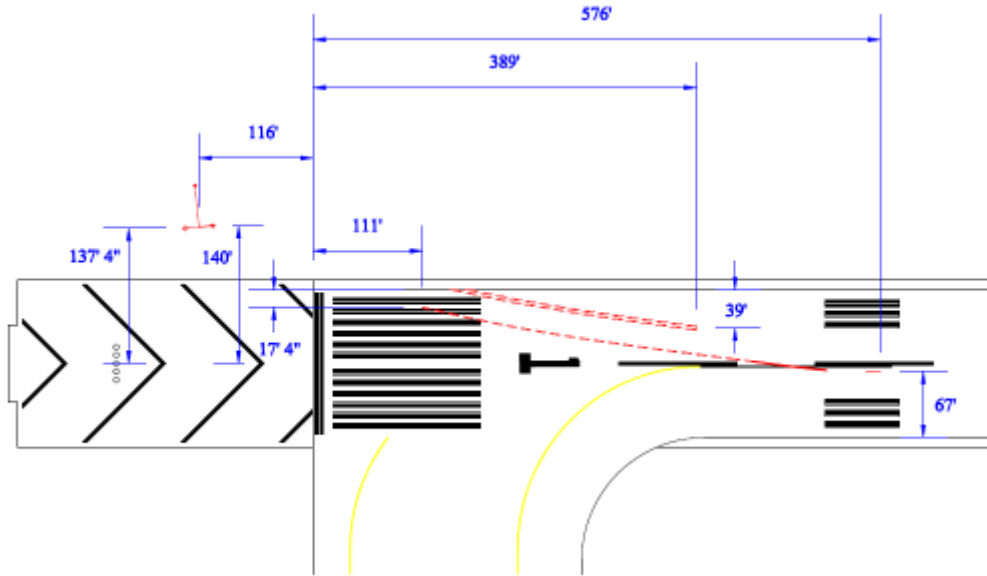
Figure 1 – Diagram of Skid Marks

Examination of the runway revealed distinct rubber transfer marks leading to an area of disturbed snow on the right side of the runway (Figure 1). The longest of the rubber transfer marks began about 576 feet from the departure threshold of runway 19 (or the approach threshold of runway 1) and 67 feet from the left runway edge and arced to the right. The mark was very light for the first 55 feet then became very heavy for 76 feet followed by 332 feet of light markings (as measured along the mark). The mark stopped about 111 feet from the threshold and 17 feet, 4 inches from the right runway edge. The heavy mark crossed the centerline at an angle of about 31 degrees. A second set of two light rubber transfer marks began about 389 feet from the threshold and 39 feet from the right runway edge. The two marks were parallel and separated by about 40 inches. The marks ended at the disturbed snow at the right runway edge. At the edge of the runway there were three sets of parallel tracks through the snow consistent with the landing gear wheels on the airplane. The center of the right main landing gear (RMLG) tracks was 149 feet from the threshold, the center of the nose landing gear (NLG) tracks was 99 feet from the threshold, and the center of the LMLG tracks was 36 feet from the threshold. The perpendicular distance between the centers of the tracks was 13 feet, 9 inches between the LMLG and NLG and 10 feet, 3 inches between the RMLG and NLG.

The airplane came to rest in the snow on the right side of the overrun area. The two RMLG and two NLG tires each left distinct impressions with tread ribs in the soil and snow where they came to rest. The LMLG outboard tire left a distinct impression with tread ribs while the inboard tire left only a light impression. The center of the RMLG was 140 feet from the extended centerline, the center of the LMLG was 137 feet, 4 inches from the centerline, and the center of the NLG was 42 feet, 2 inches forward of a line connecting the center of both MLG. The distance between the RMLG and LMLG was 28 feet. A point midway between the MLG (airplane centerline) was 116 feet beyond the threshold.
