Aviation Investigation Final Report

Location:	Soldotna, Alaska	Incident Number:	DCA12IA141
Date & Time:	September 5, 2012, 10:41 Local	Registration:	N886EA
Aircraft:	De Havilland DHC8	Aircraft Damage:	None
Defining Event:	Aerodynamic stall/spin	Injuries:	15 None
Flight Conducted Under:	Part 121: Air carrier - Scheduled

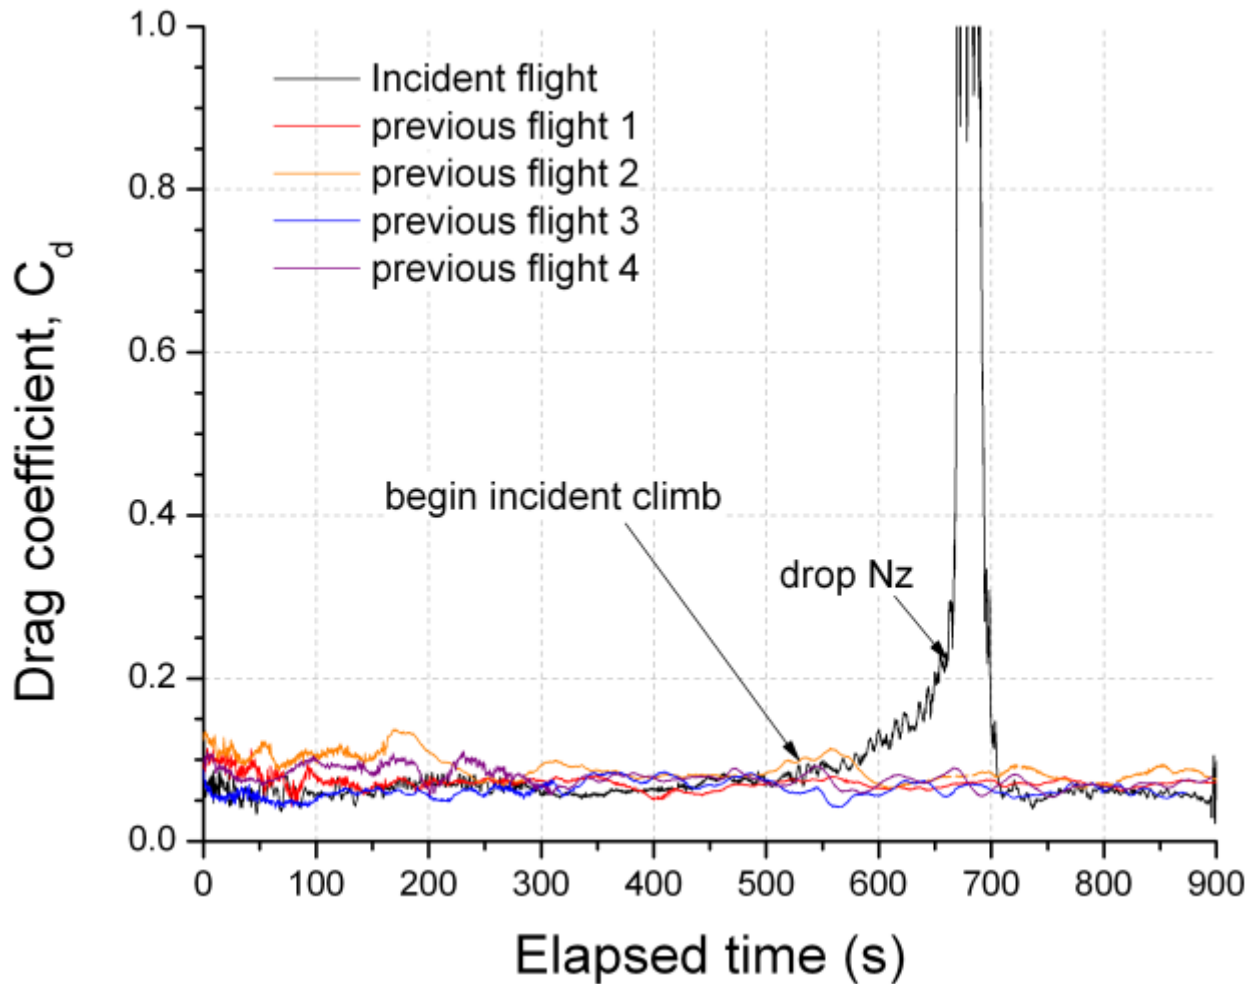
The airplane performance study also looked at the drag coefficient (C_D) of the incident airplane during its climb to help determine how much ice it might have been accumulating. See figure 2 for the calculated C_D for the incident flight compared to the four previous flights recorded on the FDR. As shown, the C_D is increasing right around the time that the airplane began climbing through 10,000 feet, which is consistent with the possibility of ice buildup and that the airplane might have had some ice accumulation at 10,000 but, but that the icing worsened during the climb.

Figure 2. A chart indicating the drag coefficient (C_D) of the incident airplane during the climb through 10,000 feet.
