# Aviation Investigation Final Report

<b>Location:</b>	Soldotna, Alaska	<b>Incident Number:</b>	DCA121A141
<b>Date &amp; Time:</b>	September 5, 2012, 10:41 Local	<b>Registration:</b>	N886EA
<b>Aircraft:</b>	De Havilland DHC8	<b>Aircraft Damage:</b>	None
<b>Defining Event:</b>	Aerodynamic stall/spin	<b>Injuries:</b>	15 None
<b>Flight Conducted Under:</b>	Part 121: Air carrier - Scheduled

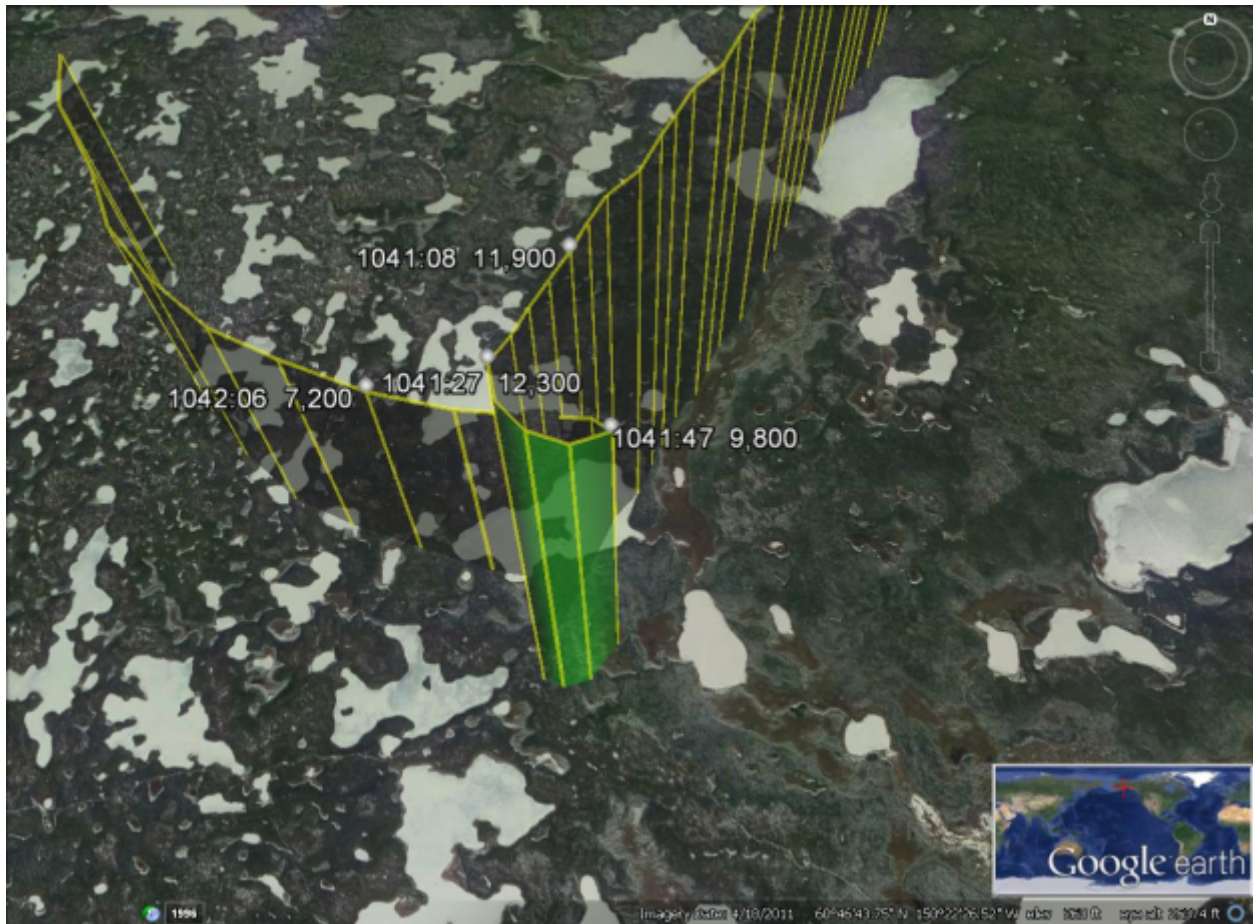
The captain stated that he attempted to control the airplane by rolling it to wings level and pulling nose up, but he was unable to regain control. He added that he made a combination of control and power inputs, pushing the yoke and power forward and back as the airplane descended rapidly. FDR data indicated that the autopilot disconnected at 1041:26.7. At 1041:27 (about the same time the airplane reached its maximum altitude of 12,288 feet), the column was pulled back rapidly from 8.5° to 33° in 3 seconds.

The column was held aft at greater than 33° until 1041:43, at which time, the captain began to release the back pressure. The airplane pitch decreased from 20° nose up to 37° nose down during this time. FDR data further show that the captain did not attempt to push the column forward during the descent for another 7 seconds until 1041:50. At 1042:04 the airplane reached its lowest altitude of 7,072 feet and began to level out and stabilize after descending more than 5,200 feet in about 37 seconds. The flight made a left 270° turn during the uncontrolled upset event. Figure 1 is a graphical depiction of the flight path and altitude of the airplane at certain points during the loss of control portion of the flight.

**Figure 1.** A graphical depiction of the flight path and altitude of the airplane at certain points during the loss of control portion of the flight.

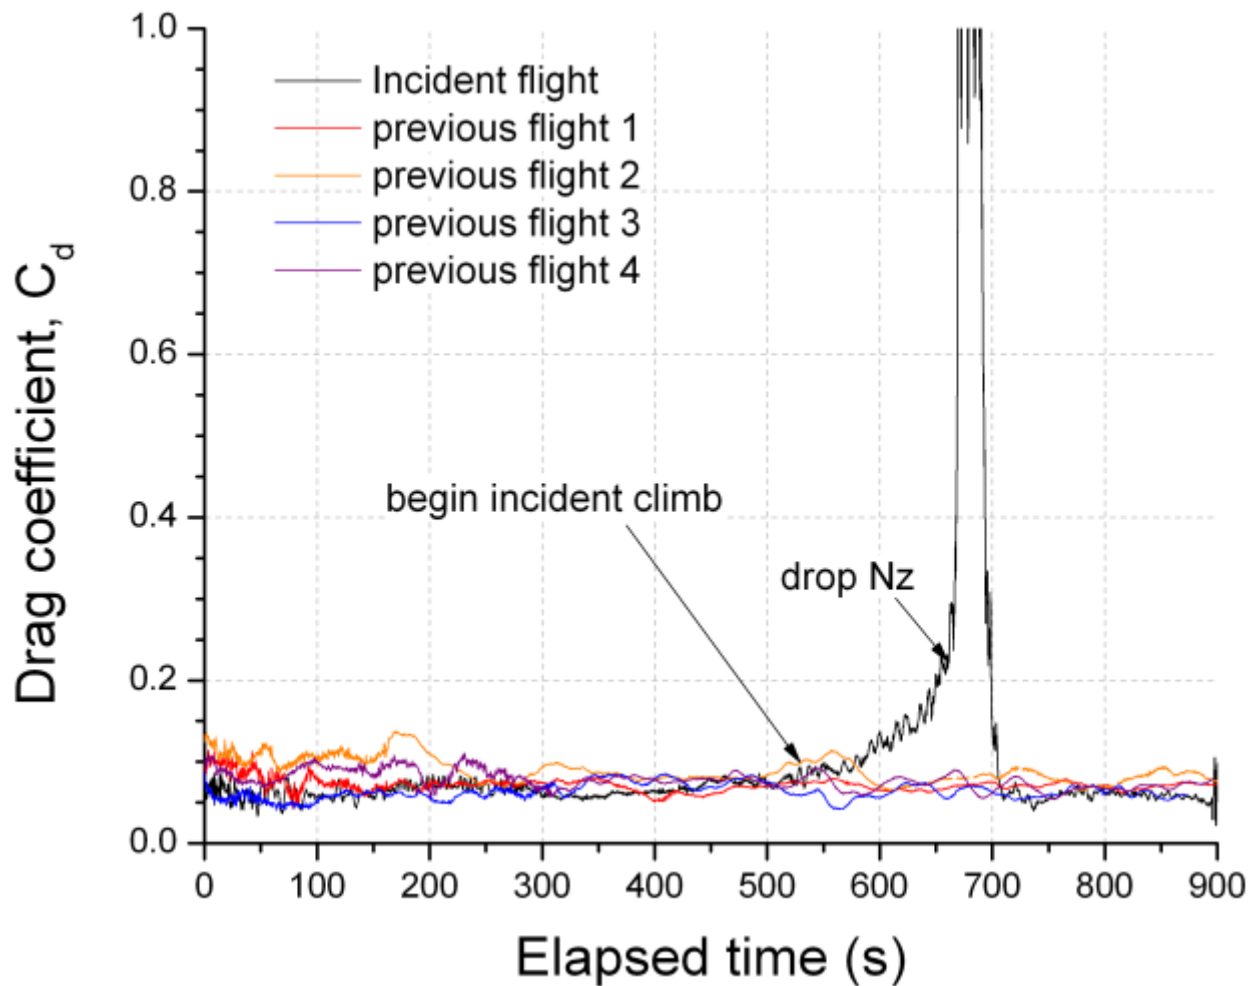
The airplane performance study also looked at the drag coefficient ( $C_d$ ) of the incident airplane during its climb to help determine how much ice it might have been accumulating. See figure 2 for the calculated  $C_d$  for the incident flight compared to the four previous flights recorded on the FDR. As shown, the  $C_d$  is increasing right around the time that the airplane began climbing through 10,000 feet, which is consistent with the possibility of ice buildup and that the airplane might have had some ice accumulation at 10,000 but, but that the icing worsened during the climb.

**Figure 2.** A chart indicating the drag coefficient ( $C_d$ ) of the incident airplane during the climb through 10,000 feet.
