Aviation Investigation Final Report

Location:	Soldotna, Alaska	Incident Number:	DCA121A141
Date & Time:	September 5, 2012, 10:41 Local	Registration:	N886EA
Aircraft:	De Havilland DHC8	Aircraft Damage:	None
Defining Event:	Aerodynamic stall/spin	Injuries:	15 None
Flight Conducted Under:	Part 121: Air carrier - Scheduled

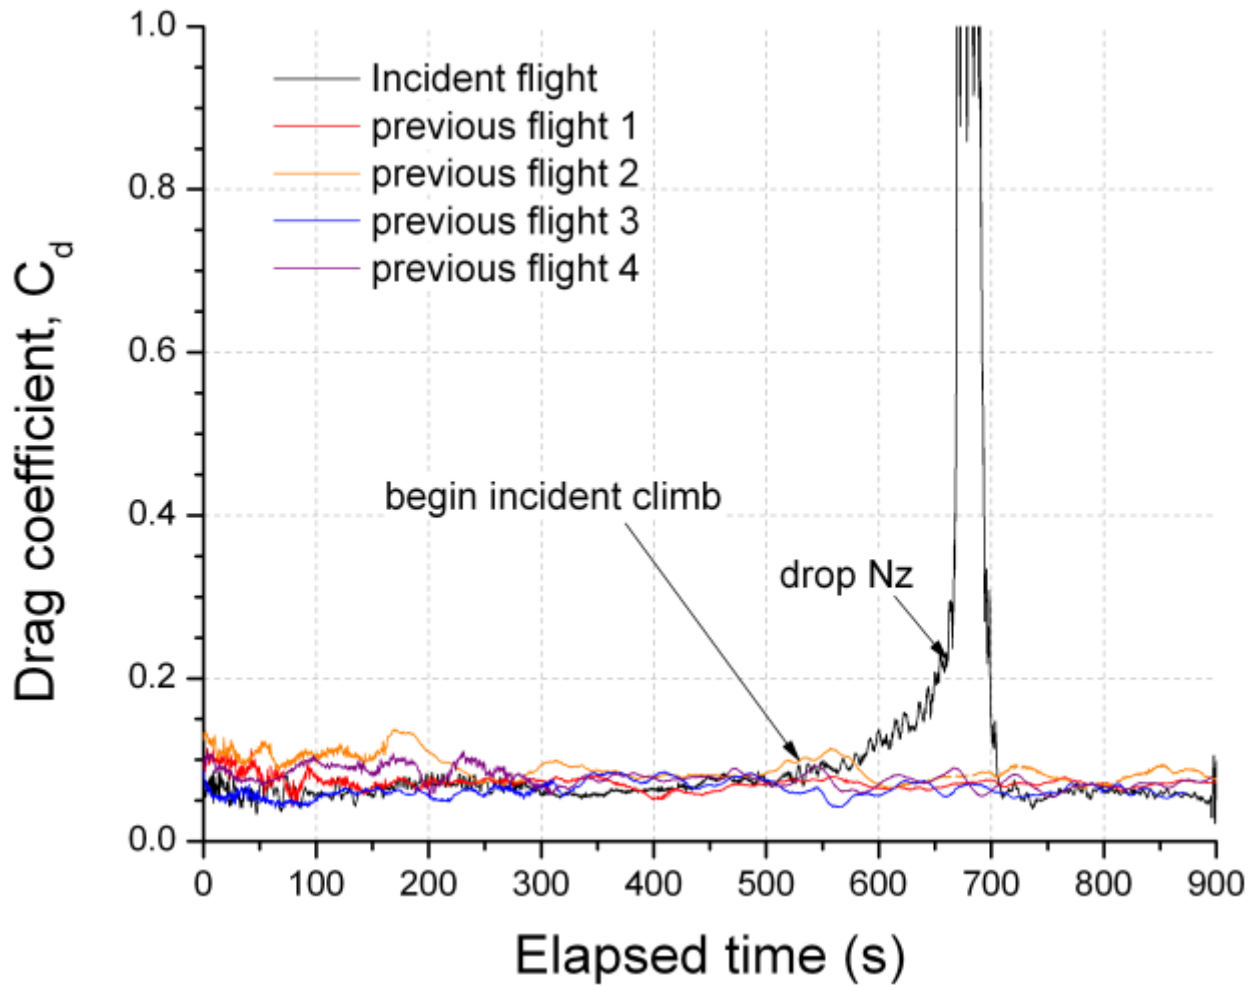
The airplane performance study also looked at the drag coefficient (C_D) of the incident airplane during its climb to help determine how much ice it might have been accumulating. See figure 2 for the calculated C_D for the incident flight compared to the four previous flights recorded on the FDR. As shown, the C_D is increasing right around the time that the airplane began climbing through 10,000 feet, which is consistent with the possibility of ice buildup and that the airplane might have had some ice accumulation at 10,000 but, but that the icing worsened during the climb.

Figure 2. A chart indicating the drag coefficient (C_D) of the incident airplane during the climb through 10,000 feet.
