# Aviation Investigation Final Report

<b>Location:</b>	Newark, New Jersey	<b>Accident Number:</b>	DCA13FA082
<b>Date &amp; Time:</b>	May 1, 2013, 19:24 Local	<b>Registration:</b>	N17560
<b>Aircraft:</b>	Embraer EMB-145LR	<b>Aircraft Damage:</b>	Substantial
<b>Defining Event:</b>	Ground collision	<b>Injuries:</b>	34 None
<b>Flight Conducted Under:</b>	Part 121: Air carrier - Scheduled

<b>Location:</b>	Newark, New Jersey	<b>Accident Number:</b>	DCA13FA082
<b>Date &amp; Time:</b>	May 1, 2013, 19:24 Local	<b>Registration:</b>	LN-RKO
<b>Aircraft:</b>	Airbus A330	<b>Aircraft Damage:</b>	Minor
<b>Defining Event:</b>	Ground collision	<b>Injuries:</b>	256 None
<b>Flight Conducted Under:</b>	Part 129: Foreign

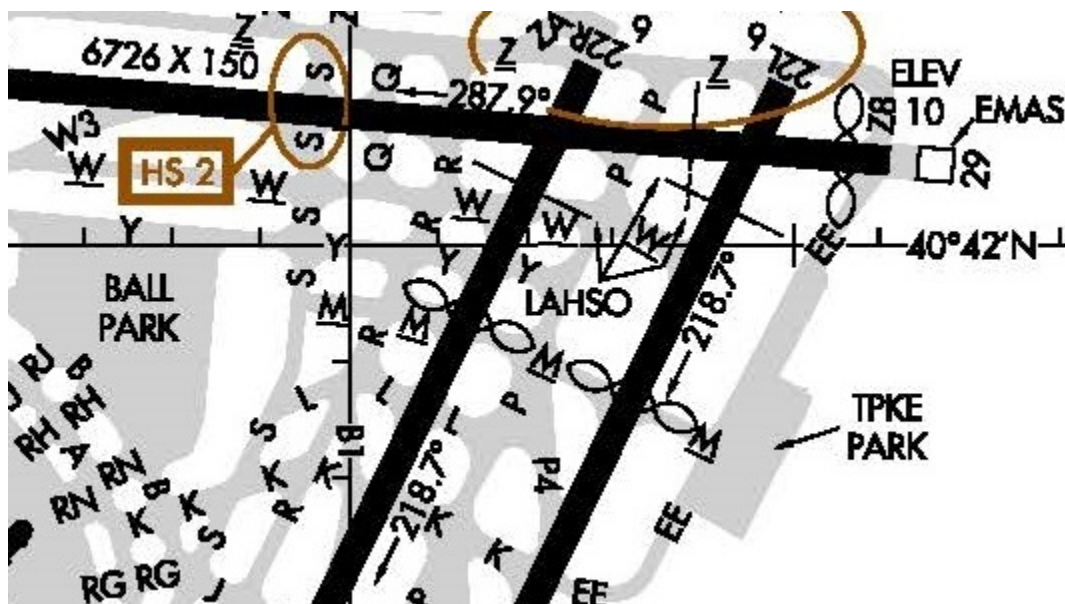
Figure 1 - Expanded view of airport diagram

The distance between the centerline of taxiway Y to the centerline of taxiway M was about 487 feet. That was the area within which flight 4226 was instructed to hold short of taxiway Y on taxiway R, in order to give way to a B737 that would pass in front of them on taxiway Y. The wingspan of a B737 is about 113 feet, which would indicate that if the B737 was positioned on the centerline of taxiway Y, its wing would project about 56.5 feet from the centerline of taxiway, with about 19 feet that would project onto taxiway R. There were no hold short lines or other guidance indicators on taxiway R that would ensure wingtip clearance of a passing aircraft on taxiway Y, nor were such lines or guidance required. There were no lines or other guidance indicators on taxiway R that would ensure wingtip clearance from an airplane passing on taxiway M, nor were such lines or indicators required.

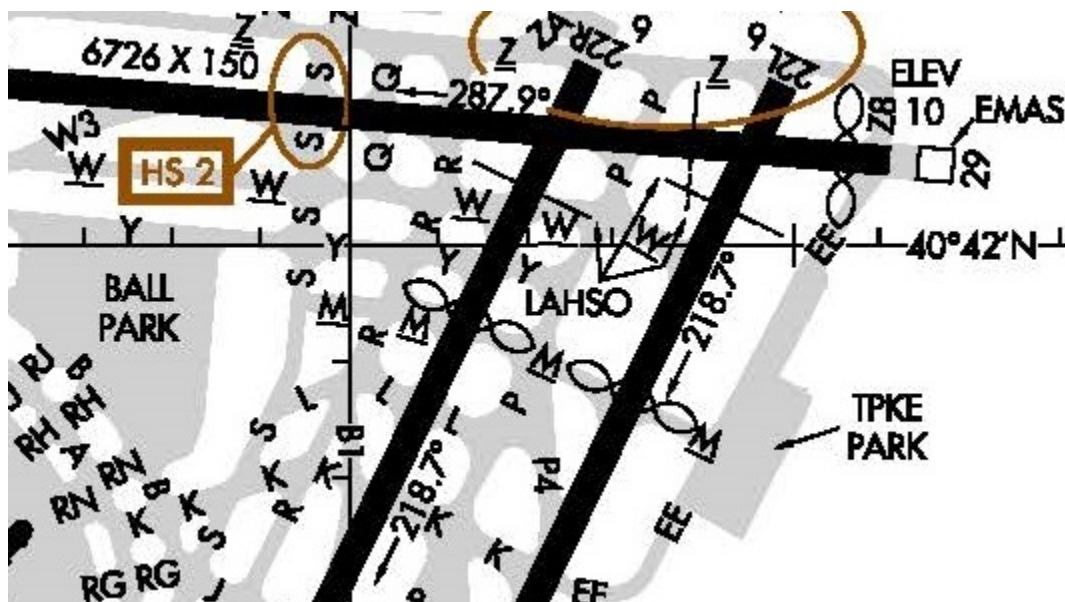
Figure 1 - Expanded view of airport

The distance between the centerline of taxiway Y to the centerline of taxiway M was about 487 feet. That was the area within which flight 4226 was instructed to hold short of taxiway Y on taxiway R, in order to give way to a B737 that would pass in front of them on taxiway Y. The wingspan of a B737 is about 113 feet, which would indicate that if the B737 was positioned on the centerline of taxiway Y, its wing would project about 56.5 feet from the centerline of taxiway, with about 19 feet that would project onto taxiway R. There were no hold short lines or other guidance indicators on taxiway R that would ensure wingtip clearance of a passing aircraft on taxiway Y, nor were such lines or guidance required. There were no lines or other guidance indicators on taxiway R that would ensure wingtip clearance from an airplane passing on taxiway M, nor were such lines or indicators required.
