# Aviation Investigation Final Report

<b>Location:</b>	Dallas, Texas	<b>Incident Number:</b>	CEN131A285
<b>Date &amp; Time:</b>	May 16, 2013, 11:20 Local	<b>Registration:</b>	N715CD
<b>Aircraft:</b>	Cirrus SR22	<b>Aircraft Damage:</b>	None
<b>Defining Event:</b>	Sys/Comp malf/fail (non-power)	<b>Injuries:</b>	1 None
<b>Flight Conducted Under:</b>	Part 91: General aviation - Personal

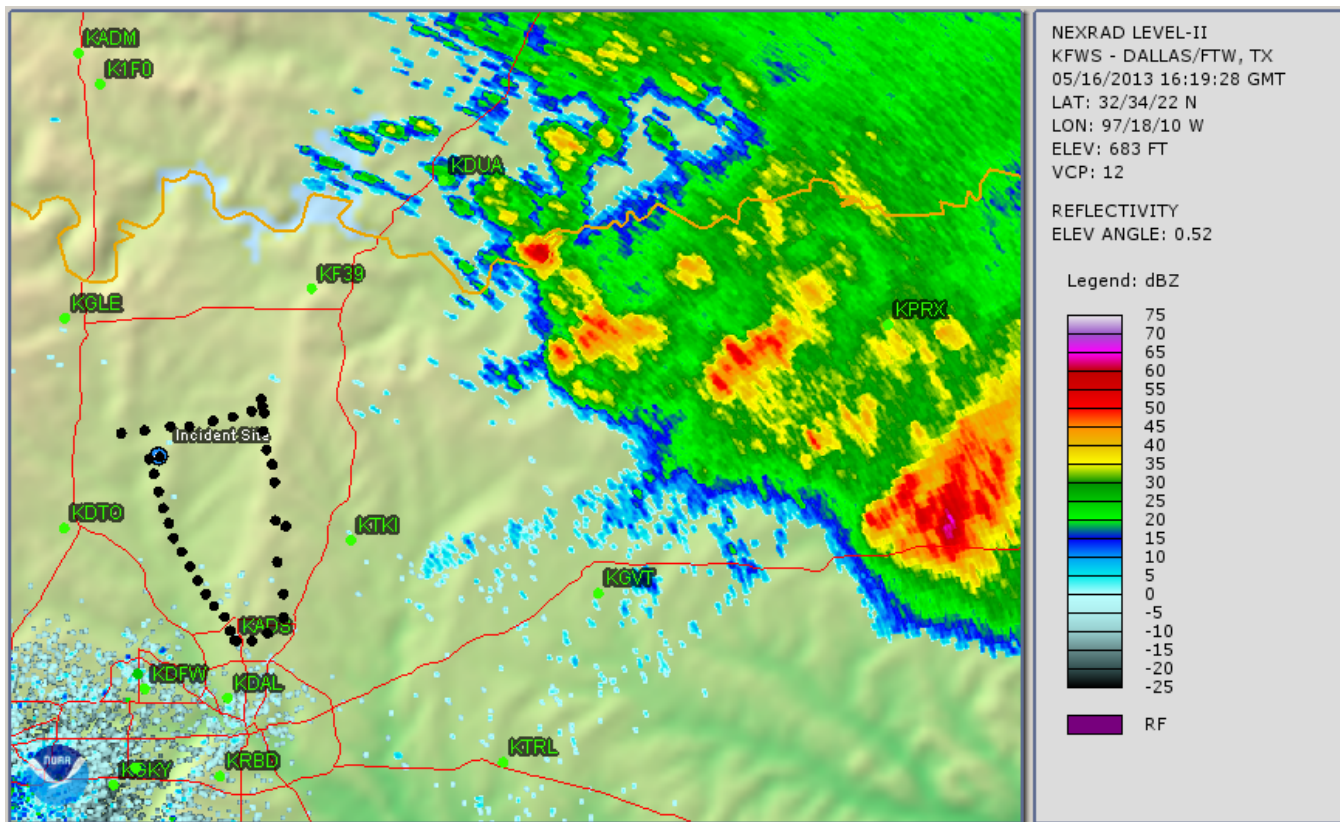
Figure 1 - FWS WSR-88D 0.5° base reflectivity imag

The pilot said that he had weather depicted on a tablet using Anywhere Map, and he was about 20 miles on the backside of the cell. He said that Anywhere Map showed that the cell was moving east, "fairly fast."

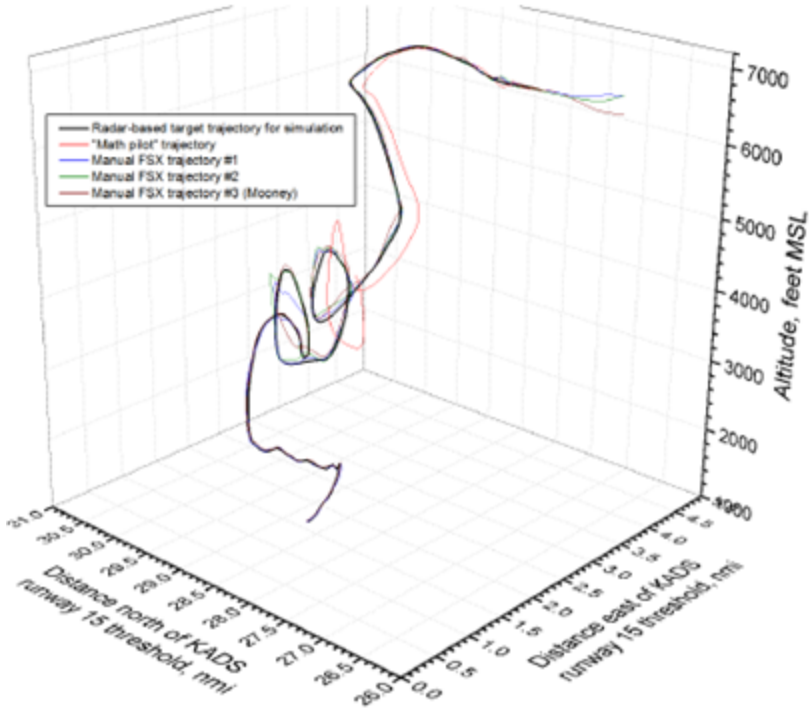
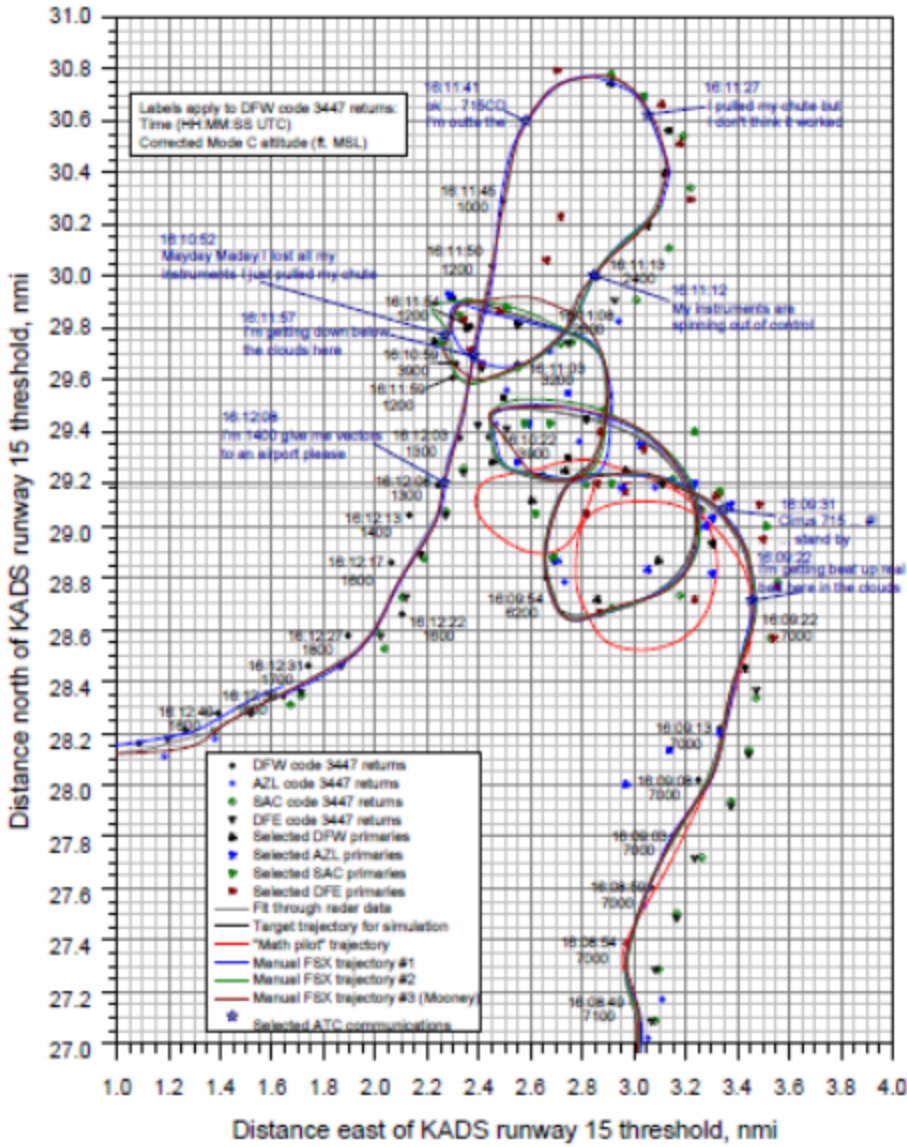
Figure 2 – Plan and 3D Views of Radar Data and Simulation Flight Tracks

manual (simulation) flights where the airplane ran out of energy and could not match the target climb). Because of all the twists and turns that precede this point, it seems possible that the parachute rocket may not be pulling the parachute from the airplane at the intended angle after it is deployed. If the airplane has a large pitch or bank angle or angular rates (or combination of these), as the parachute rocket leaves the airplane, the airplane will rotate and cause the rocket tether to pull at an angle other than that intended.

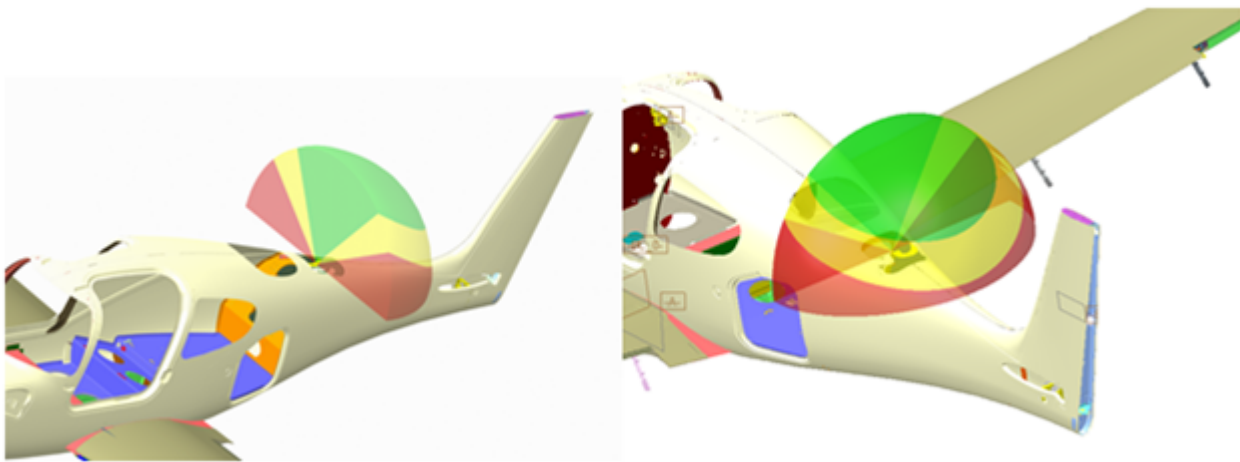
After the incident airplane was ferried to CDC, Duluth, Minnesota, the NTSB IIC requested that off-axis pull tests of the D-bag be performed. The incident D-bag was used for testing, which was carried out at various trajectories using a gantry, a cable attachment to the bag, a load cell, and a hand-crank. The vertical trajectories were 5 to 55 degrees relative to the horizontal in 10 degree increments and later trajectories from the aft direction, 45 degrees from aft, and 90 degree from aft. The results of pull force and D-bag distance movement were recorded. Testing was stopped when the D-bag reached a point where it would begin to pivot on the compartment edge or to prevent damage to the bag/airplane. The NTSB IIC requested that CDC graphically plot the recorded results relative to the airplane diagram. A quarter spherical plot centered over the CAPS compartment was defined with three zones. The green zone depicted a trajectory with an extraction force of 150 lbs or less. The yellow zone depicted a trajectory with an extraction force exceeding 150 lbs. The red zone depicted an extraction force exceeding 200 lbs.

Figure 3 - 3D Representation of Extraction Results
