Aviation Investigation Final Report

Location:	Dallas, Texas	Incident Number:	CEN131A285
Date & Time:	May 16, 2013, 11:20 Local	Registration:	N715CD
Aircraft:	Cirrus SR22	Aircraft Damage:	None
Defining Event:	Sys/Comp malf/fail (non-power)	Injuries:	1 None
Flight Conducted Under:	Part 91: General aviation - Personal

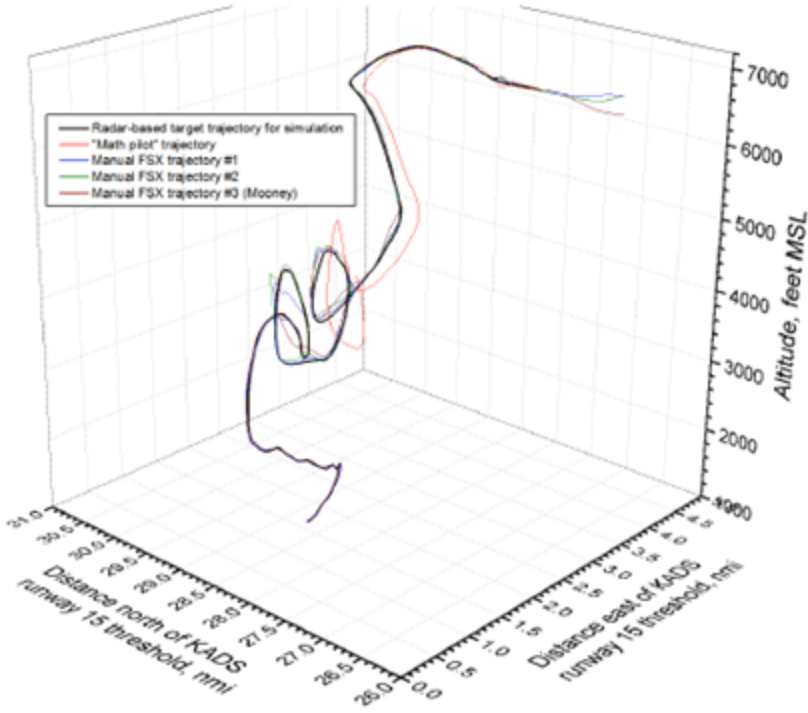
CEN13IA285: Cirrus SR22, N715CD, Dallas, TX, 05/16/2013
3D view of radar data and simulation flight tracks

Plots of radar data and performance estimates for the flight were prepared by a National Transportation Safety Board (NTSB) National Resource Specialist, Aircraft Performance. These plots used secondary radar returns and relevant primary radar returns in the area of the incident, curve fits through that data to estimate airplane position, performance parameters computed from curve fits, and 'math pilot' and 'manual' attempts to match the curve fit trajectories with simulations.

manual (simulation) flights where the airplane ran out of energy and could not match the target climb). Because of all the twists and turns that precede this point, it seems possible that the parachute rocket may not be pulling the parachute from the airplane at the intended angle after it is deployed. If the airplane has a large pitch or bank angle or angular rates (or combination of these), as the parachute rocket leaves the airplane, the airplane will rotate and cause the rocket tether to pull at an angle other than that intended.

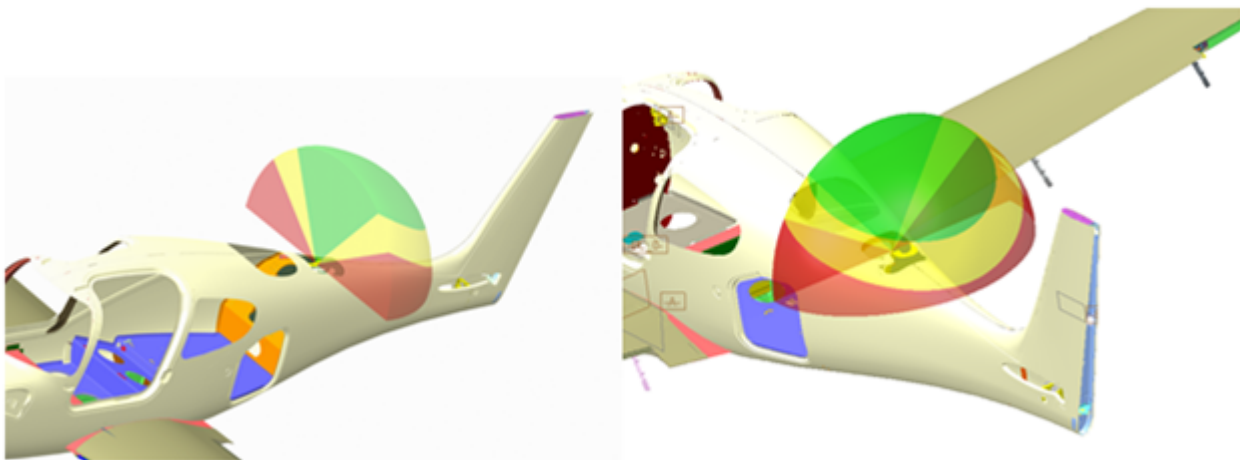
Figure 3 - 3D Representation of Extraction Results

Postincident examination of the parachute system did not reveal any system component failure. Postincident testing showed that off-axis deployment of the parachute could exceed the forces required for a successful deployment of the parachute. If the airplane has a large pitch or bank angle or angular rates (or a combination of these) as the parachute rocket leaves the airplane, the airplane will rotate and cause the rocket tether to pull at an angle other than that intended, and the parachute will fail to deploy. Radar data showed that the airplane was in a very dynamic flight pattern with extreme pitch and bank angles when the parachute system was activated. Thus, the parachute likely failed to deploy when activated due to the dynamic maneuvering of the airplane at the time of the activation, which exceeded the parachute system's certification requirements.

After the incident airplane was ferried to CDC, Duluth, Minnesota, the NTSB IIC requested that off-axis pull tests of the D-bag be performed. The incident D-bag was used for testing, which was carried out at various trajectories using a gantry, a cable attachment to the bag, a load cell, and a hand-crank. The vertical trajectories were 5 to 55 degrees relative to the horizontal in 10 degree increments and later trajectories from the aft direction, 45 degrees from aft, and 90 degree from aft. The results of pull force and D-bag distance movement were recorded. Testing was stopped when the D-bag reached a point where it would begin to pivot on the compartment edge or to prevent damage to the bag/airplane. The NTSB IIC requested that CDC graphically plot the recorded results relative to the airplane diagram. A quarter spherical plot centered over the CAPS compartment was defined with three zones. The green zone depicted a trajectory with an extraction force of 150 lbs or less. The yellow zone depicted a trajectory with an extraction force exceeding 150 lbs. The red zone depicted an extraction force exceeding 200 lbs.
