# Aviation Investigation Final Report

<b>Location:</b>	Dallas, Texas	<b>Incident Number:</b>	CEN131A285
<b>Date &amp; Time:</b>	May 16, 2013, 11:20 Local	<b>Registration:</b>	N715CD
<b>Aircraft:</b>	Cirrus SR22	<b>Aircraft Damage:</b>	None
<b>Defining Event:</b>	Sys/Comp malf/fail (non-power)	<b>Injuries:</b>	1 None
<b>Flight Conducted Under:</b>	Part 91: General aviation - Personal

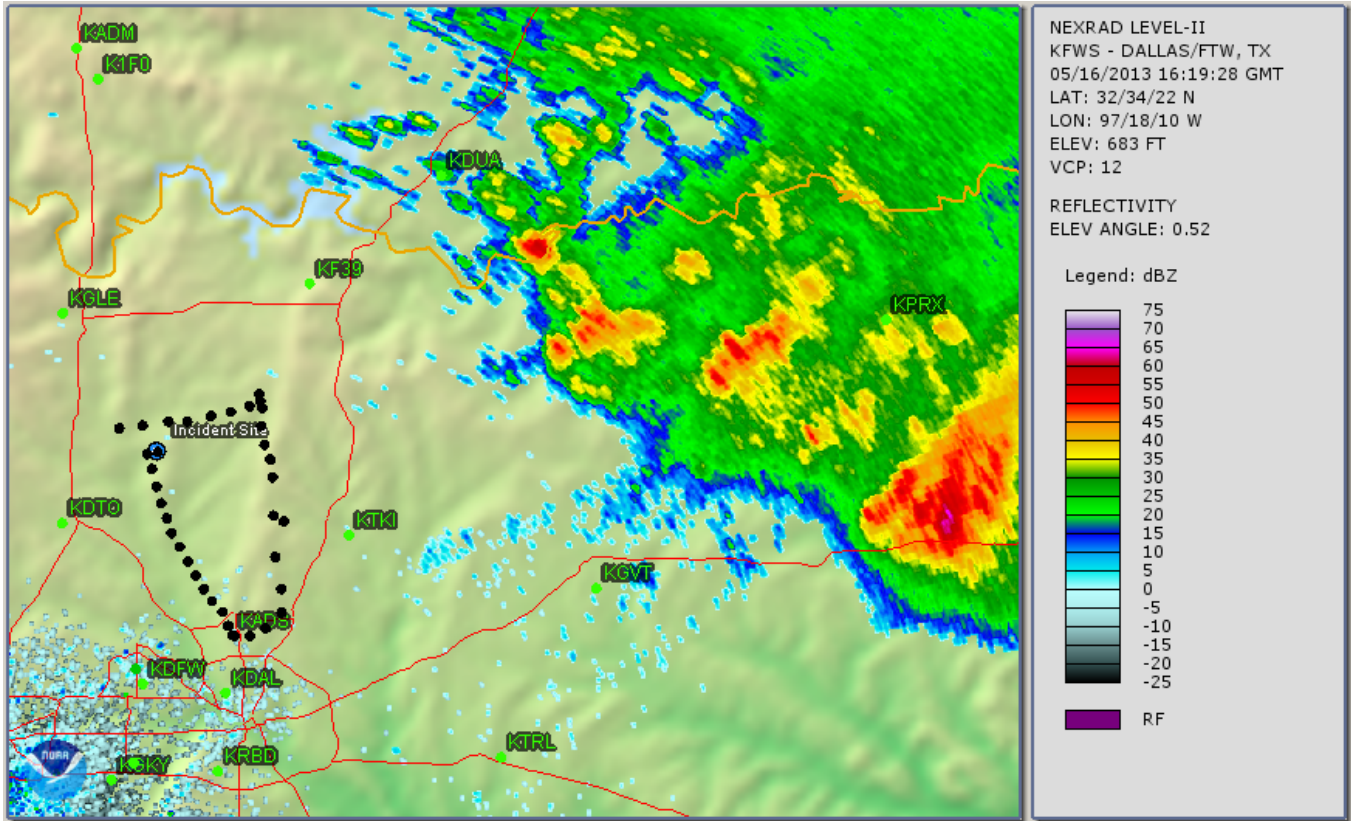
Figure 1 - FWS WSR-88D 0.5° base reflectivity imag

The pilot said that he had weather depicted on a tablet using Anywhere Map, and he was about 20 miles on the backside of the cell. He said that Anywhere Map showed that the cell was moving east, "fairly fast."

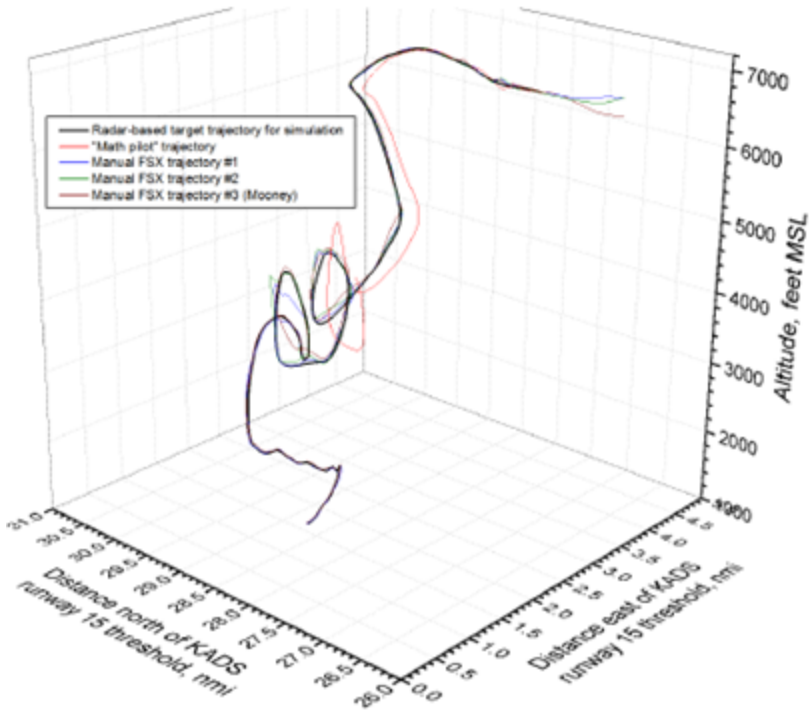
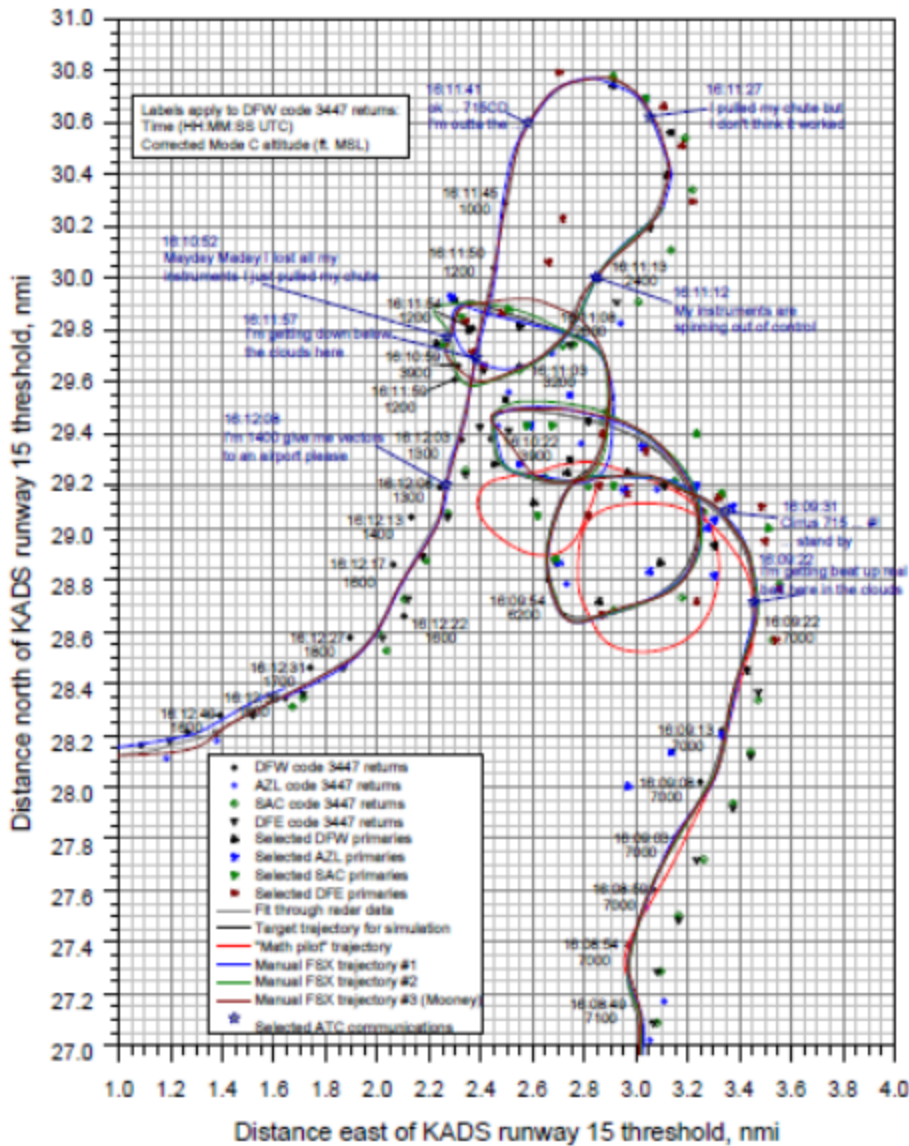
Figure 2 – Plan and 3D Views of Radar Data and Simulation Flight Tracks

Plots of radar data and performance estimates for the flight were prepared by a National Transportation Safety Board (NTSB) National Resource Specialist, Aircraft Performance. These plots used secondary radar returns and relevant primary radar returns in the area of the incident, curve fits through that data to estimate airplane position, performance parameters computed from curve fits, and 'math pilot' and 'manual' attempts to match the curve fit trajectories with simulations.

manual (simulation) flights where the airplane ran out of energy and could not match the target climb). Because of all the twists and turns that precede this point, it seems possible that the parachute rocket may not be pulling the parachute from the airplane at the intended angle after it is deployed. If the airplane has a large pitch or bank angle or angular rates (or combination of these), as the parachute rocket leaves the airplane, the airplane will rotate and cause the rocket tether to pull at an angle other than that intended.
