Aviation Investigation Final Report

Location:	Johnstown, New York	Accident Number:	ERA13FA253
Date & Time:	May 24, 2013, 17:10 Local	Registration:	N31743
Aircraft:	Piper PA-34-200T	Aircraft Damage:	Destroyed
Defining Event:	Loss of control in flight	Injuries:	3 Fatal
Flight Conducted Under:	Part 91: General aviation - Personal

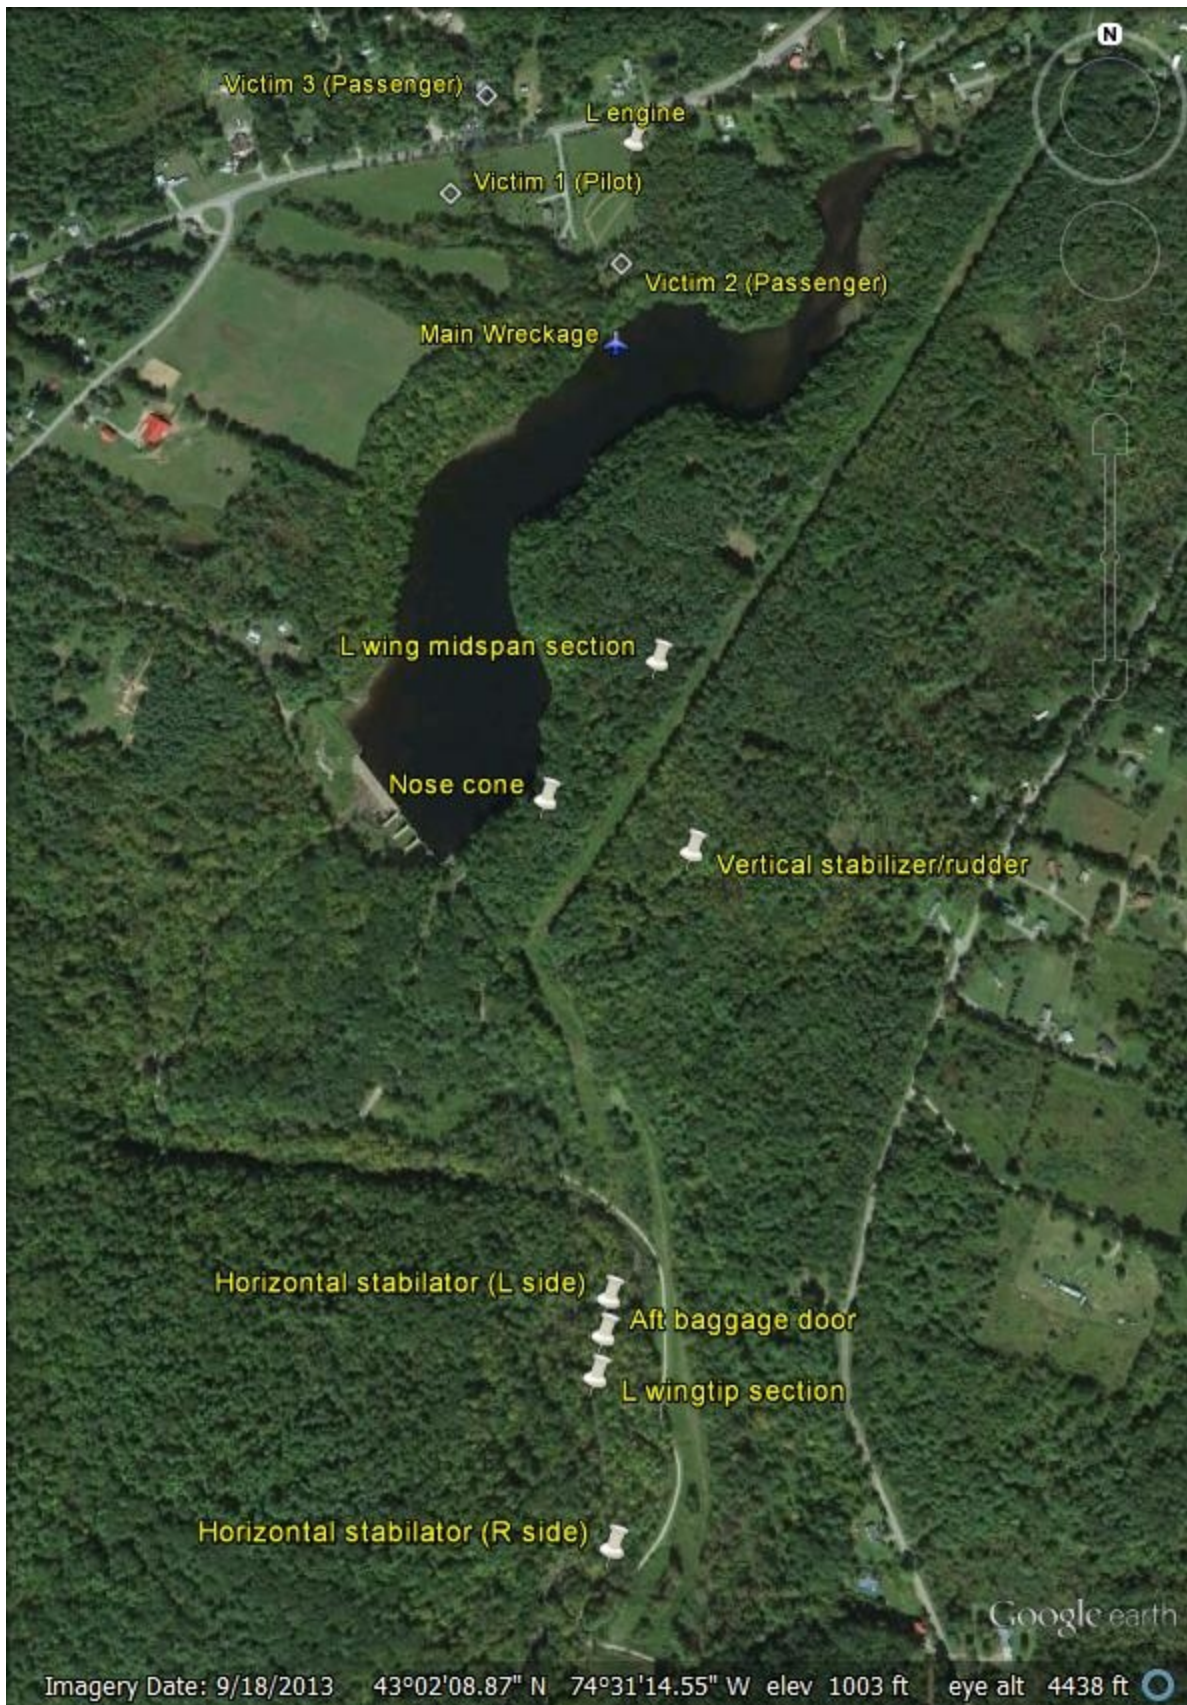
Figure 1 - Wreckage Diagram

The debris field measured approximately one mile in length, beginning on the southeast side of Garoga Reservoir, continuing to the north side of the reservoir, and was oriented on a heading of approximately 360 degrees magnetic. Portions of the empennage, sections of the left wing, and portions of the fuselage skin were located south of the reservoir. The main wreckage came to rest in the reservoir. The left engine was found on the north side of the reservoir. (See figure 1.)
