# Aviation Investigation Final Report

| <b>Location:</b> | Johnstown, New York | <b>Accident Number:</b> | ERA13FA253 |
| <b>Date &amp; Time:</b> | May 24, 2013, 17:10 Local | <b>Registration:</b> | N31743 |
| <b>Aircraft:</b> | Piper PA-34-200T | <b>Aircraft Damage:</b> | Destroyed |

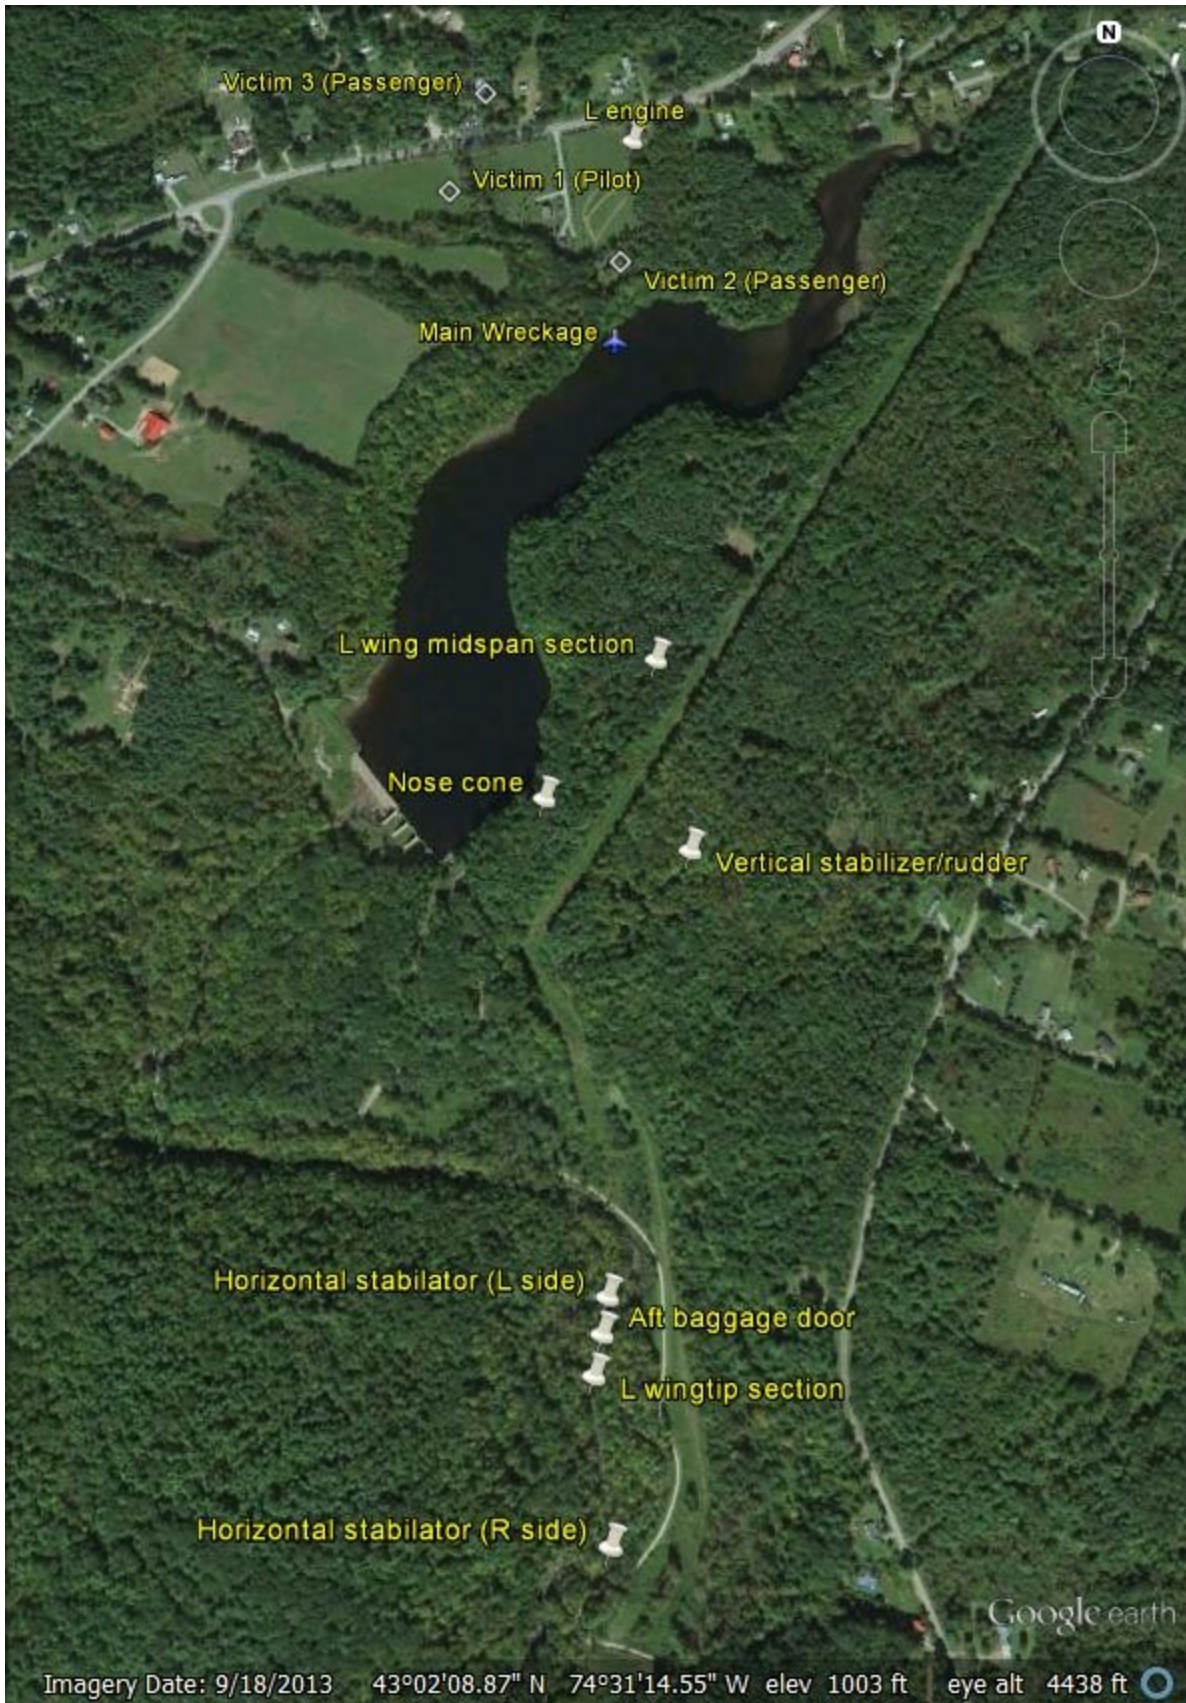
Figure 1 - Wreckage Diagram

The debris field measured approximately one mile in length, beginning on the southeast side of Garoga Reservoir, continuing to the north side of the reservoir, and was oriented on a heading of approximately 360 degrees magnetic. Portions of the empennage, sections of the left wing, and portions of the fuselage skin were located south of the reservoir. The main wreckage came to rest in the reservoir. The left engine was found on the north side of the reservoir. (See figure 1.)
