# Aviation Investigation Final Report

<b>Location:</b>	Philadelphia, Pennsylvania	<b>Accident Number:</b>	DCA14MA081
<b>Date &amp; Time:</b>	March 13, 2014, 18:22 Local	<b>Registration:</b>	N113UW
<b>Aircraft:</b>	Airbus A320 - 214	<b>Aircraft Damage:</b>	Substantial
<b>Defining Event:</b>	Abnormal runway contact	<b>Injuries:</b>	154 None
<b>Flight Conducted Under:</b>	Part 121: Air carrier - Scheduled

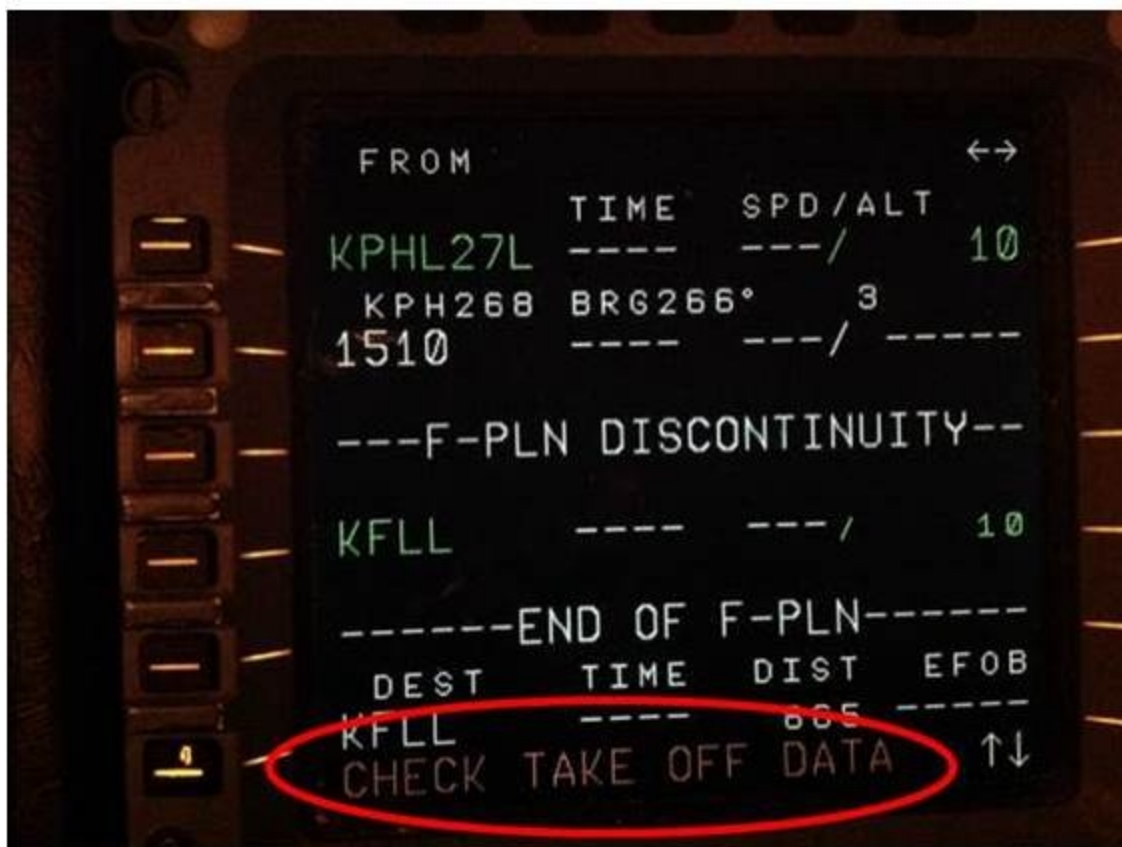
**Figure 3.** MCDU flight plan page after runway change (27R to 27L), with MCDU message (indicated).

During the March 26, 2014, testing in an A320 simulator at the US Airways training facility in Charlotte, North Carolina, NTSB investigators conducted a runway change in the MCDU from runway 27R to 27L without entering the new takeoff V-speeds or a FLEX temperature and documented the MCDU screen, the PFD, and the ECAM. Following the runway change in the MCDU, the "CHECK TAKE OFF DATA" message was visible in the MCDU scratchpad and the upper ECAM indicated a TO/GA target power setting since no FLEX temperature was entered (see figures 3 and 4).

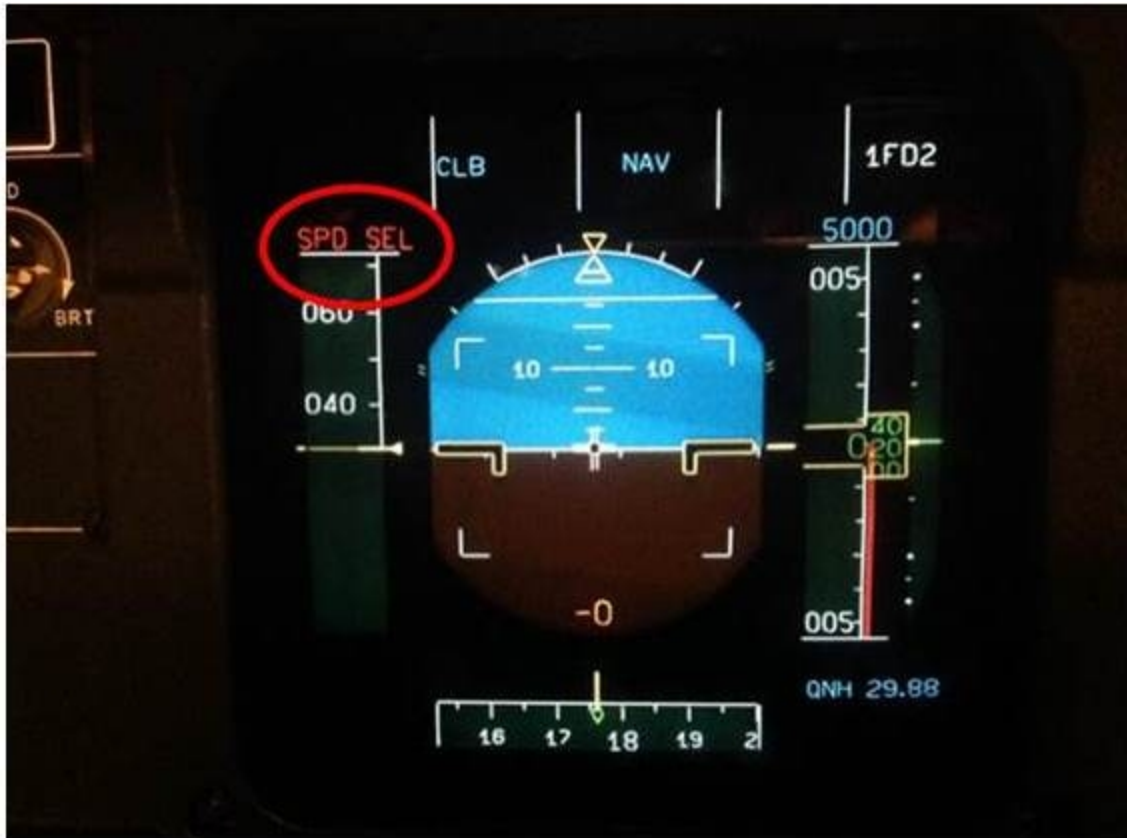
**Figure 5.** PFD after runway change with no V-speeds inserted in MCDU and SPD SEL on speed tape (indicated).

If the V speeds are not entered in the MCDU, a red "SPD SEL" message will appear on the top of the speed scale.

As shown in figure 5, a red "SPD SEL" appeared at the top of the speed tape when there were no V-speeds indicated on the PFD speed tape.

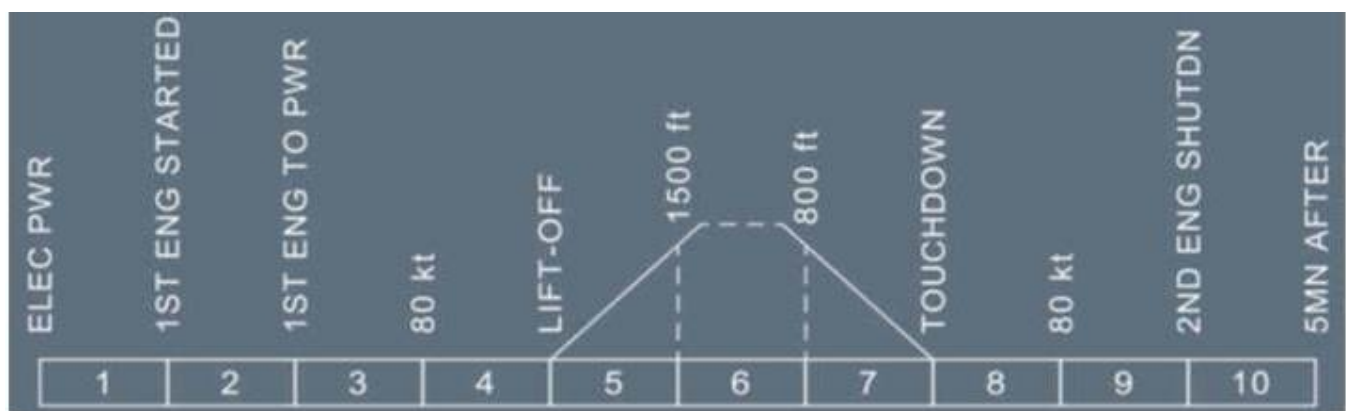
**Figure 6.** Chart of flight phase segments.

If the takeoff is initiated with an abnormal thrust setting, during the acceleration phase FWC remains in flight phase 2 and does not enter into flight phase 3 because of low TLA. When over 80 KIAS, the FWC leaves the flight phase 2 for speed above the defined threshold and computes the flight phase 8 corresponding to a landing roll (see figure 6).

The RETARD callout is therefore triggered at around 80 KIAS. Airbus stated that, in this scenario, the RETARD callout is not associated with Master Caution or Master Warning lights, and the RETARD callout experienced during the takeoff roll is linked to a divergence between the FWC computation and the aircraft's flight phase, due to the throttles position not being set in the TO POWER condition (TO/GA or FLX/MCT TLA positions). Airbus stated that this FWC behavior is due to the TLA configuration combined with the flex temperature not being entered in the FMS.
