Aviation Investigation Final Report

Location:	Northport, Alabama	Accident Number:	ERA14FA396
Date & Time:	August 19, 2014, 11:00 Local	Registration:	N444RS
Aircraft:	McDonnell Douglas Helicopter 369E	Aircraft Damage:	Substantial
Defining Event:	Unknown or undetermined	Injuries:	2 Fatal
Flight Conducted Under:	Part 91: General aviation - Aerial observation

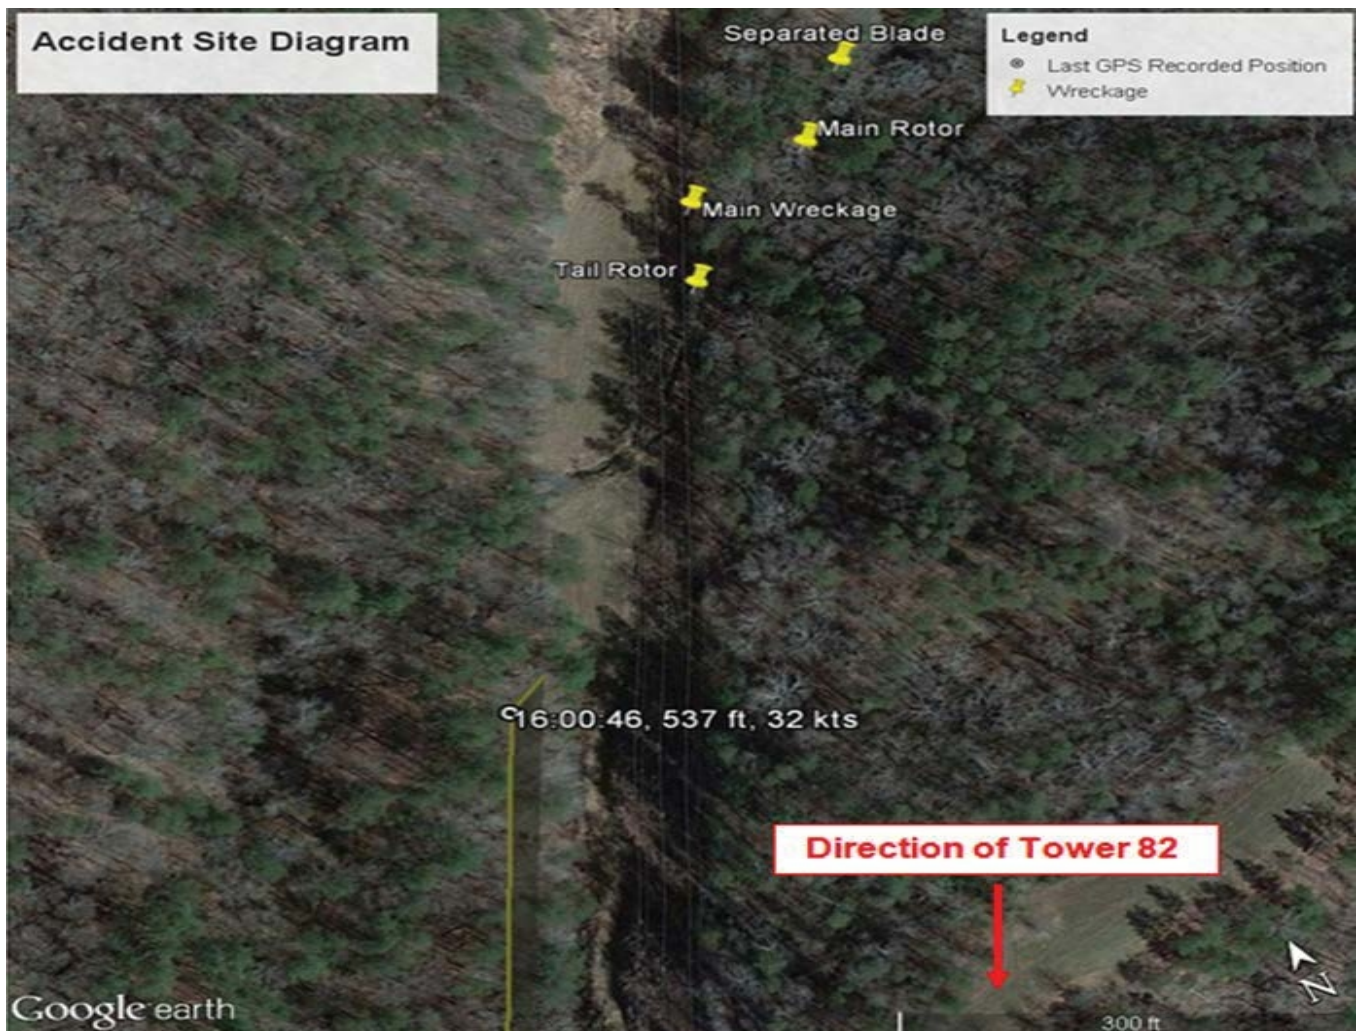
According to the data, the helicopter departed from TCL at 1034 and proceeded east before intercepting the north/south oriented powerline span about 1040, and proceeding north. The helicopter maintained approximate GPS groundspeeds between 30 and 60 knots, GPS altitudes between 300 and 700 feet, and generally flew on the west (left) side of the powerlines. The ground track briefly slowed and transitioned to the east (right) of the powerlines on two occasions, about 1047 and 1058. Both of the transitions occurred roughly at points along the powerlines where transmission towers were present. At 1100:26, the calculated GPS groundspeed was 32 knots, and the GPS altitude was 467 feet, or about 120 feet agl. The next recorded position, at 1100:36, placed the helicopter at 33 knots GPS groundspeed, 522 feet GPS altitude, and about 125 feet agl. The final recorded position, at 1100:46, recorded a GPS groundspeed of 32 knots, 537 feet GPS altitude, or about 164 feet agl. This position was roughly 410 feet north of transmission tower 82. The helicopter's tail rotor was recovered about 400 feet northeast of the final recorded GPS position.

Figure 1 – Accident Site Diagram Depicting GPS Flight Path and Helicopter Wreckage
