# Aviation Investigation Final Report

| <b>Location:</b> | Lanai, Hawaii | <b>Accident Number:</b> | DCA15LA011 |
| <b>Date &amp; Time:</b> | October 16, 2014, 14:47 Local | <b>Registration:</b> | N301KH |
| <b>Aircraft:</b> | Boeing 737 330 | <b>Aircraft Damage:</b> | Substantial |

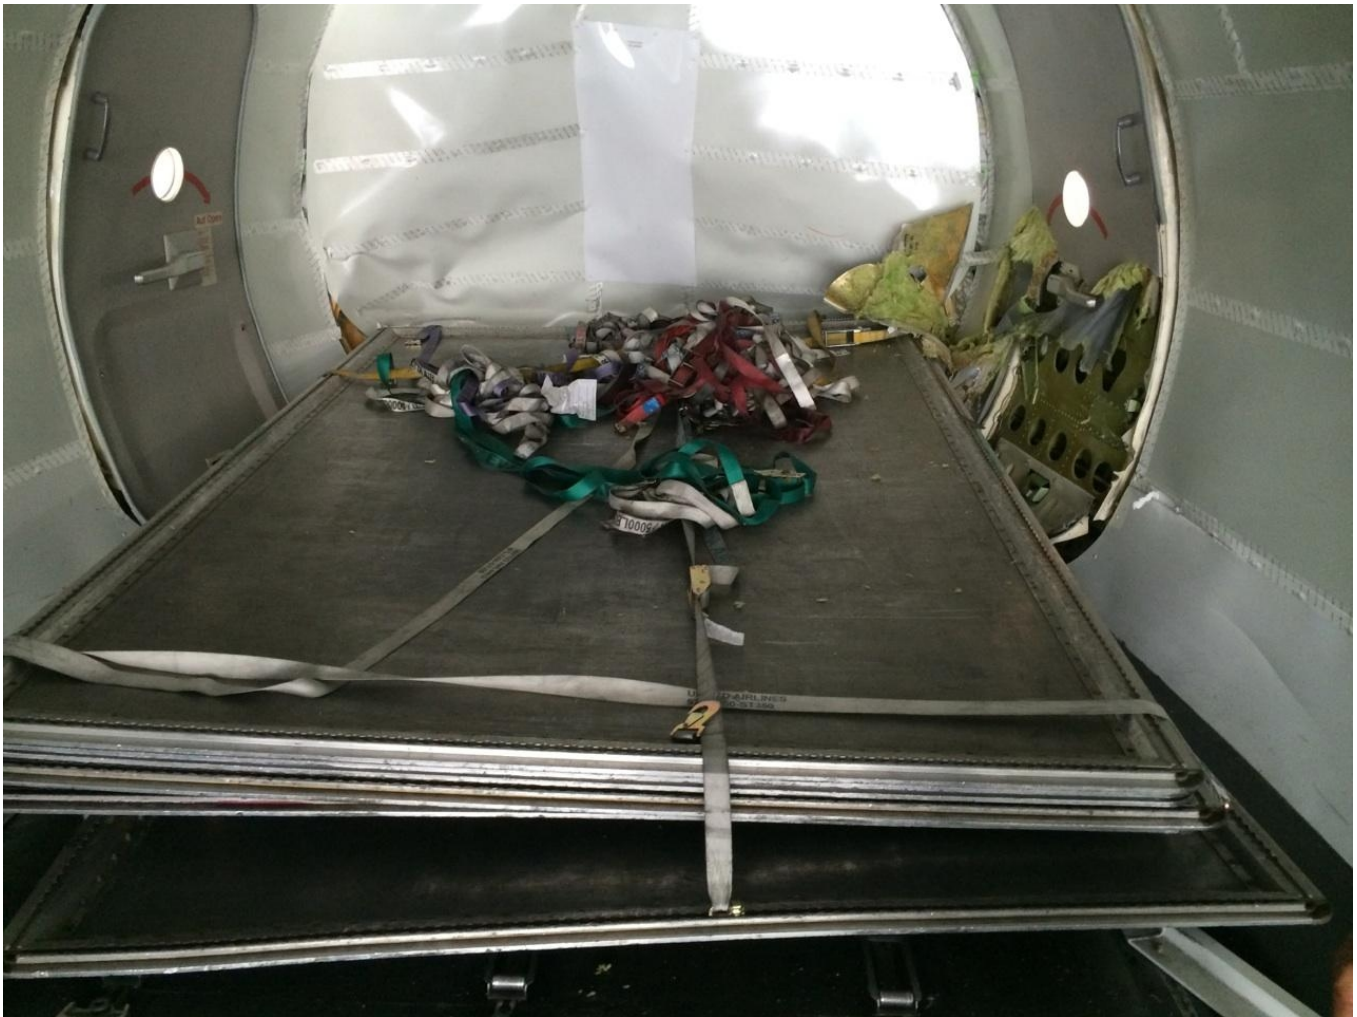
The cargo floor locks will only secure the bottom pallet when engaged properly and not the stacked pallets. The decision was made to secure the stacked pallets with a cargo strap which was insufficient to keep the pallets from moving. Even though it was stated that during the loading process that the locks were "up" and locked, when the Marshaller entered the airplane he observed the locks between station 8 and 9 were down/unlocked. In addition, there was damage found to the right hand forward and aft locking mechanisms, implying these locks were used but failed due to overload.

The National Transportation Safety Board determines the probable cause(s) of this accident to be: the improper loading and securing of the cargo pallets, which shifted on departure, resulting in substantial damage to the aft pressure bulkhead.&nbsp;bsp;

Per company procedures, Marshaller A performs a post arrival check of the aircraft and verifies the content of the cargo before unloading can begin. Marshaller A noticed that all of the pallets were loaded into position 9, that none of the locks between position 8 and 9 were up, and the straps holding the sheets had allowed the sheets to shift aft making contact with the aft pressure bulkhead. Post event examination revealed that the aft pressure bulkhead had substantial damage, left aft (L2) door panel was damaged, and the right hand forward and aft pop up locking mechanism "claws" were detached/torn from their seat tracks. (See Figure 1)

Figure 1: Pallet cookie sheets and damage to aft pressure bulkhead
