# Aviation Investigation Final Report

<b>Location:</b>	Bahama, North Carolina	<b>Accident Number:</b>	ERA15FA023
<b>Date &amp; Time:</b>	October 21, 2014, 10:44 Local	<b>Registration:</b>	N64GM
<b>Aircraft:</b>	Beech D95	<b>Aircraft Damage:</b>	Substantial
<b>Defining Event:</b>	Loss of control in flight	<b>Injuries:</b>	1 Fatal, 1 Serious
<b>Flight Conducted Under:</b>	Part 91: General aviation - Instructional

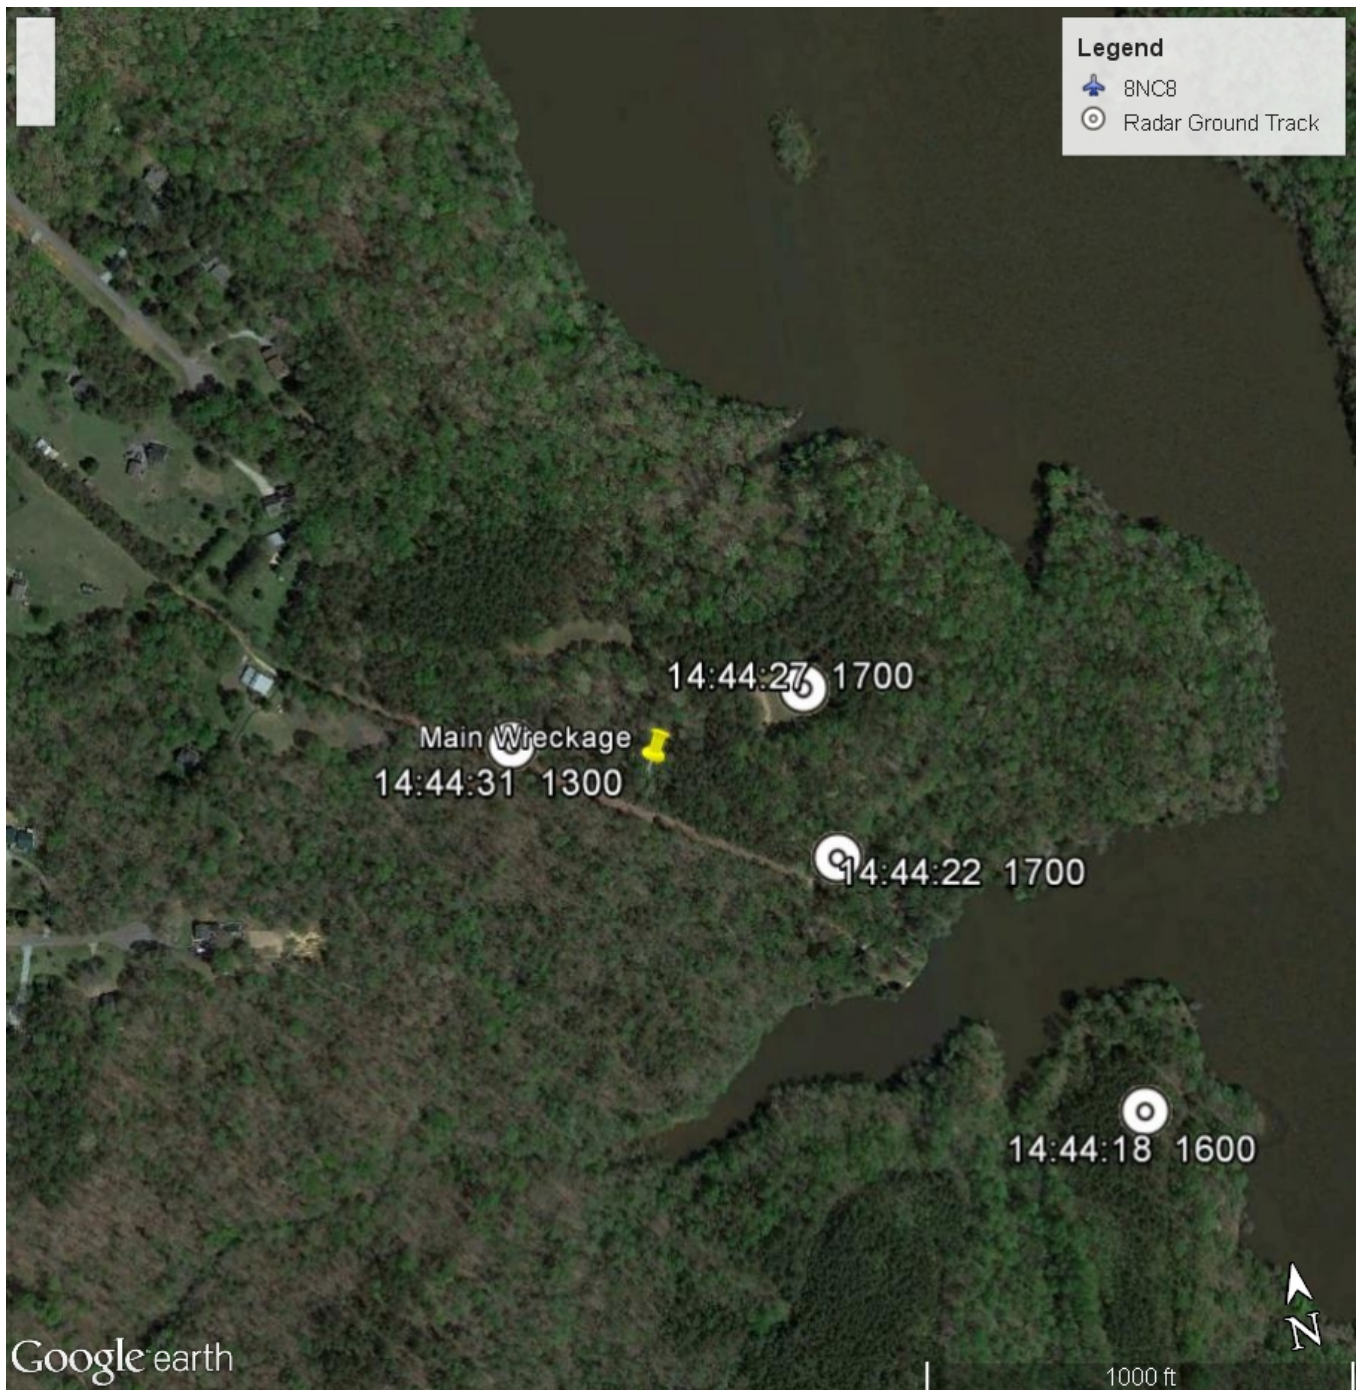
**Figure 1 - Radar and Accident Site Plot**

According to the study, the airplane climbed and gained speed from takeoff to about 1042, when the altitude leveled off around 1,300 feet msl. About 1043, the airplane descended to about 1,200 feet for about 45 seconds, before climbing again to 1,700 feet by 1044:23. From 1043 until near the end of the flight, the airplane's airspeed decreased from about 130 to about 45 knots at 1044:27, when the airplane entered a rapid descent.

At 1044:23, the peak of the airplane's final climb, the equivalent airspeed was calculated to be less than 50 knots and slowing. For a gross weight of 4,200 pounds (maximum take-off weight), 50 knots was below any of the landing gear and flaps up stall speeds, that were published in the airplane owner's manual. An exact accounting of the airplane's weight at the time of the accident could not be calculated; however, the empty weight of the airplane was 2,555 pounds; at that weight, the power-on stall speed would be expected to reduce from 53 to 41 knots.
