Aviation Investigation Final Report

Location:	Bahama, North Carolina	Accident Number:	ERA15FA023
Date & Time:	October 21, 2014, 10:44 Local	Registration:	N64GM
Aircraft:	Beech D95	Aircraft Damage:	Substantial
Defining Event:	Loss of control in flight	Injuries:	1 Fatal, 1 Serious
Flight Conducted Under:	Part 91: General aviation - Instructional

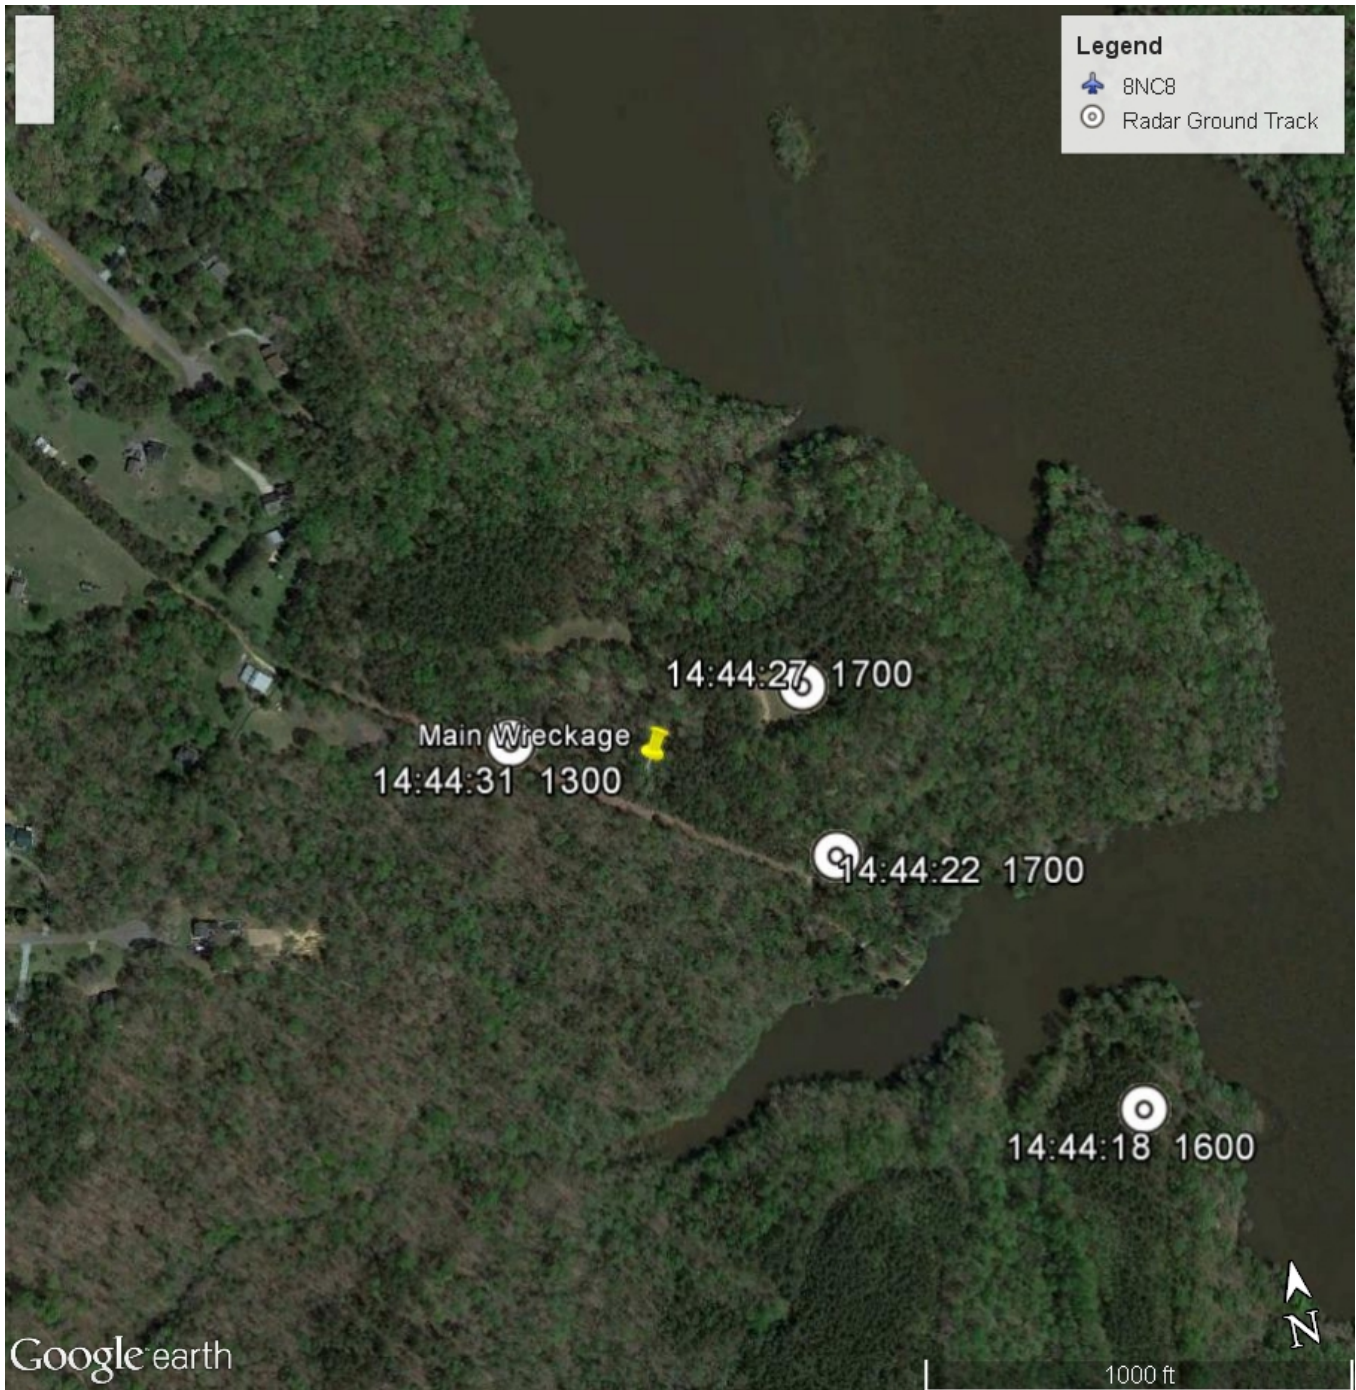
Figure 1 - Radar and Accident Site Plot

According to the study, the airplane climbed and gained speed from takeoff to about 1042, when the altitude leveled off around 1,300 feet msl. About 1043, the airplane descended to about 1,200 feet for about 45 seconds, before climbing again to 1,700 feet by 1044:23. From 1043 until near the end of the flight, the airplane's airspeed decreased from about 130 to about 45 knots at 1044:27, when the airplane entered a rapid descent.

At 1044:23, the peak of the airplane's final climb, the equivalent airspeed was calculated to be less than 50 knots and slowing. For a gross weight of 4,200 pounds (maximum take-off weight), 50 knots was below any of the landing gear and flaps up stall speeds, that were published in the airplane owner's manual. An exact accounting of the airplane's weight at the time of the accident could not be calculated; however, the empty weight of the airplane was 2,555 pounds; at that weight, the power-on stall speed would be expected to reduce from 53 to 41 knots.
