# Aviation Investigation Final Report

<b>Location:</b>	Port Huron, Michigan	<b>Accident Number:</b>	CEN15FA087
<b>Date &amp; Time:</b>	December 24, 2014, 12:54 Local	<b>Registration:</b>	N38884
<b>Aircraft:</b>	Piper PA-34-200T	<b>Aircraft Damage:</b>	Destroyed
<b>Defining Event:</b>	Loss of control in flight	<b>Injuries:</b>	1 Fatal
<b>Flight Conducted Under:</b>	Part 91: General aviation

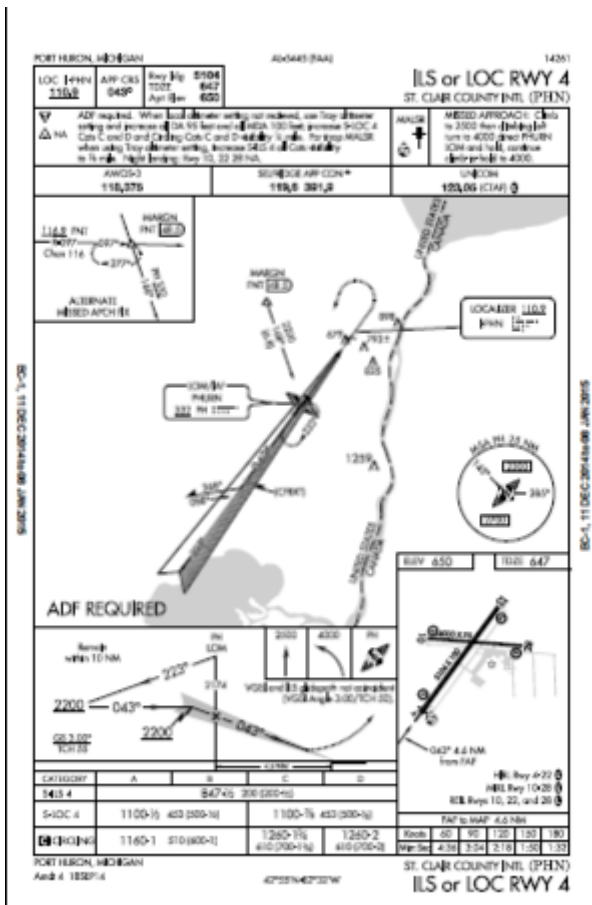
Figure 1: The ILS 4 approach chart shows straight-in approach minimums with a decision height of 847 feet and a ½ mile visibility. The locator outer marker, PHURN, was 4.6 miles from the approach end of runway 4 which had a touchdown zone elevation of 647 feet. The missed approach procedure upon reaching the missed approach point/decision height was climb to 2,500 feet then climbing left turn to 4,000 feet direct PHURN and hold, continue climb-in-hold to 4,000 feet.

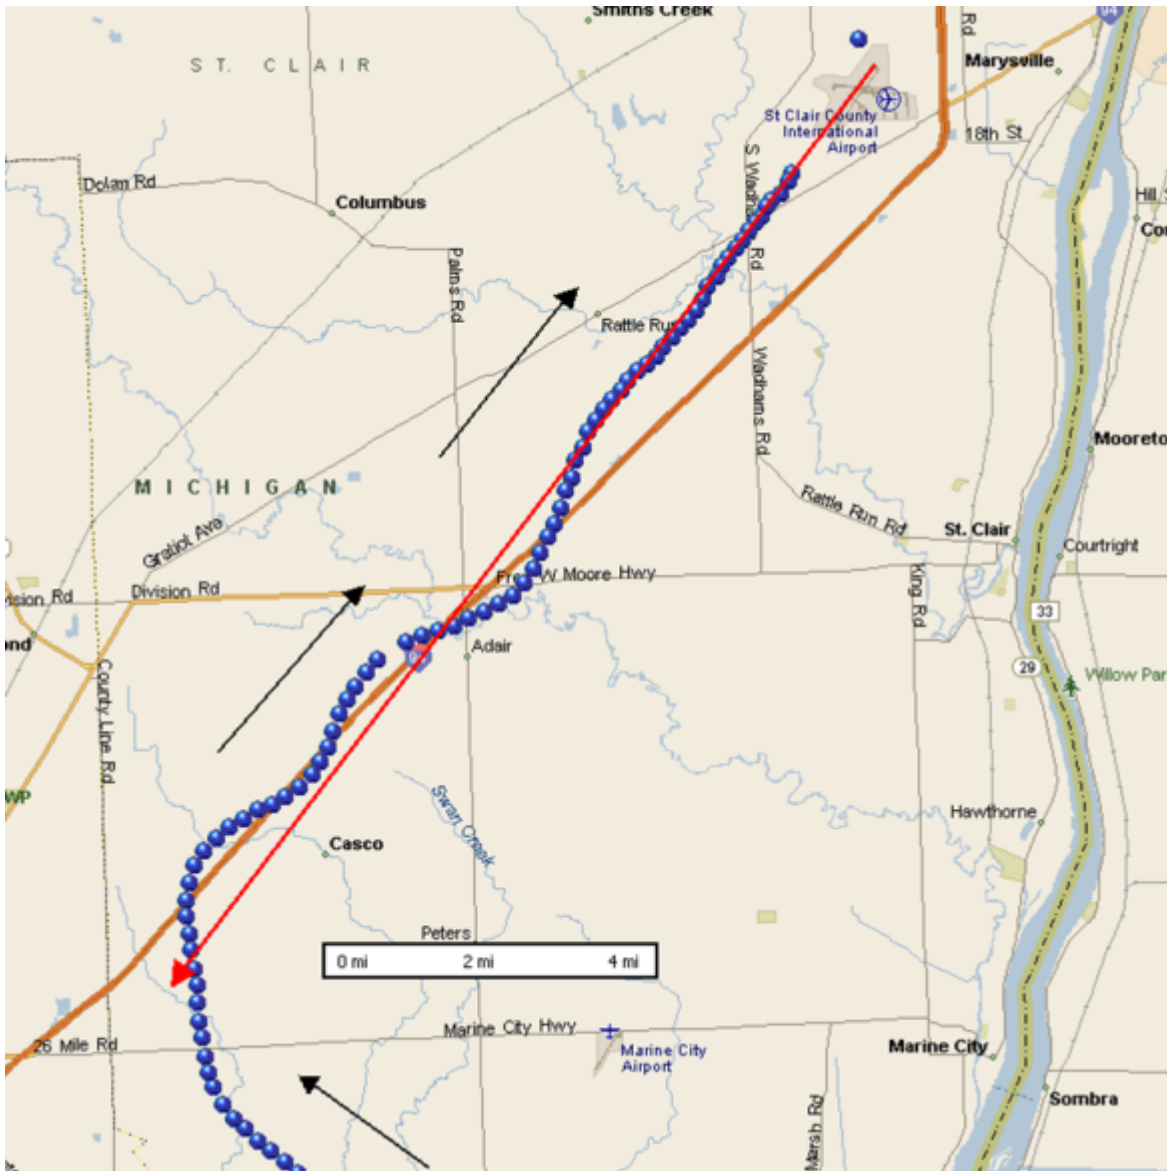
Figure 1: The radar flight track of N38884 is indicated by red dots. Direction of flight is indicated by black arrows. Final approach course of the ILS RWY 4 approach to PHN is indicated by a red arrow.

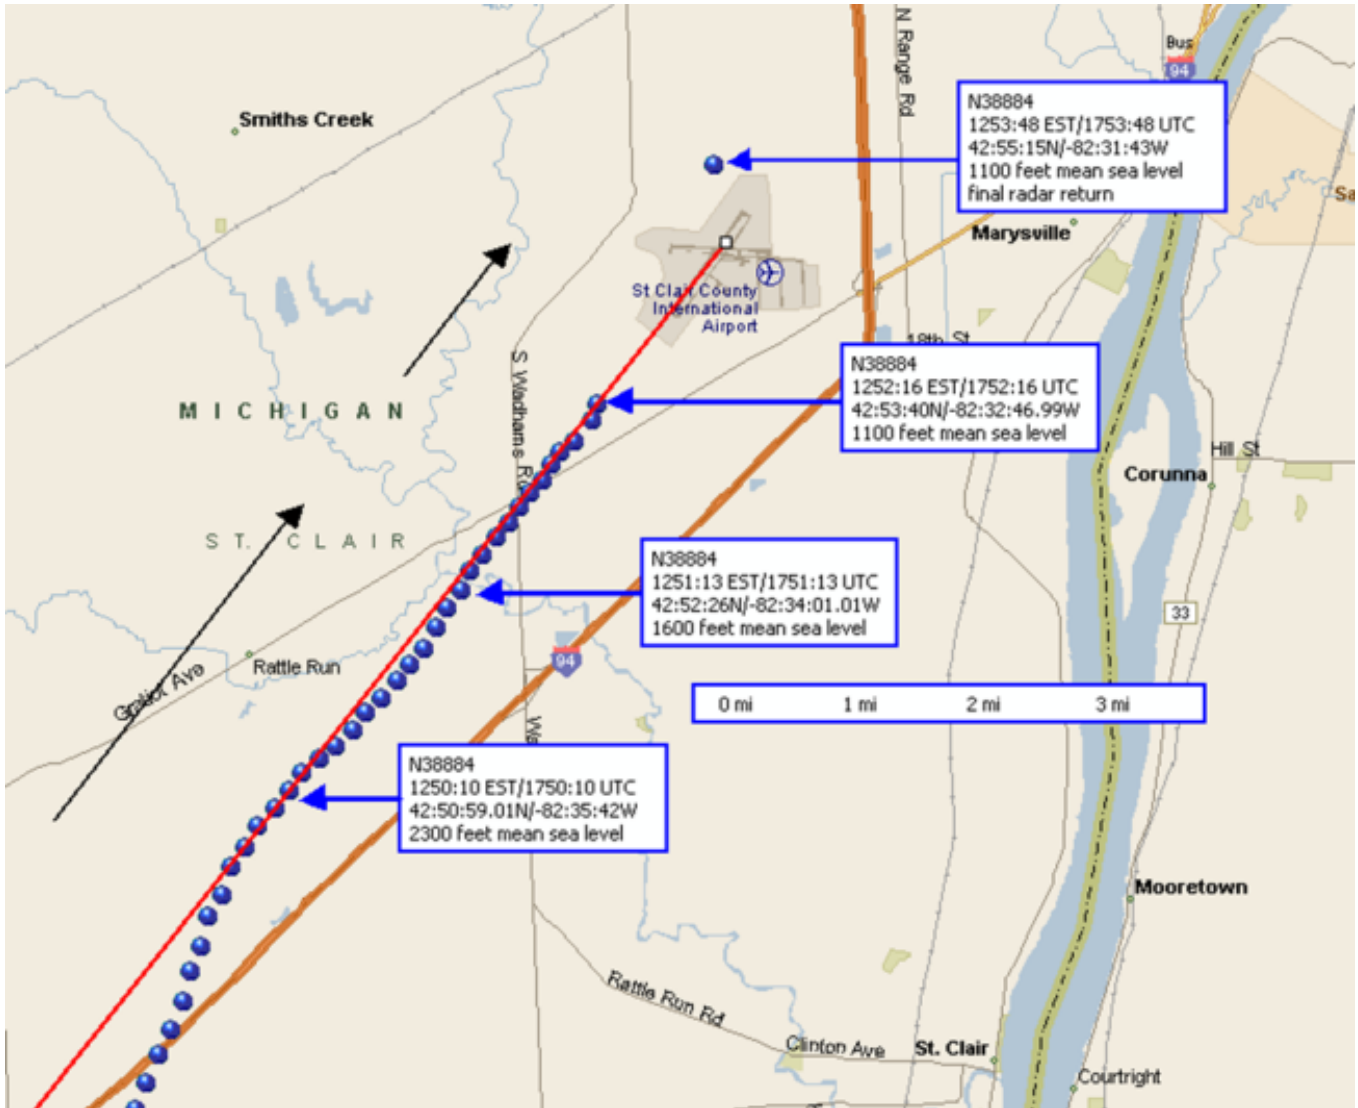
Figure 2: A closer view of the radar flight track for N38884 showing the last recorded radar altitude of the airplane which was 1,100 feet and about 0.7 miles from the approach end of runway 4. The next recorded radar altitude for the airplane was northwest of the departure end of runway 4 near the accident site.
