Aviation Investigation Final Report

Location:	Chicago, Illinois	Incident Number:	OPS15IA011
Date & Time:	February 17, 2015, 21:45 Local	Registration:	N698CB
Aircraft:	Embraer EMB 145LR	Aircraft Damage:	None
Defining Event:	Runway incursion veh/AC/person	Injuries:	53 None
Flight Conducted Under:	Part 121: Air carrier - Scheduled

Location:	Chicago, Illinois	Incident Number:	OPS15IA011
Date & Time:	February 17, 2015, 21:45 Local	Registration:	N154GJ
Aircraft:	BOMBARDIER INC CL 600 2C10	Aircraft Damage:	None
Defining Event:	Runway incursion veh/AC/person	Injuries:	60 None
Flight Conducted Under:	Part 121: Air carrier - Scheduled

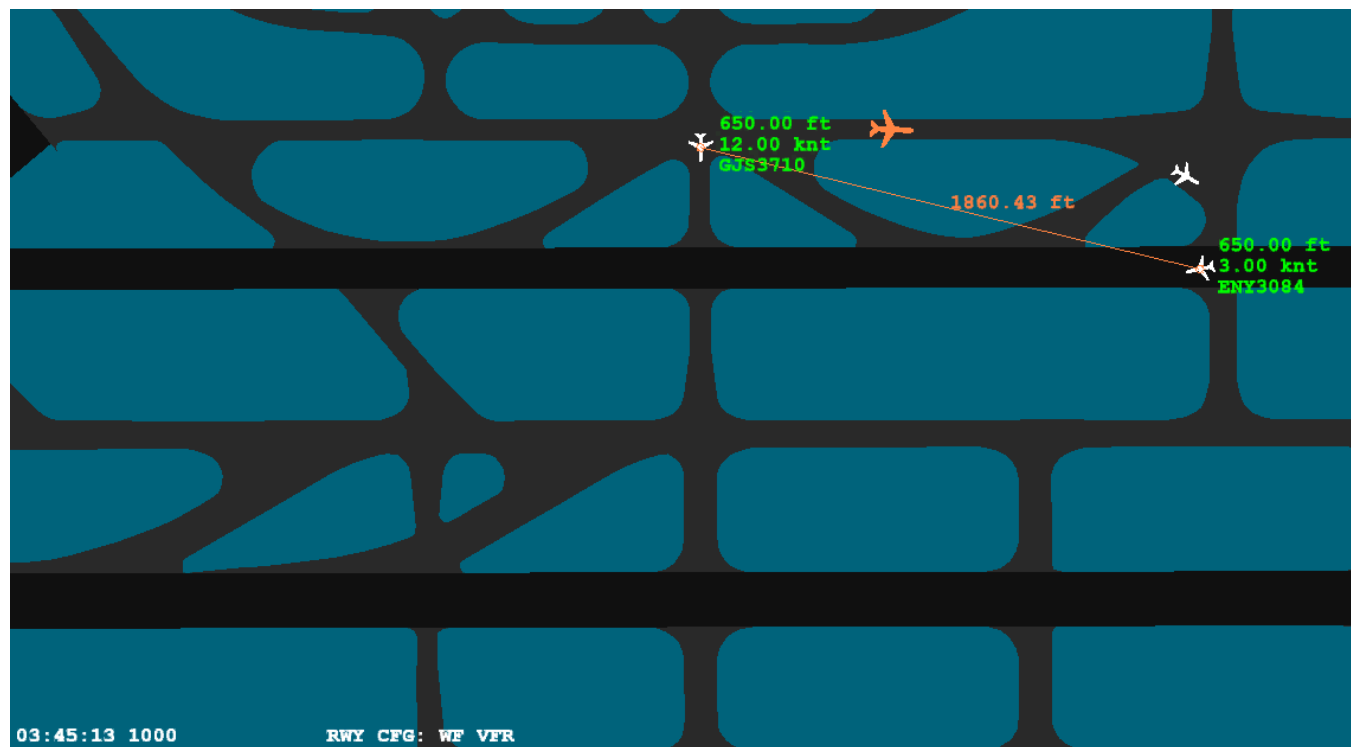
According to recorded Airport Surface Detection Equipment, Model X (ASDE-X) data, ENY3084 began departure roll at 2145:17. GJS3710 was about 265 feet north of the runway 28R edge line, taxiing south on Taxiway F at approximately 11 knots.

Figure 1 – ASDE-X presentation of ENY3084 and GJS3710 at 2145:13.

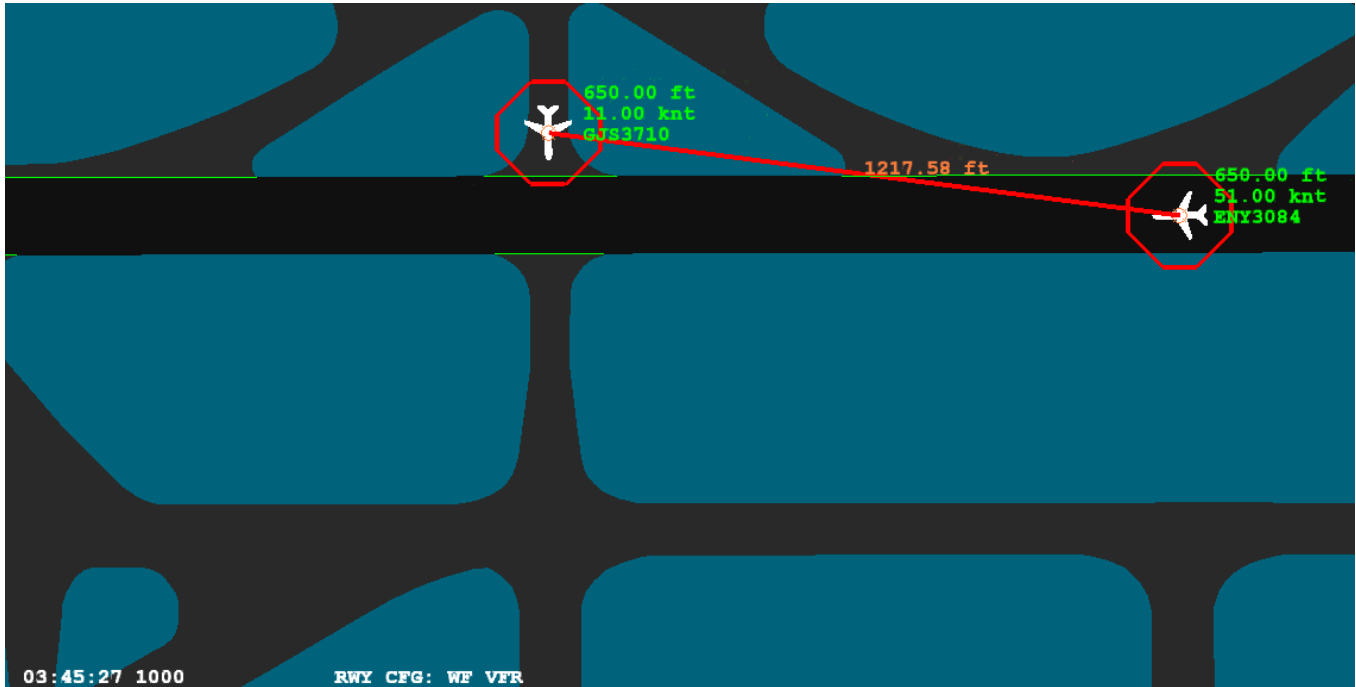
At 21:45:28, an ASDE-X alert was issued when ENY3084 met the velocity and acceleration parameters that are required by the ASDE-X to be considered a departure. ENY3084 was traveling at approximately 56 knots and was approximately 1041 feet from the runway 28R/taxiway F intersection. GJS3710 was on taxiway F approximately 42 feet from crossing the runway 28R edge line and was traveling at approximately 11 knots.

Figure 2 – ASDE-X presentation of ENY3084 and GJS3710 at 2145:27.

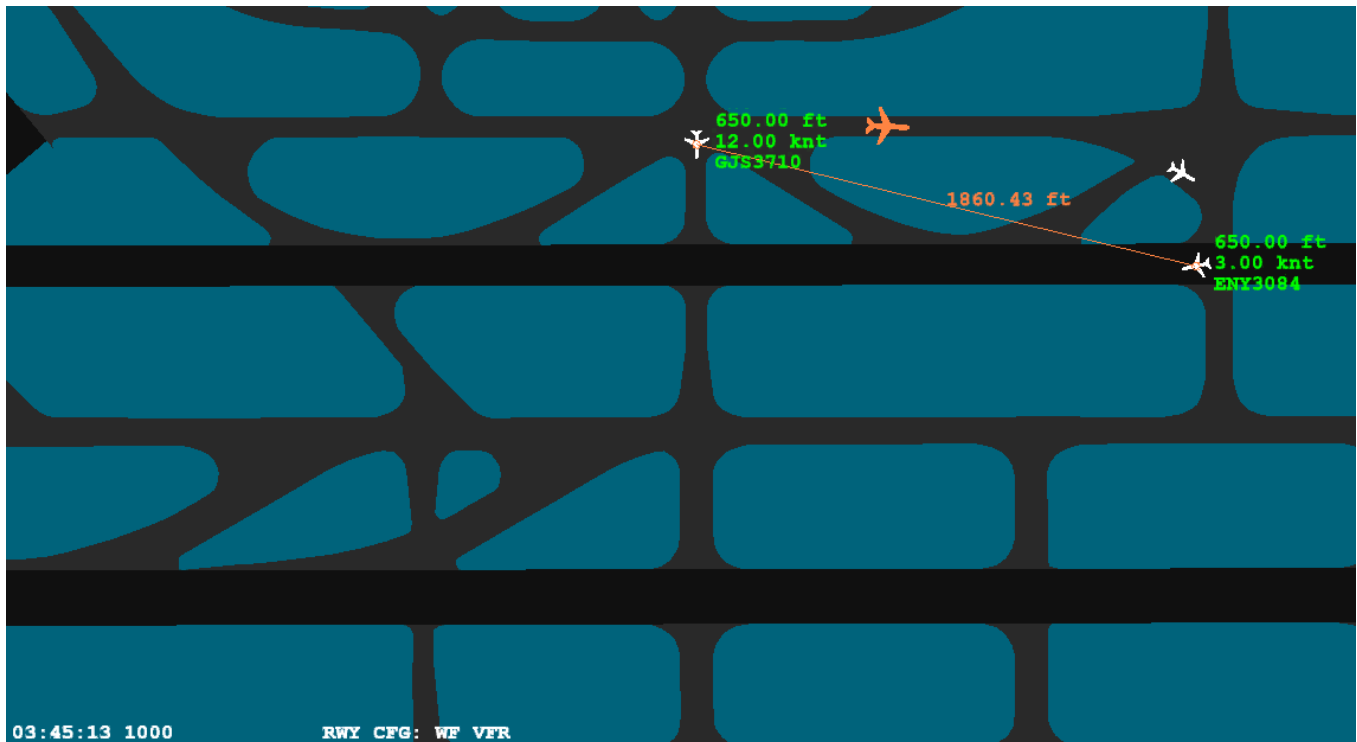
According to recorded Airport Surface Detection Equipment, Model X (ASDE-X) data, ENY3084 began departure roll at 2145:17. GJS3710 was about 265 feet north of the runway 28R edge line, taxiing south on Taxiway F at approximately 11 knots.

Figure 1 – ASDE-X presentation of ENY3084 and GJS3710 at 2145:13.

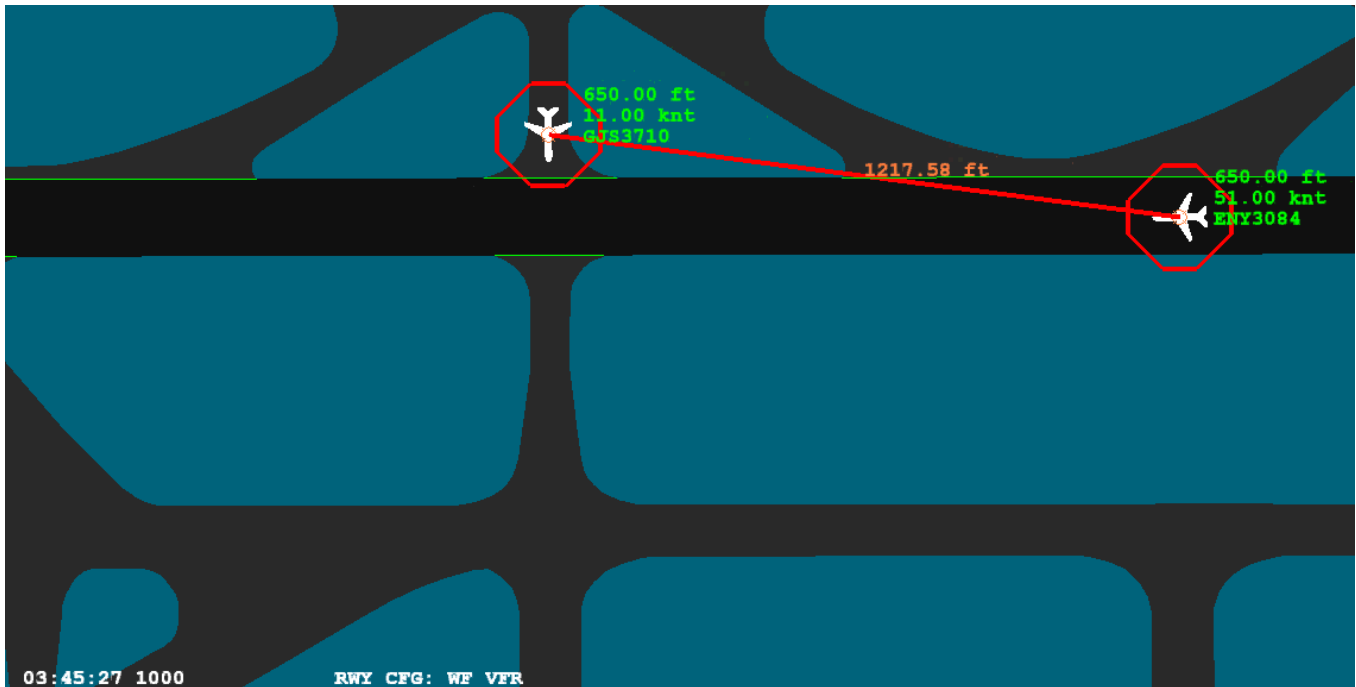
At 21:45:28, an ASDE-X alert was issued when ENY3084 met the velocity and acceleration parameters that are required by the ASDE-X to be considered a departure. ENY3084 was traveling at approximately 56 knots and was approximately 1041 feet from the runway 28R/taxiway F intersection. GJS3710 was on taxiway F approximately 42 feet from crossing the runway 28R edge line and was traveling at approximately 11 knots.

Figure 2 – ASDE-X presentation of ENY3084 and GJS3710 at 2145:27.
