Aviation Investigation Final Report

Location:	Norfolk, Virginia	Accident Number:	ERA15FA144
Date & Time:	March 4, 2015, 04:13 Local	Registration:	N66BB
Aircraft:	Mooney M20F	Aircraft Damage:	Substantial
Defining Event:	Controlled flight into terr/obj (CFIT)	Injuries:	3 Fatal
Flight Conducted Under:	Part 91: General aviation - Personal

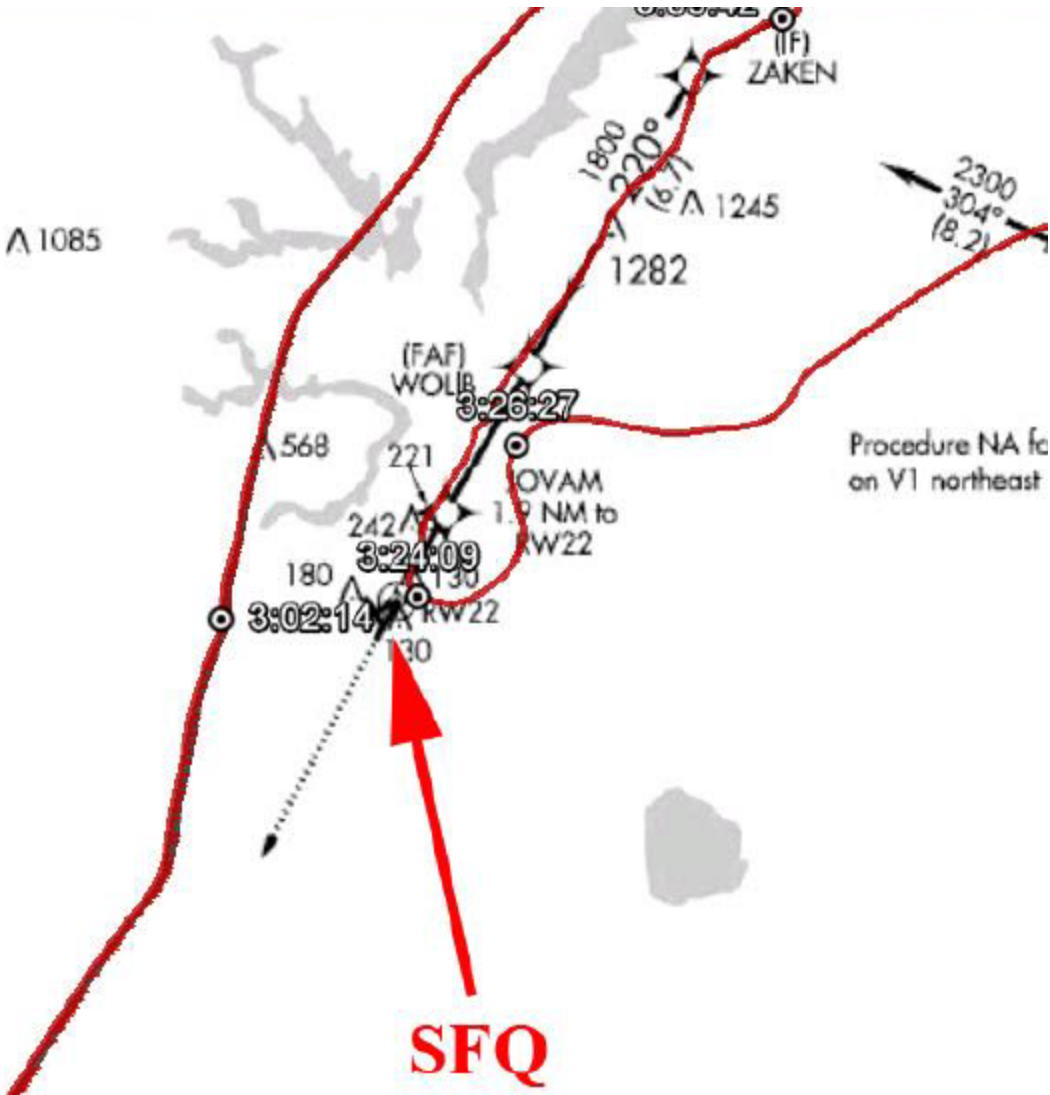
At 0307, the pilot was given a radar vector and cleared to execute the instrument approach (see figure 2 for the GPS-derived ground track plotted on the instrument approach procedure). About 1 minute later, the controller noted that the flight had not intercepted the proper final approach course and queried the pilot. The pilot responded, "we're having a problem with our GPS plates." The controller provided the

According to GPS track log data, the airplane passed abeam WOLIB, the final approach fix for the approach, at 0319:43. The airplane's GPS-derived altitude was 1,571 ft, and its groundspeed was 50 knots. The airplane continued toward JOVAM and passed abeam JOVAM at 0322:41, at a GPS altitude of 600 ft and a groundspeed between 75 and 85 knots.

Figure 2 - The airplane's GPS-derived ground track overlaid onto the SFQ RNAV GPS 22 instrument approach procedure plan view.

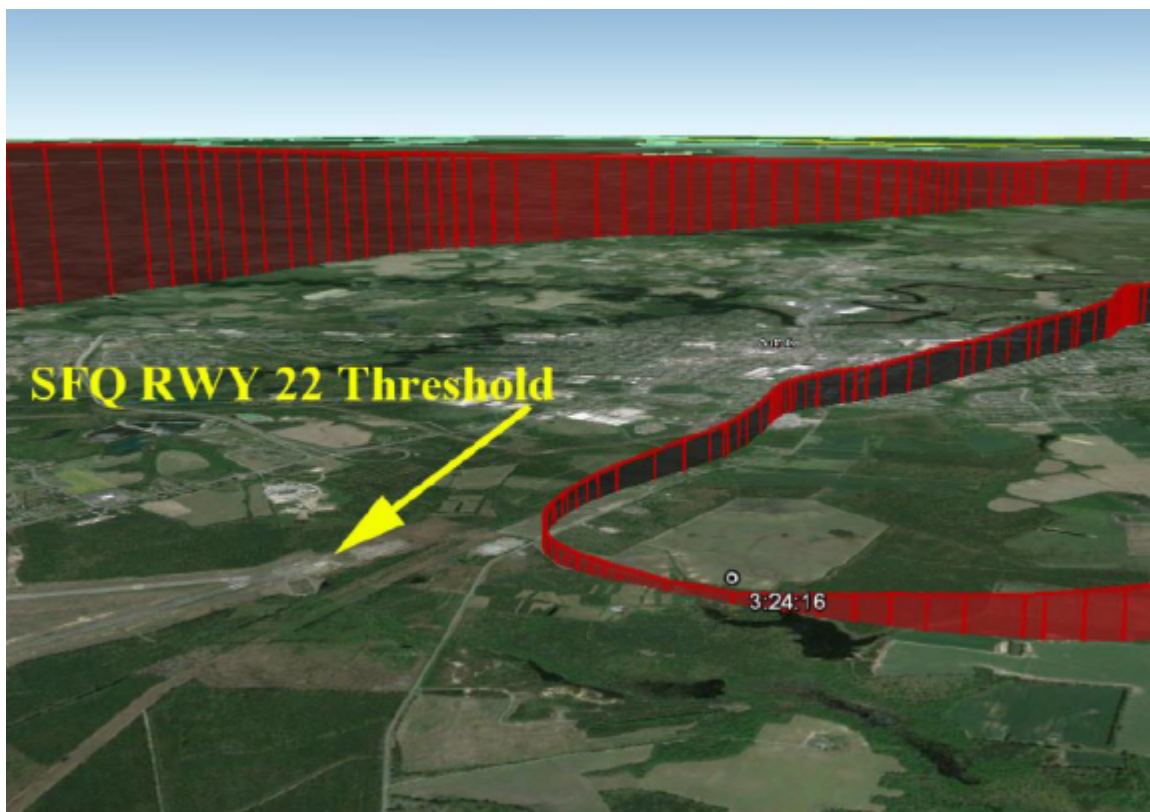
The airplane continued toward the runway 22 threshold, passing abeam it at 0323:54 and turning to the east. At this time, track log data showed that the airplane had a groundspeed of about 80 knots and a GPS altitude of 331 ft. The airplane continued descending to a lowest-recorded GPS altitude of 167 ft (about 100 ft above ground level [agl]) at 0324:16, at which time the ground speed was 109 knots. The airplane was about 3/4 nautical miles east of the runway 22 threshold and tracking to the east away from the runway threshold (see figure 3).

Figure 3 - Orthographic projection of the airplane's final approach to SFQ, descent to 167 feet GPS altitude, and flight away from the airport.
