# Aviation Investigation Final Report

<b>Location:</b>	Norfolk, Virginia	<b>Accident Number:</b>	ERA15FA144
<b>Date &amp; Time:</b>	March 4, 2015, 04:13 Local	<b>Registration:</b>	N66BB
<b>Aircraft:</b>	Mooney M20F	<b>Aircraft Damage:</b>	Substantial
<b>Defining Event:</b>	Controlled flight into terr/obj (CFIT)	<b>Injuries:</b>	3 Fatal
<b>Flight Conducted Under:</b>	Part 91: General aviation - Personal

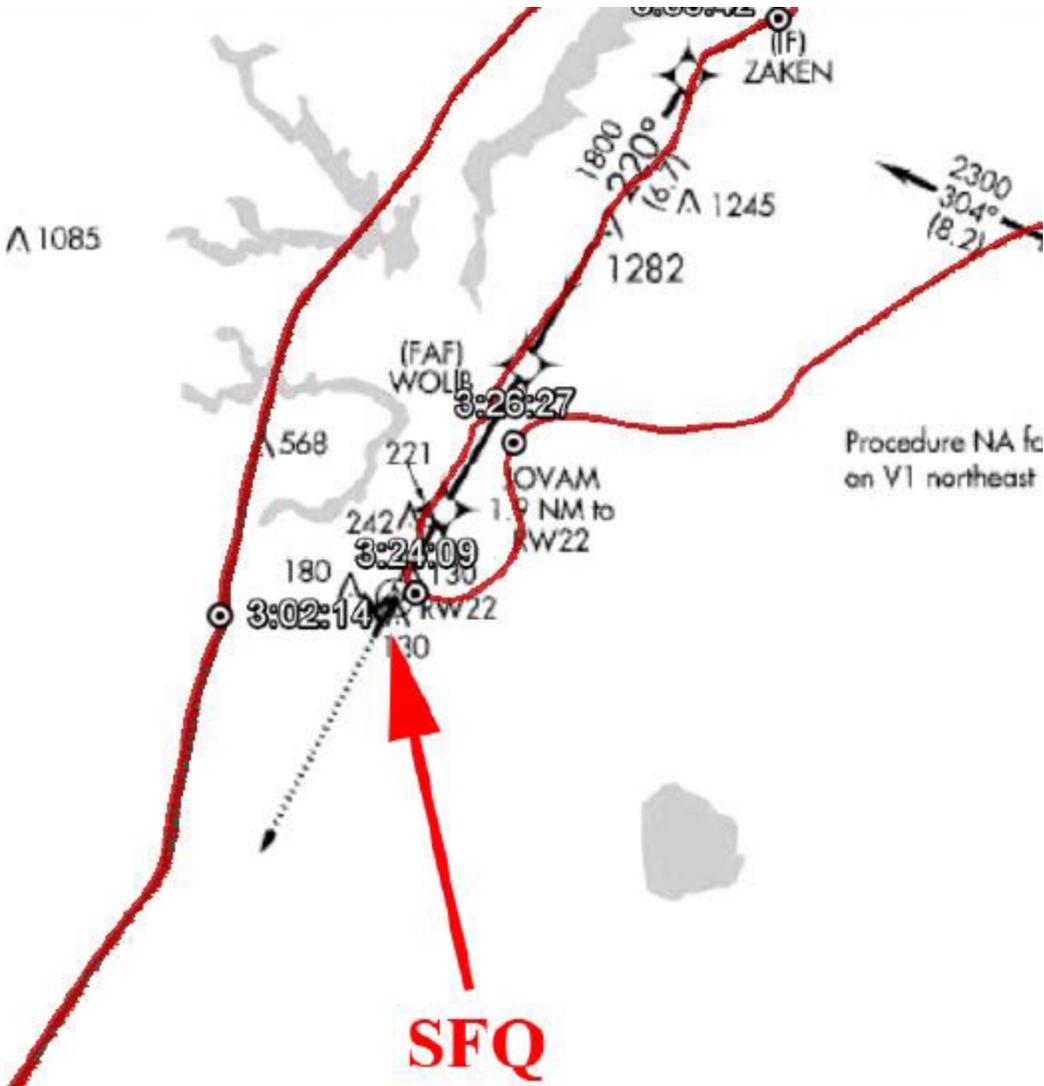
**Figure 2 - The airplane's GPS-derived ground track overlaid onto the SFQ RNAV GPS 22 instrument approach procedure plan view.**

At 0307, the pilot was given a radar vector and cleared to execute the instrument approach (see figure 2 for the GPS-derived ground track plotted on the instrument approach procedure). About 1 minute later, the controller noted that the flight had not intercepted the proper final approach course and queried the pilot. The pilot responded, "we're having a problem with our GPS plates." The controller provided the

According to GPS track log data, the airplane passed abeam WOLIB, the final approach fix for the approach, at 0319:43. The airplane's GPS-derived altitude was 1,571 ft, and its groundspeed was 50 knots. The airplane continued toward JOVAM and passed abeam JOVAM at 0322:41, at a GPS altitude of 600 ft and a groundspeed between 75 and 85 knots.

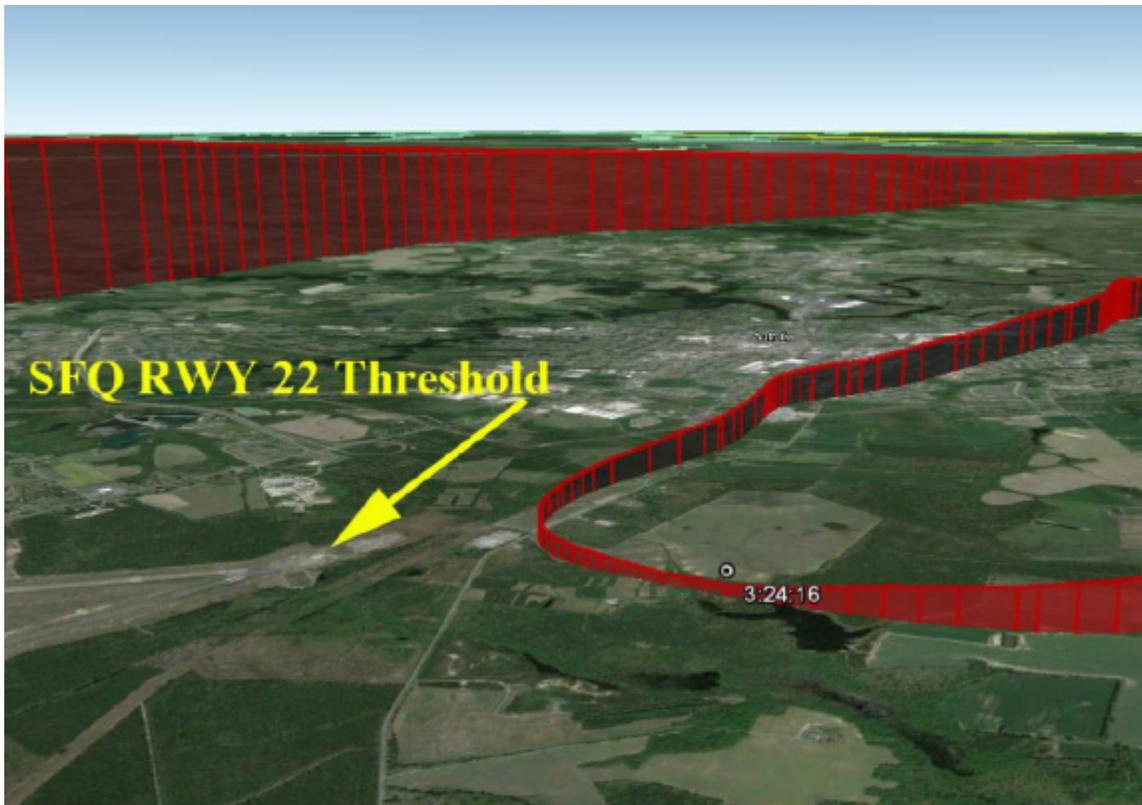
**Figure 3 - Orthographic projection of the airplane's final approach to SFQ, descent to 167 feet GPS altitude, and flight away from the airport.**

The airplane continued toward the runway 22 threshold, passing abeam it at 0323:54 and turning to the east. At this time, track log data showed that the airplane had a groundspeed of about 80 knots and a GPS altitude of 331 ft. The airplane continued descending to a lowest-recorded GPS altitude of 167 ft (about 100 ft above ground level [agl]) at 0324:16, at which time the ground speed was 109 knots. The airplane was about 3/4 nautical miles east of the runway 22 threshold and tracking to the east away from the runway threshold (see figure 3).
