# Aviation Investigation Final Report

<b>Location:</b>	St Louis, Missouri	<b>Accident Number:</b>	CEN15FA164
<b>Date &amp; Time:</b>	March 6, 2015, 23:10 Local	<b>Registration:</b>	N356AM
<b>Aircraft:</b>	Airbus Helicopters (Eurocopte EC-130-B4)	<b>Aircraft Damage:</b>	Destroyed
<b>Defining Event:</b>	Settling with power/vortex ring state	<b>Injuries:</b>	1 Fatal
<b>Flight Conducted Under:</b>	Part 91: General aviation - Positioning

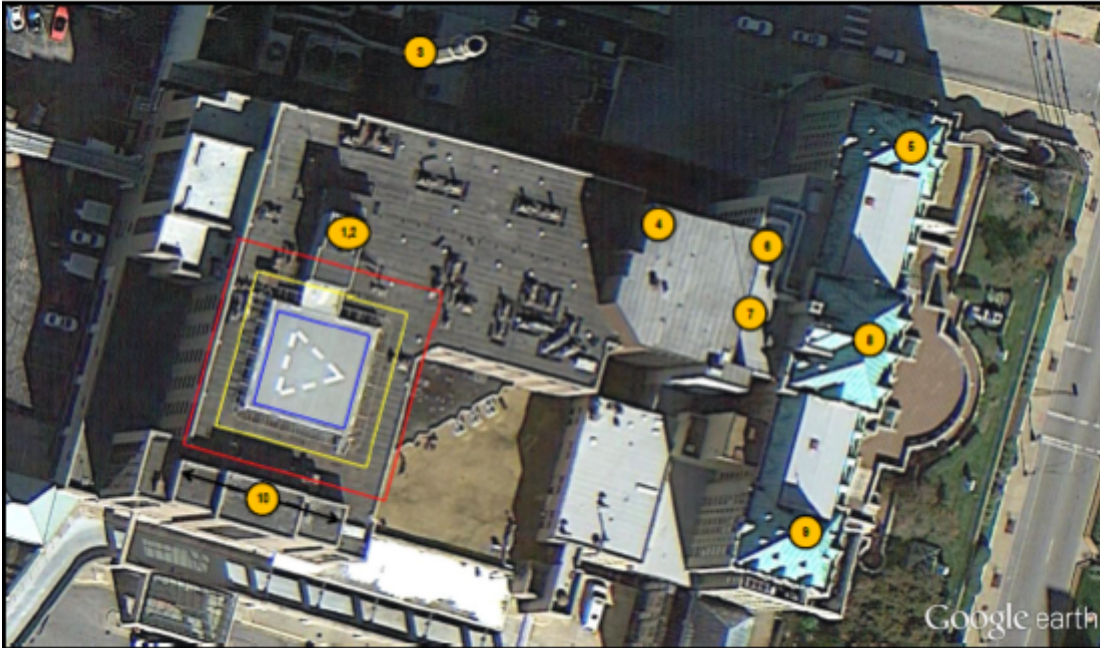
The NTSB IIC requested that the FAA perform post-accident inspection of MO55, which was performed on April 16, 2015. The inspection results were documented in a Heliport Safety Evaluation Report, Case Number: 2015–ACE–1749–NRA. The report cited 10 obstructions within the final approach and takeoff area (FATO)/safety area of the heliport/helipad and 4 obstructions outside the FATO/safety area. The 10 obstructions outside the FATO/safety area had a ranged in azimuth from 005 – 236 degrees and there were no obstructions from 236 – 005 degrees, or west, northwest.

Figure 1: Obstructions Outside the FATO/Safety Area

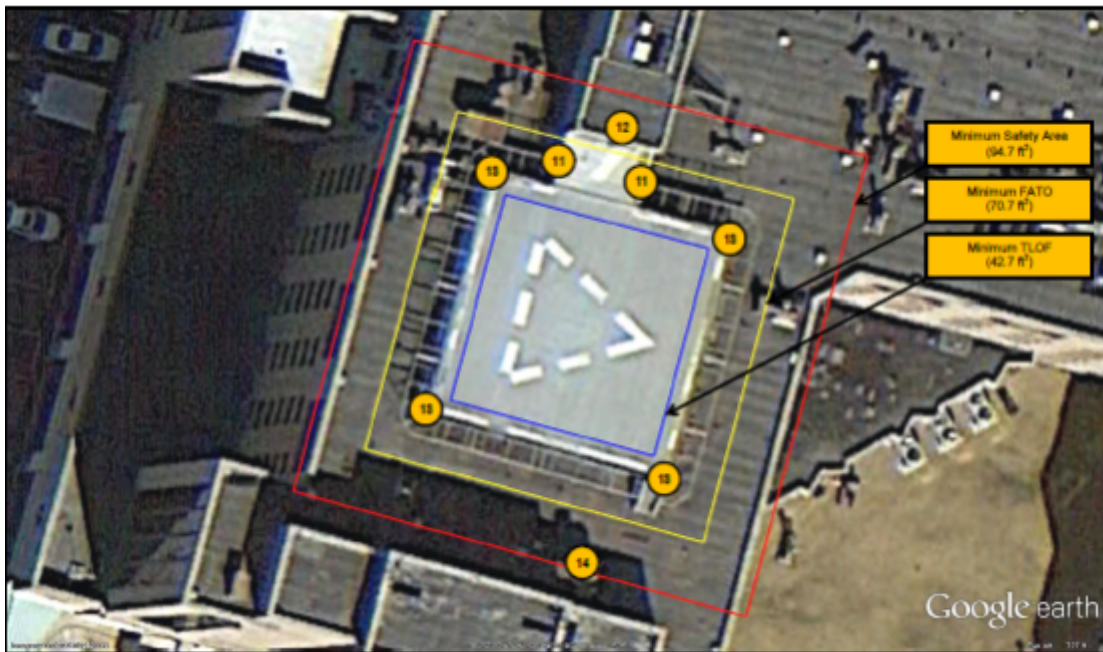
Figure 2: Obstructions Inside the FATO/Safety Area

"The heliport FATO/safety area is obstructed by permanent and semi-permanent objects that pose a

serious hazard to helicopter operations. The most serious obstructions cannot be easily lowered or removed. Flight Standards cannot recommend an approach/departure route into or out of a hazardous area that does not appear to have reasonable alternatives for mitigation. Therefore, no recommendation for ingress/egress is made in this case."

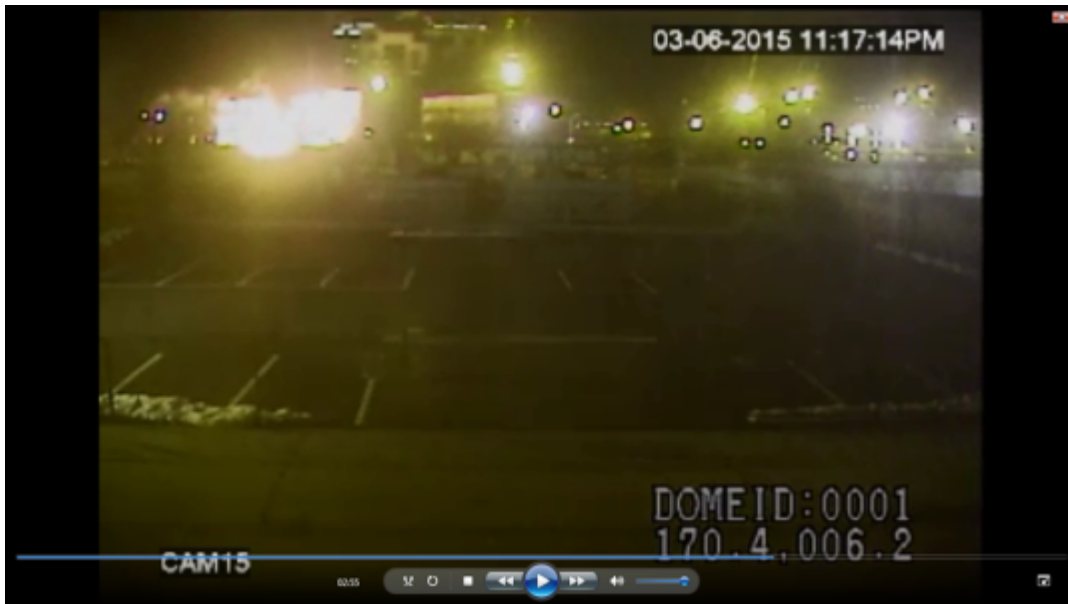
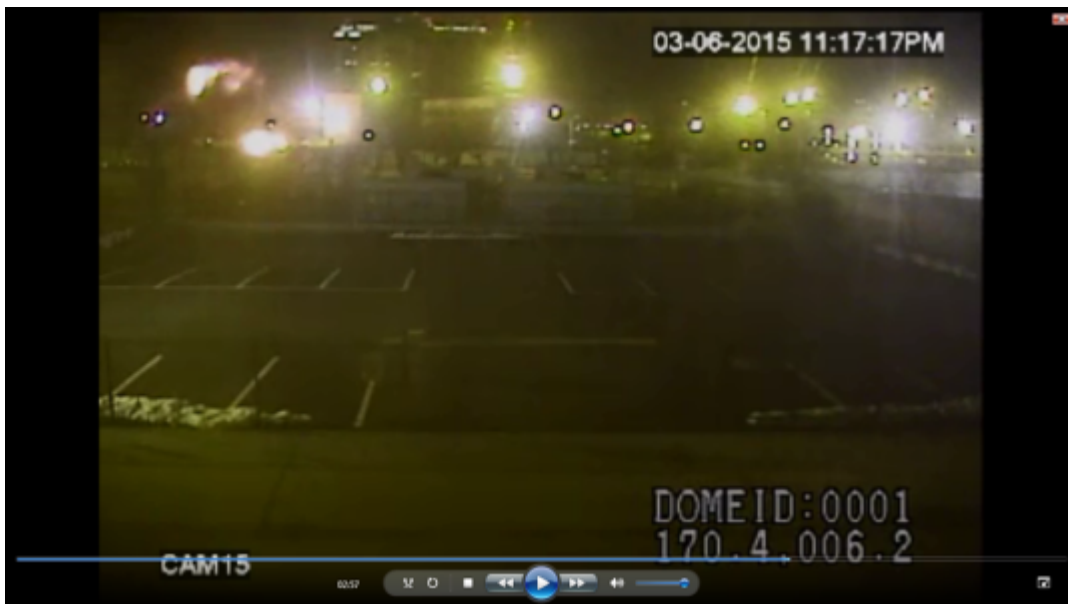
A post-crash fire and explosion occurred upon impact when the helicopter impacted the parking lot adjacent to the building entrance which was captured by a security video. The following two frames

from a security camera show the explosion and fire that ensued after the helicopter's impact.

Figure 3: The top video frame at 11:17:14 PM shows the fire/explosion during the impact of N356AM and the bottom frame at 11:17:17 PM shows a fire ball separated from the initial fire and moved upwards and to the left of the screen in a direction consistent with approximate wind direction.

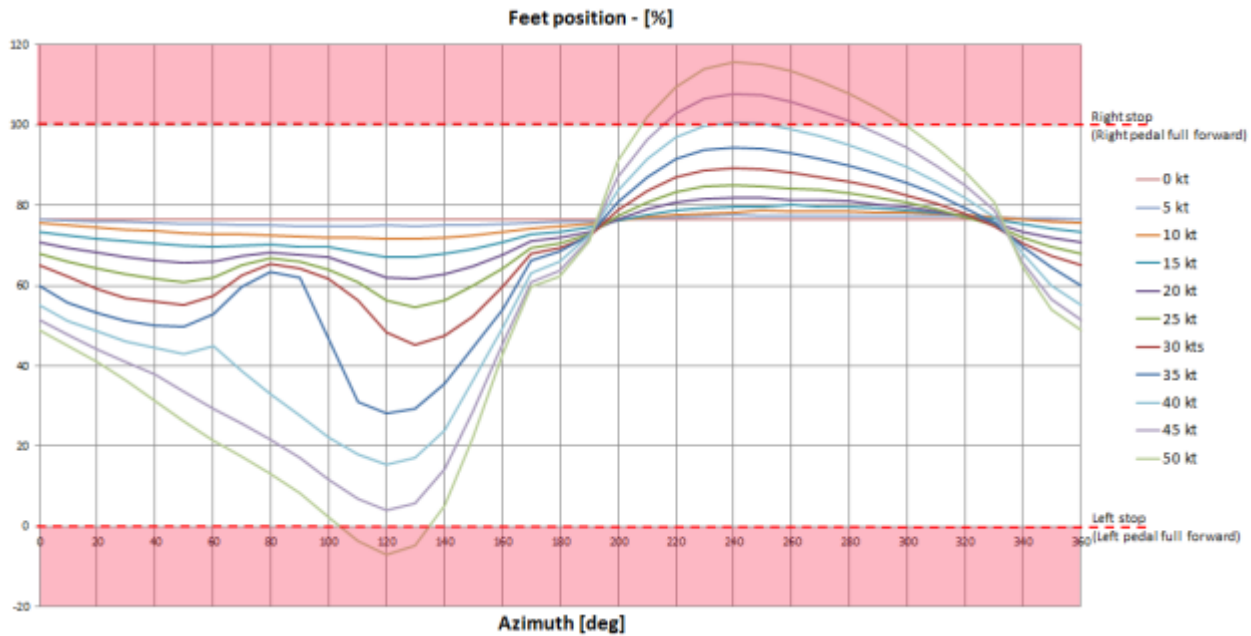
Figure 4: The plot shows percentage of foot position versus azimuth at wind speeds from 0-50 knots. The left stop limit occurs at azimuths of about 103 degrees to 138 degrees with a wind of 50 knots. The right pedal stop occurs at azimuths of about 230 degrees to 253 degrees at a wind speed of 40 knots; the azimuth range for the right pedal stop increases with increasing wind speeds of 45 knots and 50 knots.

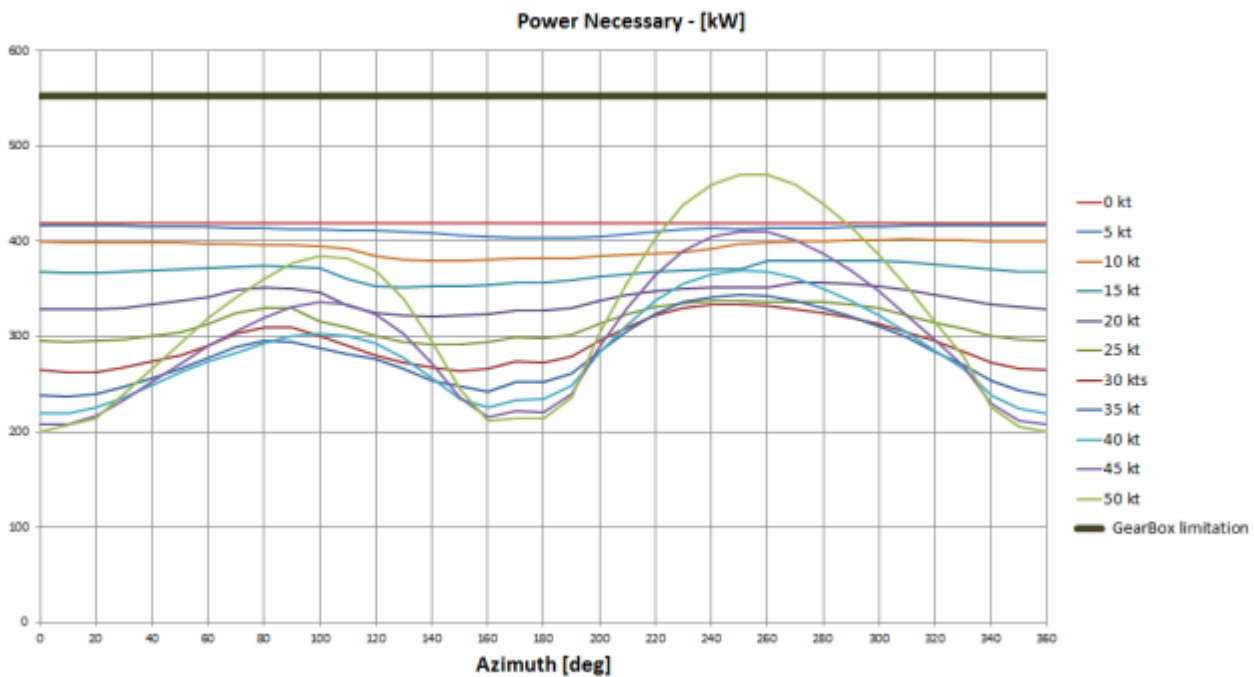
Figure 5: Plot of power necessary versus azimuth at wind speeds from 0-50 knots. The upper limit of power occurred at approximate azimuth of 223 degrees to 290 degrees with a wind speed of 50 knots.
