# Aviation Investigation Final Report

<b>Location:</b>	St Louis, Missouri	<b>Accident Number:</b>	CEN15FA164
<b>Date &amp; Time:</b>	March 6, 2015, 23:10 Local	<b>Registration:</b>	N356AM
<b>Aircraft:</b>	Airbus Helicopters (Eurocopte EC-130-B4	<b>Aircraft Damage:</b>	Destroyed
<b>Defining Event:</b>	Settling with power/vortex ring state	<b>Injuries:</b>	1 Fatal
<b>Flight Conducted Under:</b>	Part 91: General aviation - Positioning

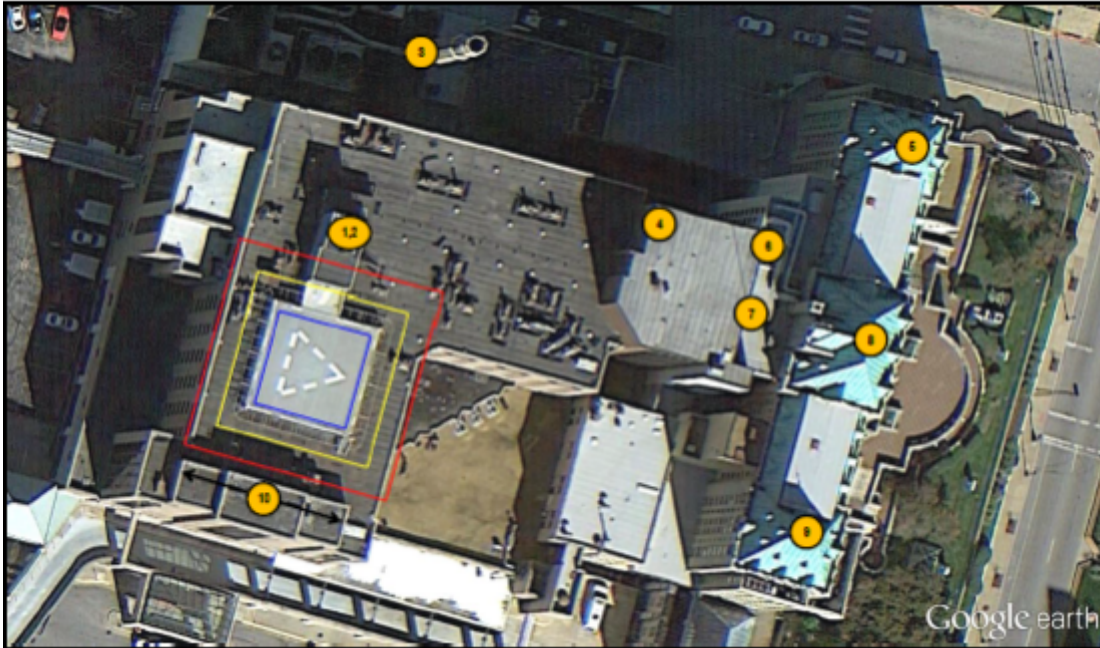
The NTSB IIC requested that the FAA perform post-accident inspection of MO55, which was performed on April 16, 2015. The inspection results were documented in a Heliport Safety Evaluation Report, Case Number: 2015–ACE–1749–NRA. The report cited 10 obstructions within the final approach and takeoff area (FATO)/safety area of the heliport/helipad and 4 obstructions outside the FATO/safety area. The 10 obstructions outside the FATO/safety area had a ranged in azimuth from 005 – 236 degrees and there were no obstructions from 236 – 005 degrees, or west, northwest.

Figure 1: Obstructions Outside the FATO/Safety Area

"The heliport FATO/safety area is obstructed by permanent and semi-permanent objects that pose a

serious hazard to helicopter operations. The most serious obstructions cannot be easily lowered or removed. Flight Standards cannot recommend an approach/departure route into or out of a hazardous area that does not appear to have reasonable alternatives for mitigation. Therefore, no recommendation for ingress/egress is made in this case."

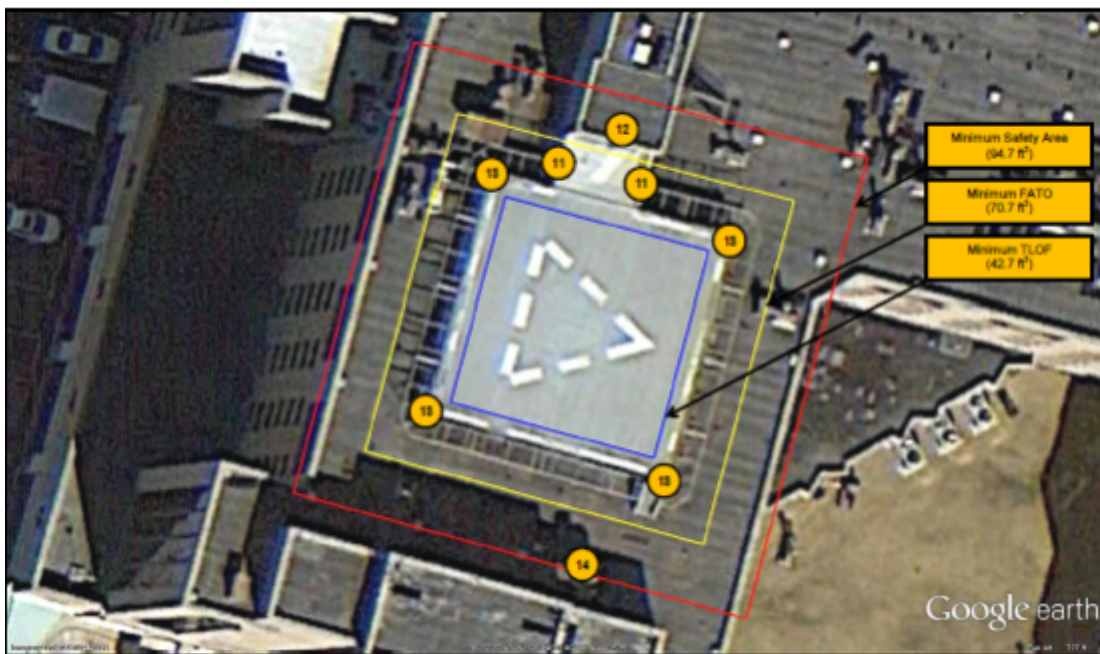
Figure 2: Obstructions Inside the FATO/Safety Area

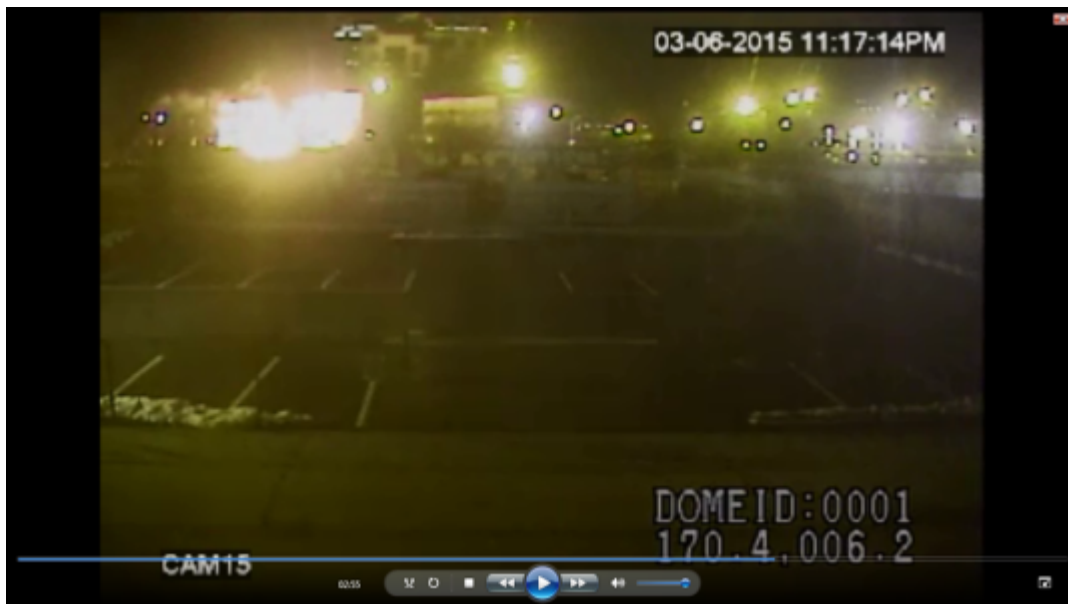
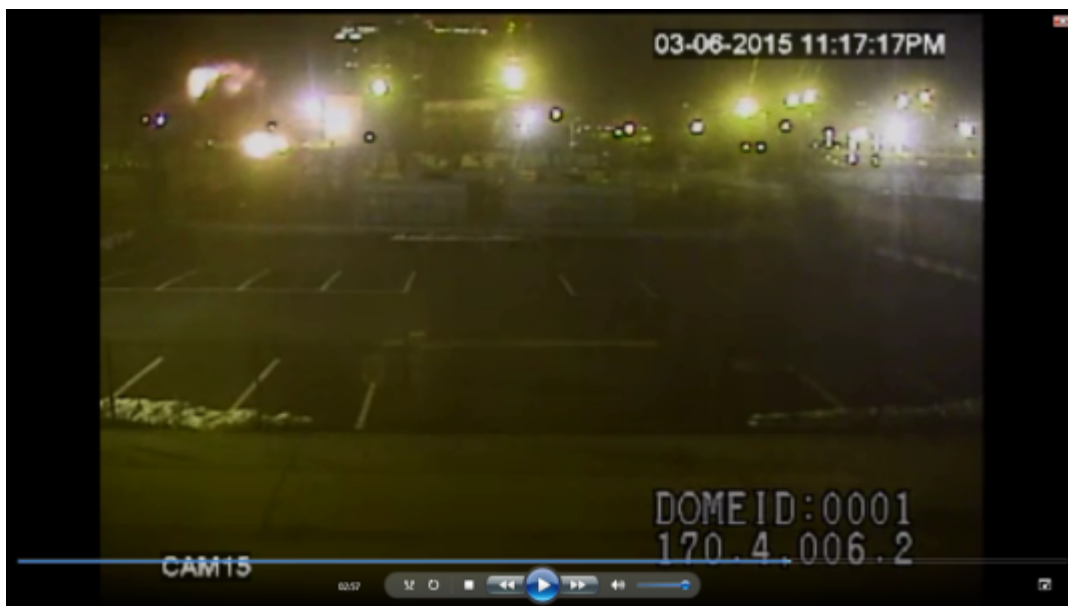
A post-crash fire and explosion occurred upon impact when the helicopter impacted the parking lot adjacent to the building entrance which was captured by a security video. The following two frames

Figure 3: The top video frame at 11:17:14 PM shows the fire/explosion during the impact of N356AM and the bottom frame at 11:17:17 PM shows a fire ball separated from the initial fire and moved upwards and to the left of the screen in a direction consistent with approximate wind direction.

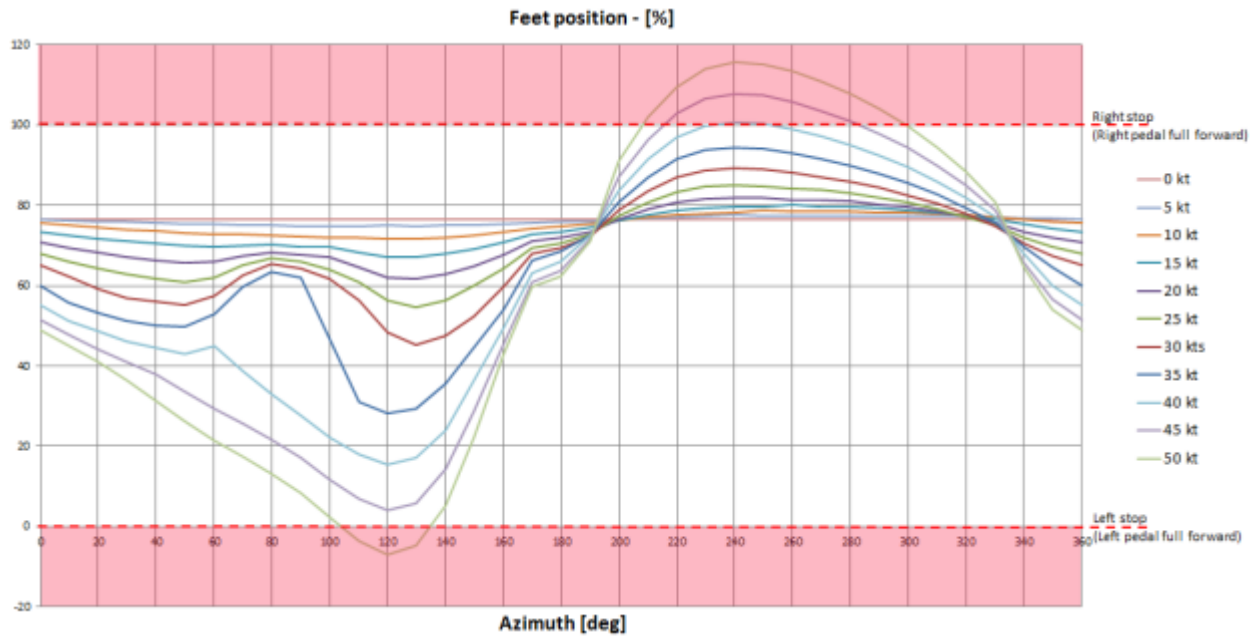
During the accident investigation, the NTSB Investigator-In-Charge requested that Airbus Helicopters perform a critical azimuth analysis and in response to that request, Airbus Helicopters provided the following charts showing pedal control and power required to maintain an out of ground effect hover relative to azimuth/wind speed.

Figure 4: The plot shows percentage of foot position versus azimuth at wind speeds from 0-50 knots. The left stop limit occurs at azimuths of about 103 degrees to 138 degrees with a wind of 50 knots. The right pedal stop occurs at azimuths of about 230 degrees to 253 degrees at a wind speed of 40 knots; the azimuth range for the right pedal stop increases with increasing wind speeds of 45 knots and 50 knots.

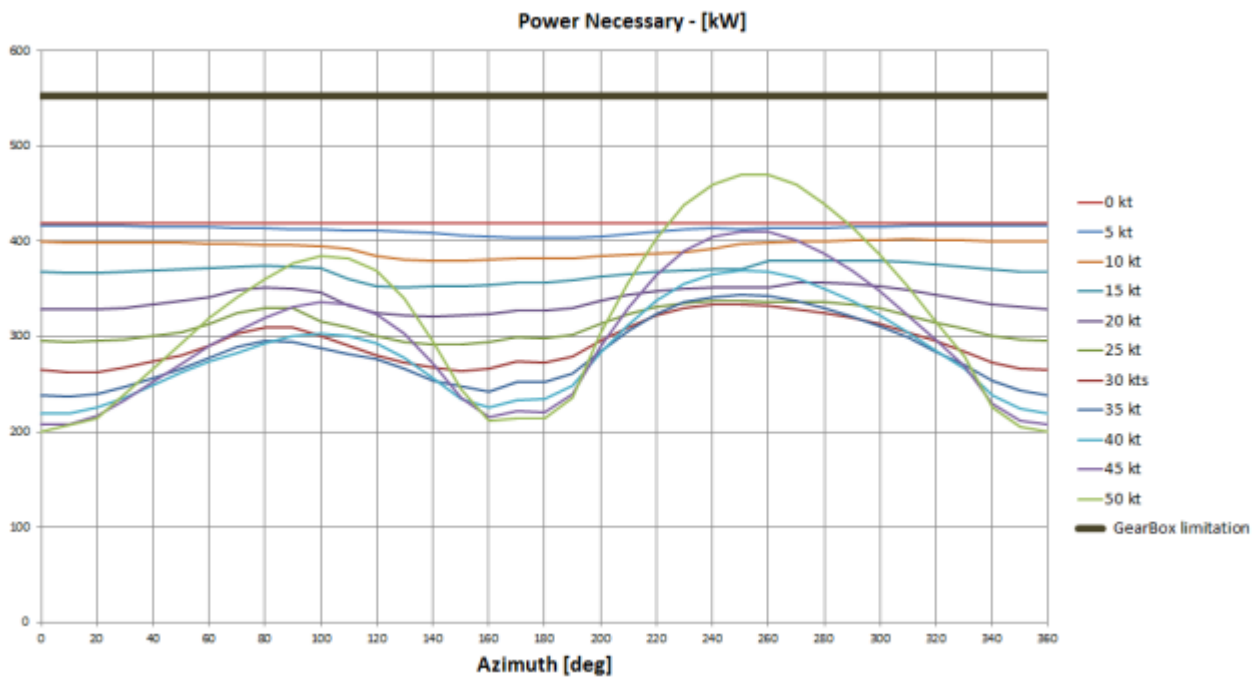
Figure 5: Plot of power necessary versus azimuth at wind speeds from 0-50 knots. The upper limit of power occurred at approximate azimuth of 223 degrees to 290 degrees with a wind speed of 50 knots.
