# Aviation Investigation Final Report

<b>Location:</b>	Eufaula, Oklahoma	<b>Accident Number:</b>	CEN15FA171
<b>Date &amp; Time:</b>	March 12, 2015, 23:15 Local	<b>Registration:</b>	N919EM
<b>Aircraft:</b>	Eurocopter AS 350 B2	<b>Aircraft Damage:</b>	Destroyed
<b>Defining Event:</b>	Loss of visual reference	<b>Injuries:</b>	1 Fatal, 2 Serious
<b>Flight Conducted Under:</b>	Part 135: Air taxi & commuter - Non-scheduled - Air Medical (Unspecified)

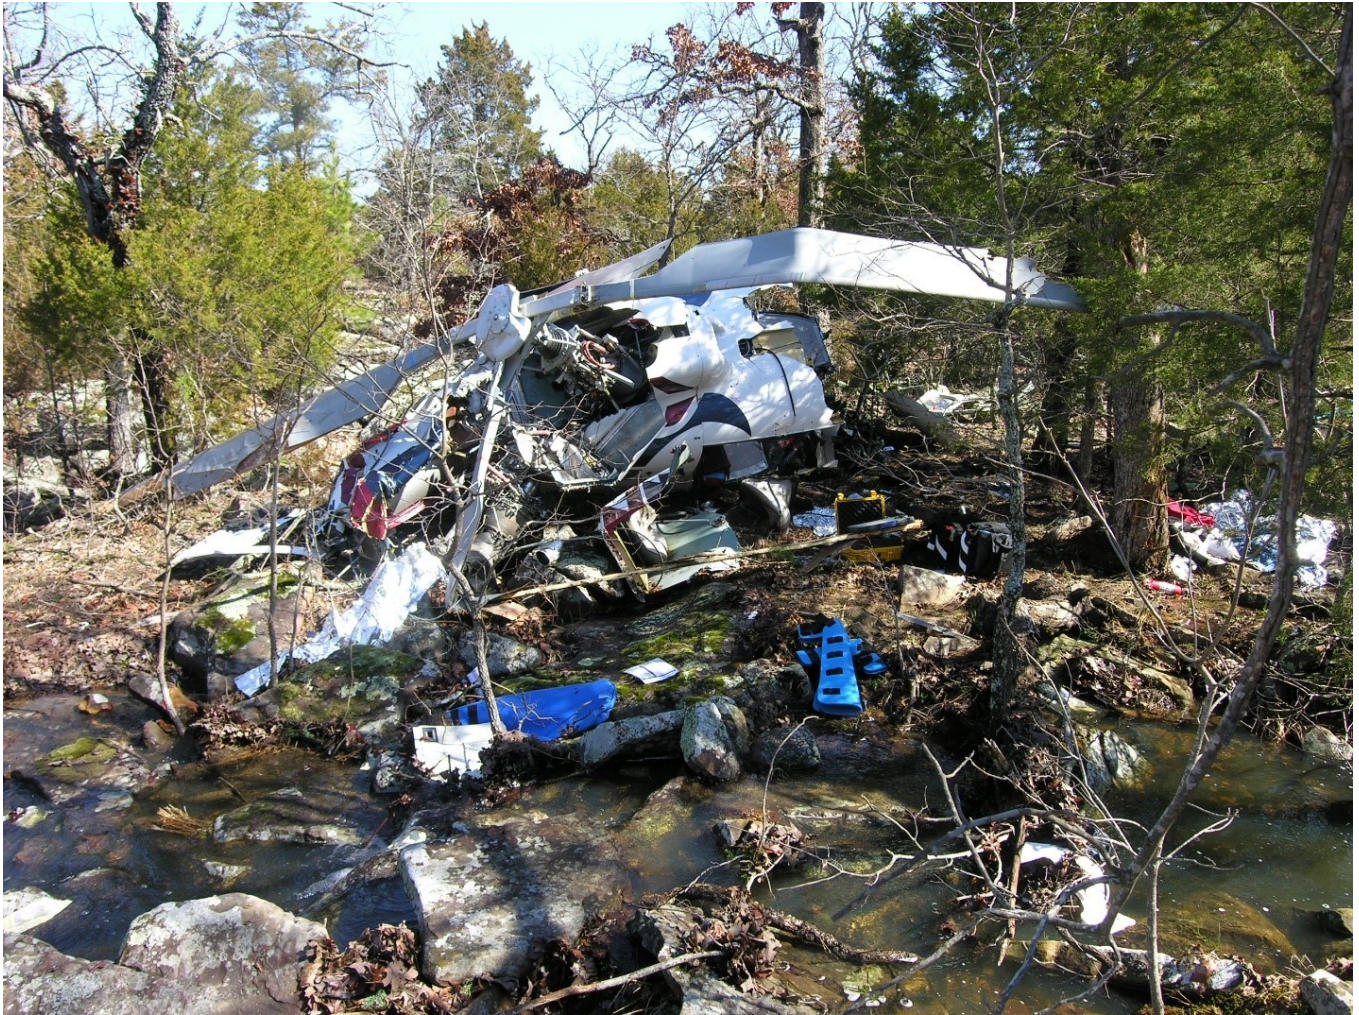
The accident site was located atop a wooded hill on an embankment next to a creek about 9 miles west of Eufaula at an elevation of 840 ft. msl. The helicopter came to rest on its right side and was oriented on an easterly heading. (See figure 1 for a photograph showing the accident site and main wreckage.)

Figure 1. A photograph showing the accident site and main wreckage.
