# Aviation Investigation Final Report

<b>Location:</b>	Lebec, California	<b>Accident Number:</b>	WPR15FA147
<b>Date &amp; Time:</b>	April 14, 2015, 08:11 Local	<b>Registration:</b>	N75BH
<b>Aircraft:</b>	ROBERT C. HANSON PITTS S2E	<b>Aircraft Damage:</b>	Destroyed
<b>Defining Event:</b>	Controlled flight into terr/obj (CFIT)	<b>Injuries:</b>	1 Fatal
<b>Flight Conducted Under:</b>	Part 91: General aviation - Personal

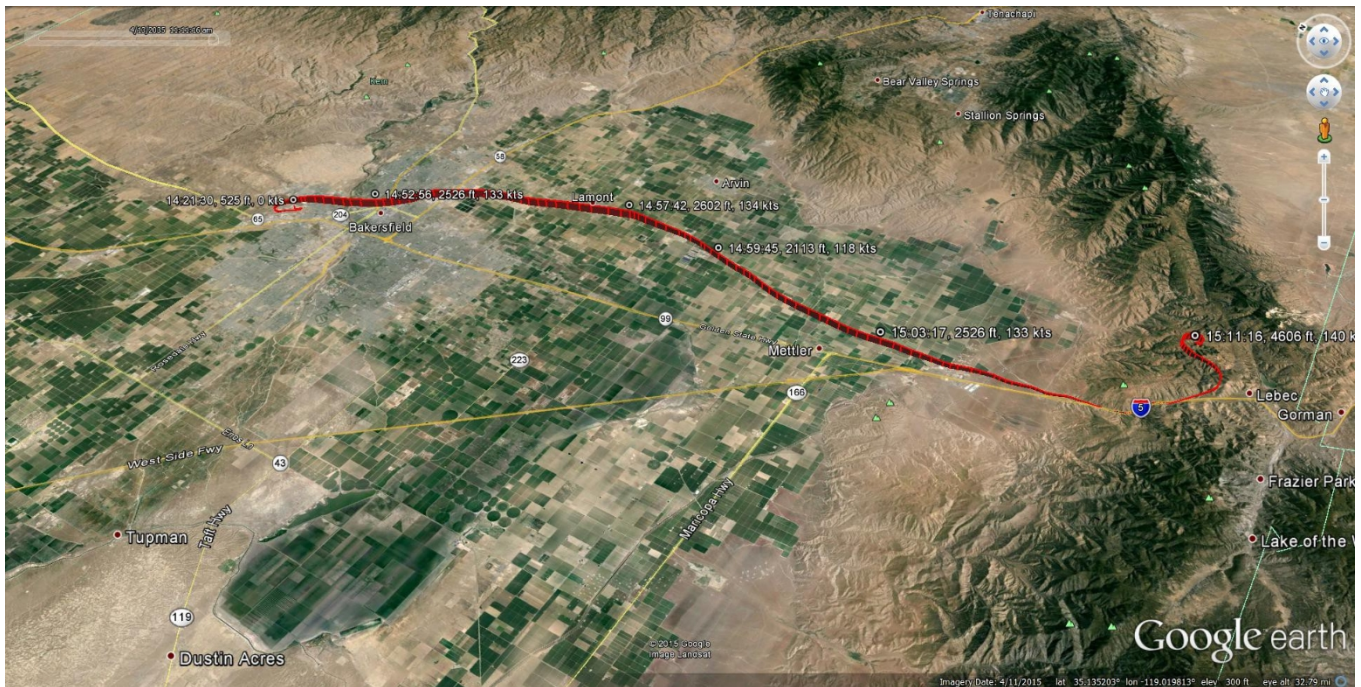
Figure 1. Overlay of flightpath on Google Earth

The data revealed that at 0750 the airplane began its takeoff roll from BFL. The airplane reached a maximum altitude of about 2,500 feet above ground level (agl), until descending over the interstate to about 200 feet agl, before turning east towards the Tehachapi Mountains. The final portion of the recording identified the airplane in a climbing turn, starting from about 100 feet agl, climbing to 900 feet agl before the airplane began a descending right turn before the recording stopped at 0811.
