Aviation Investigation Final Report

Location:	Lebec, California	Accident Number:	WPR15FA147
Date & Time:	April 14, 2015, 08:11 Local	Registration:	N75BH
Aircraft:	ROBERT C. HANSON PITTS S2E	Aircraft Damage:	Destroyed
Defining Event:	Controlled flight into terr/obj (CFIT)	Injuries:	1 Fatal
Flight Conducted Under:	Part 91: General aviation - Personal

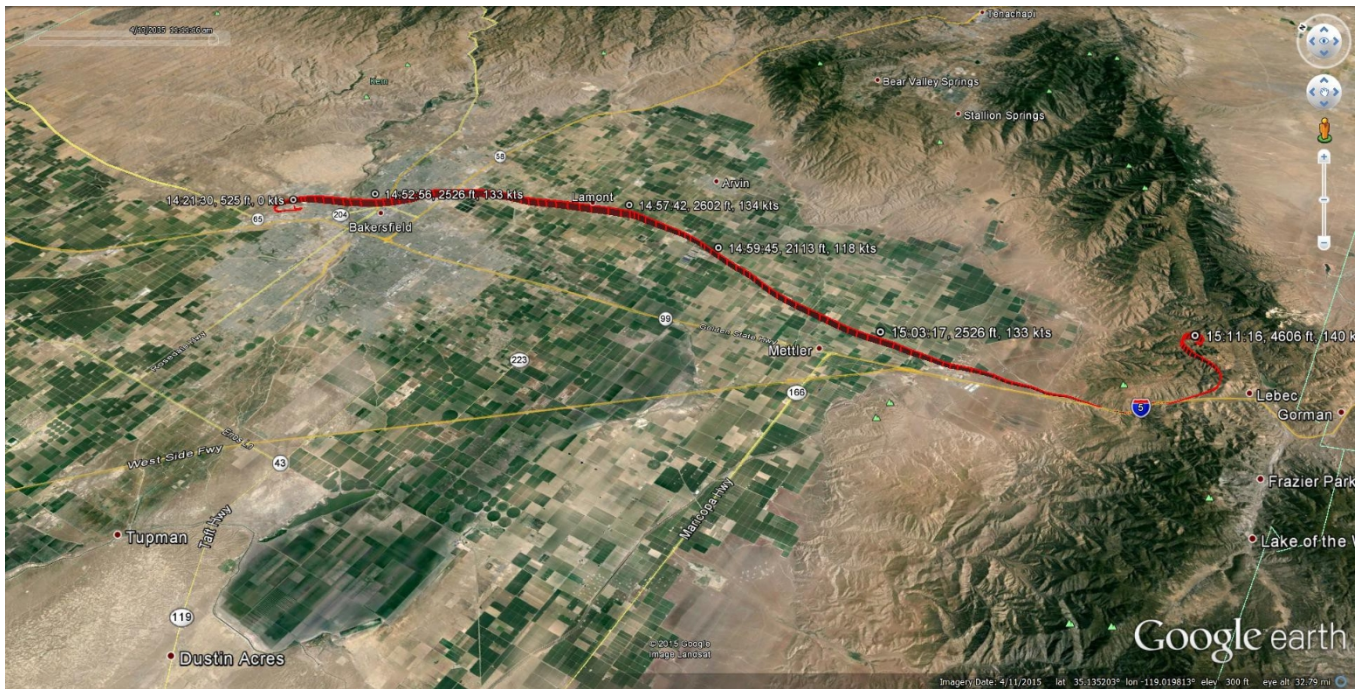
Figure 1. Overlay of flightpath on Google Earth

The data revealed that at 0750 the airplane began its takeoff roll from BFL. The airplane reached a maximum altitude of about 2,500 feet above ground level (agl), until descending over the interstate to about 200 feet agl, before turning east towards the Tehachapi Mountains. The final portion of the recording identified the airplane in a climbing turn, starting from about 100 feet agl, climbing to 900 feet agl before the airplane began a descending right turn before the recording stopped at 0811.
