Aviation Investigation Final Report

Location:	Plainview, Texas	Accident Number:	CEN15FA245
Date & Time:	May 29, 2015, 21:15 Local	Registration:	N221D
Aircraft:	Beech A36	Aircraft Damage:	Destroyed
Defining Event:	Loss of control in flight	Injuries:	3 Fatal
Flight Conducted Under:	Part 91: General aviation - Personal

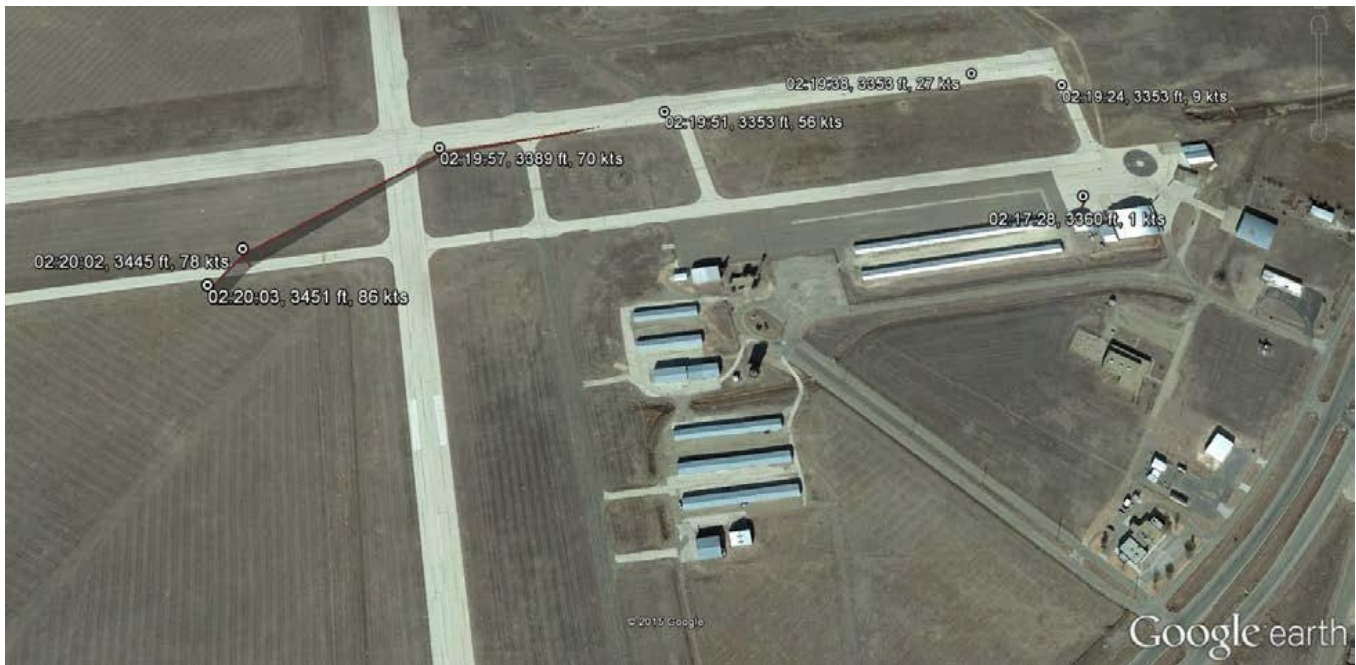
Figure 1: Google Earth overlay showing the accident flight path.

A handheld GPS was retrieved from the accident site, Figure 1 depicts its downloaded data. It was revealed that the flight departed from runway 22 about 2119, banked left, and then reached about 80 ft above ground level (agl) at a groundspeed of 86 knots before the recording stopped less than 1 minute later. See Figure 5 for a wreckage diagram. Several witnesses reported seeing the airplane take off to the southwest, make a sharp left turn, and then head straight down. One of the witnesses stated that they could not believe anybody would take off in the approaching storm. Another witness reported that she was "watching the storm clouds" and heard an engine at "full throttle" and then looked over and saw the airplane "traveling very fast" toward the ground.

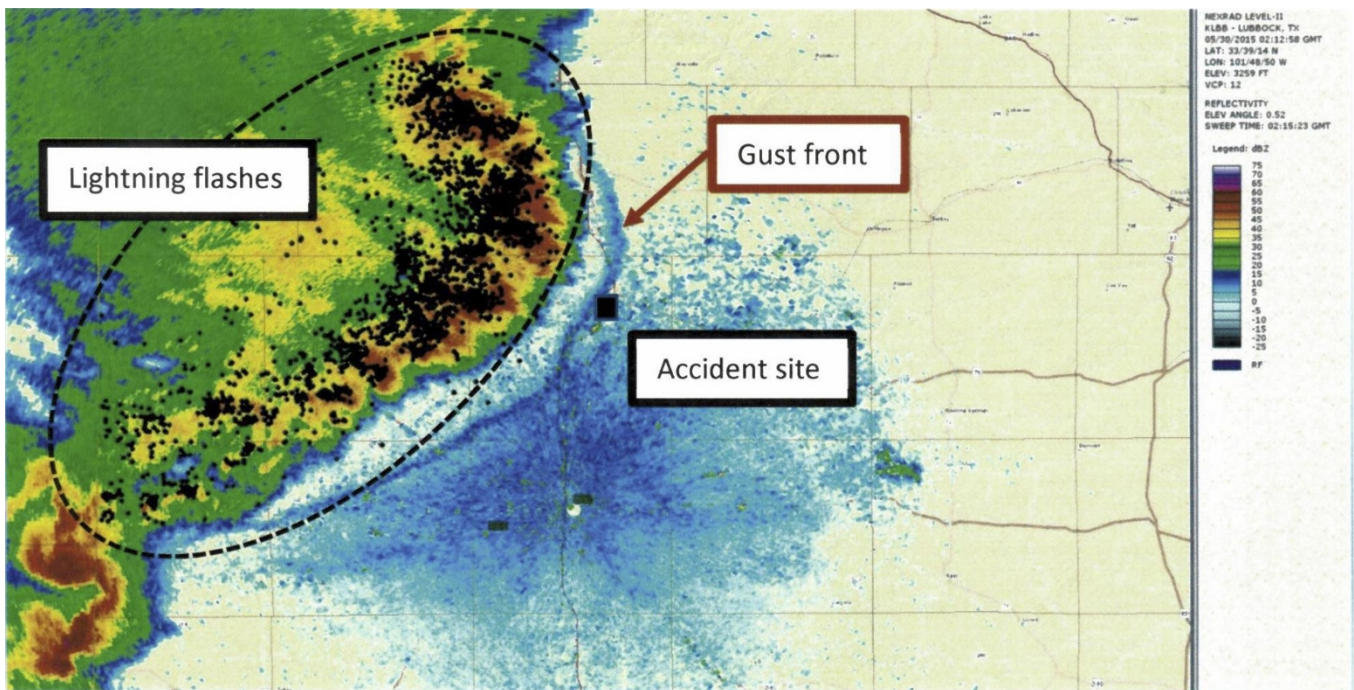
Figure 2: KLBB WSR-88D reflectivity for the 0.5° elevation scan initiated at 2115 CDT with the lightning data.

The closest NWS Weather Surveillance Radar-1988, Doppler (WSR-88D) was from Lubbock Preston Smith International Airport (LBB), Lubbock, Texas, which was located 31 miles south of the accident site at an elevation of 3,282 ft. Figure 2 shows the LBB WSR-88D base reflectivity images for the 0.5° elevation scans initiated at 2115. The image shows lightning flashes and strikes associated with a squall line, which are indicated by small black dots, north and west of the accident site between 2100 and 2115. The figure shows the gust front's location, depicted by a red line. The gust front was moving eastward over the accident site at the accident time.

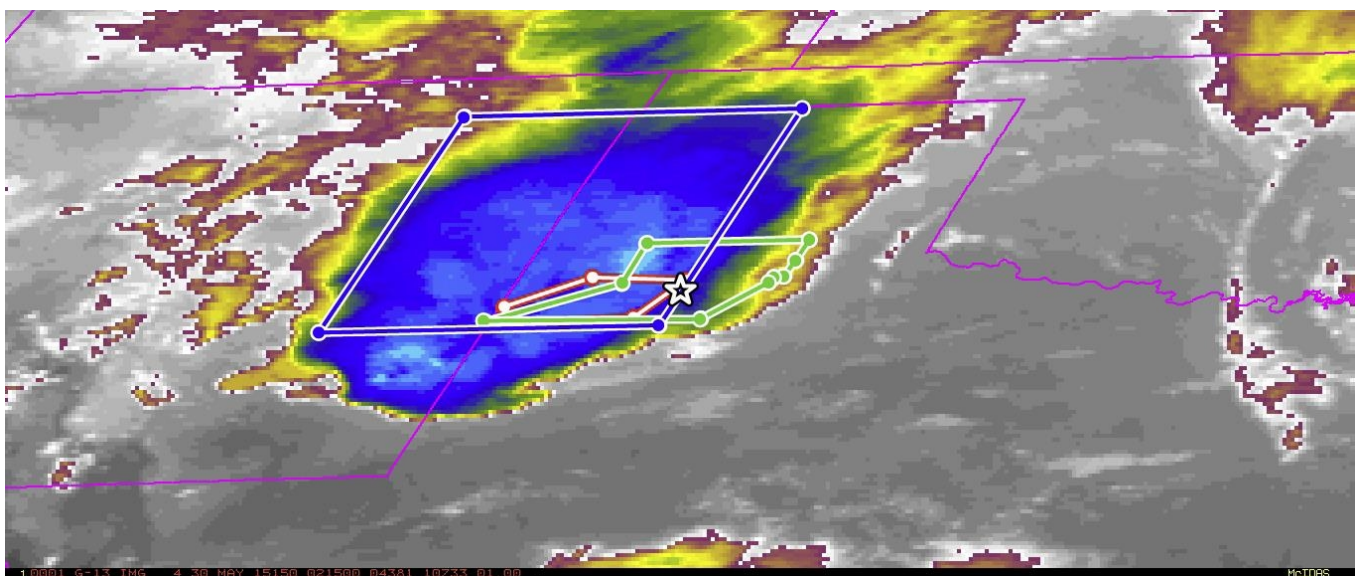
Figure 3: Severe thunderstorm warnings (red and green) and severe thunderstorm watch (blue) valid at the accident time.

The first severe thunderstorm warning that included the accident site was issued at 2046 by the NWS Office in Lubbock, Texas. Another severe thunderstorm warning, which was valid for the accident site at the accident time, was issued at 2113; and a severe thunderstorm watch was issued at 1545 and was valid through 2300. Figure 3 shows the 2046 severe thunderstorm warning area outlined in red, the 2113 severe thunderstorm warning area outlined in green, and the severe thunderstorm watch area outlined in blue. The accident site is marked by the star in figure 3. The severe thunderstorm warnings reported 60 mph wind gusts and hail.

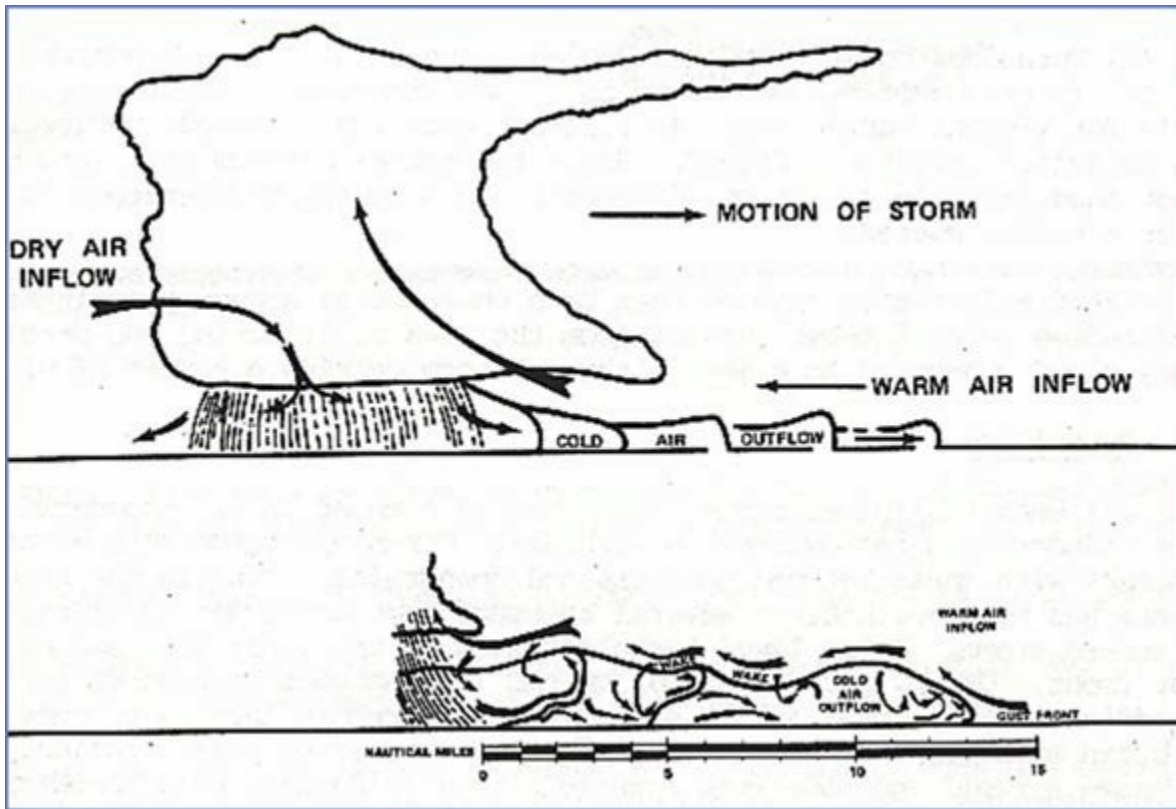
Figure 4: Cross section of a thunderstorm showing the cold air outflow and gust front.

FAA Advisory Circular AC 00-24C, "Thunderstorms," issued in February 2013, is a training guide for pilots on thunderstorm hazards. Figure 4 shows a cross-section of a squall line thunderstorm from AC 00-24B depicting a shelf cloud, gust front, and its related cold air outflow. A gust front typically causes a sudden wind shift and increase in wind speed along with potentially moderate-to-severe turbulence up to 1,000 ft and occasionally to 3,000 ft agl. A sudden wind shift and gusty winds associated with a gust front can be seen at both PVW and LBB, when the gust front moves across those airports. Multiple

surges of cold dense air are typical results in individual strong gusts. Gust fronts often extend up to 15 miles from the main precipitation core of the thunderstorm.

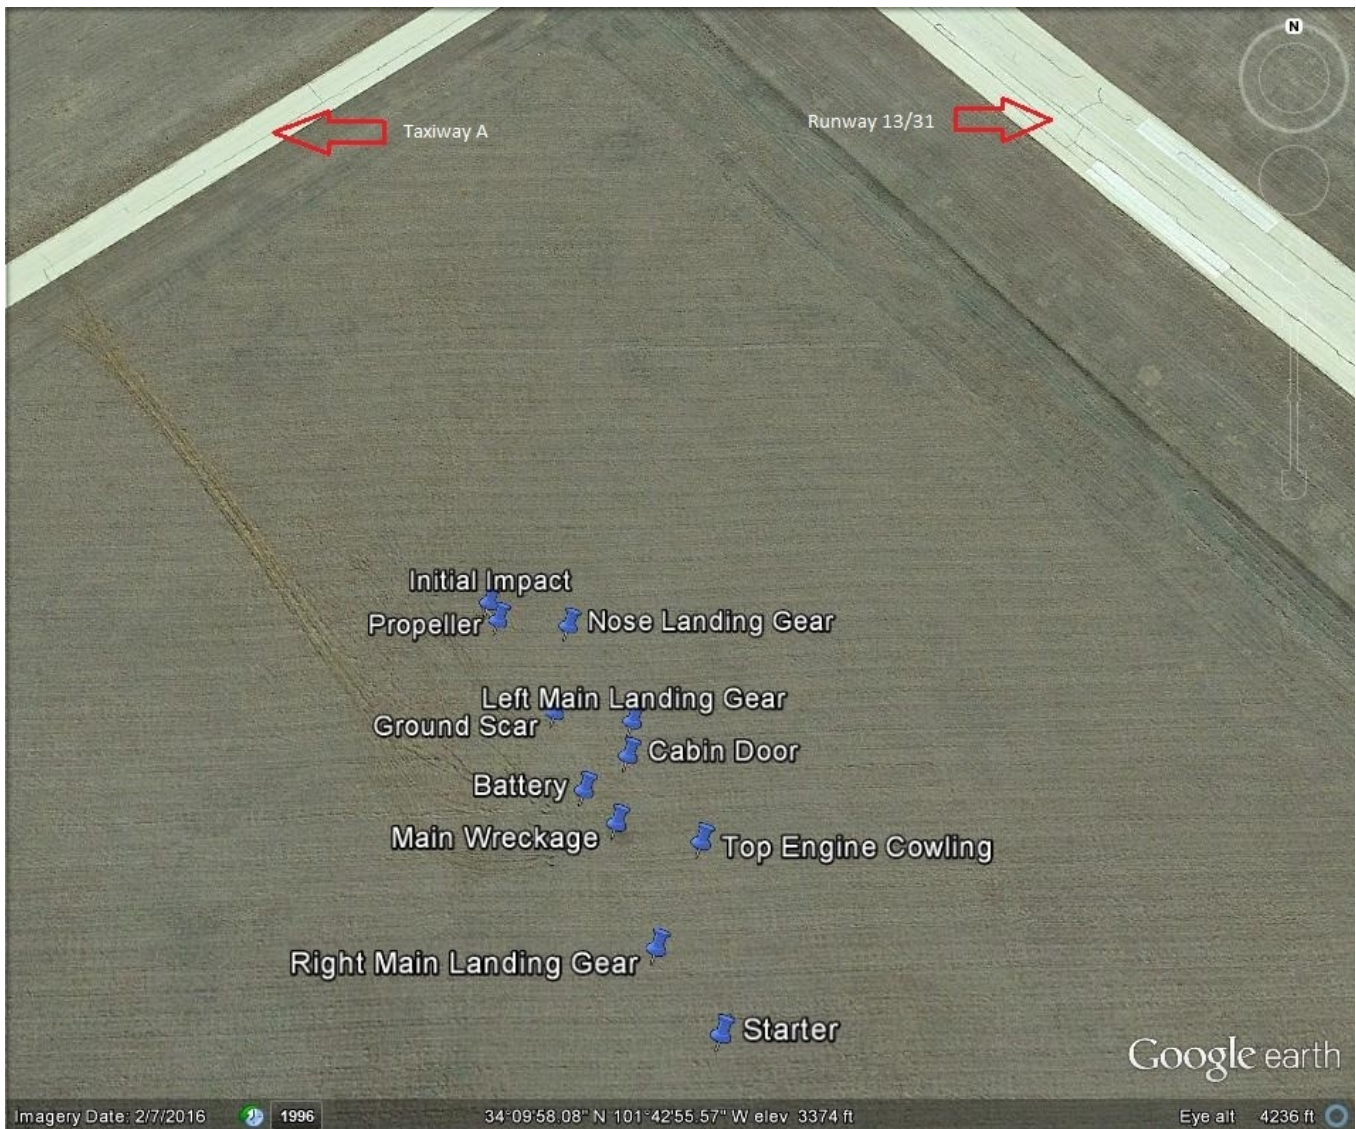
Figure 5: Wreckage Diagram

The main wreckage was located in a flat, grass field about 1,100 ft southeast of runway 04/22. The airplane came to rest on a magnetic heading of 130° at an elevation of 3,609 ft. A postimpact fire had ensued.

The airplane impacted terrain in about a 20°-nose-down attitude. Ground scars were consistent with a near vertical impact. The ground scars were also consistent with the landing gear being extended at the initial impact; however, fire damage precluded determination of the landing gear actuator position. A propeller blade fractured at impact and separated from the crankshaft, and the hub separated from the engine's propeller flange. The remainder of the airframe continued to travel on a southeasterly heading and impacted the ground about 100 ft from the initial impact.

As viewed from the initial impact point looking south, the main cabin door separated from the fuselage and came to rest left of, and about 162 ft from, the main wreckage. The separated nose landing gear was found near the initial impact point and 152 ft from the main wreckage. The separated left main landing gear (MLG) was found left of the main debris path and about 74 ft from the main wreckage. The separated right MLG was found right of the main debris path and about 90 ft from the main wreckage. The postimpact fire consumed major portions of the fuselage, empennage, and wings.
