Aviation Investigation Final Report

Location:	Moncks Corner, South Carolina	Accident Number:	ERA15MA259
Date & Time:	July 7, 2015, 11:00 Local	Registration:	N3601V
Aircraft:	Cessna 150M	Aircraft Damage:	Destroyed
Defining Event:	Midair collision	Injuries:	2 Fatal
Flight Conducted Under:	Part 91: General aviation - Personal

Location:	Moncks Corner, South Carolina	Accident Number:	ERA15MA259
Date & Time:	July 7, 2015, 11:00 Local	Registration:	96-0085
Aircraft:	LOCKHEED-MARTIN F-16CM	Aircraft Damage:	Destroyed
Defining Event:	Midair collision	Injuries:	1 Minor
Flight Conducted Under:	Armed Forces

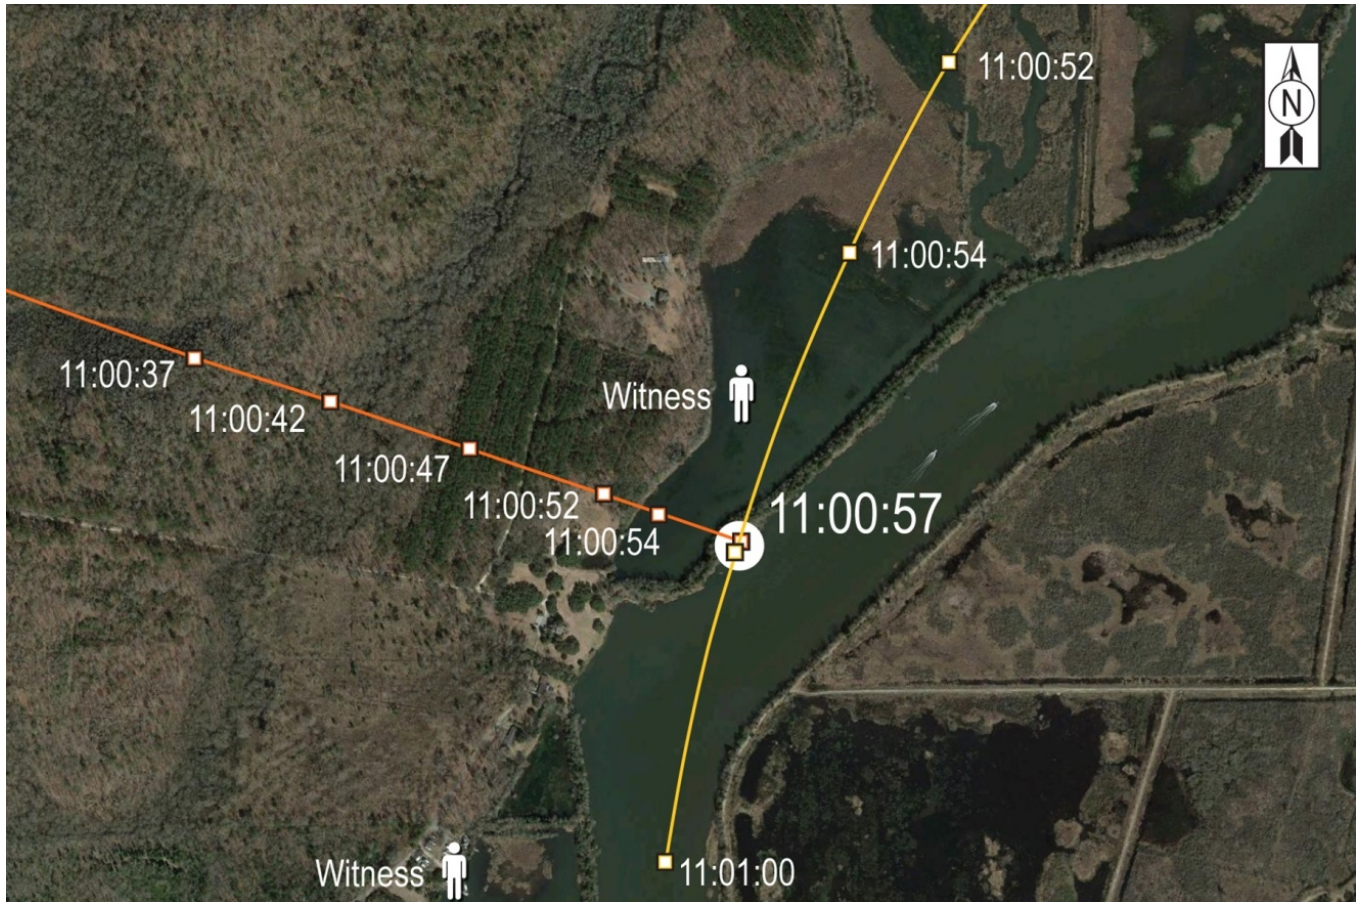
ft, radar contact was lost at 1103:17 in the vicinity of the F-16 crash site. The F-16 pilot used the airplane's emergency escape system (ejection seat) to egress, incurring minor injuries as he landed on the ground under canopy. He was subsequently met by first responders. Figure 1 shows the calculated flight track for the F-16 and the Cessna.

Figure 1. Calculated flight track for the F-16 (yellow) and the Cessna (orange). (The first witness is located north of the collision point, and the second witness is located southwest of the collision point.)

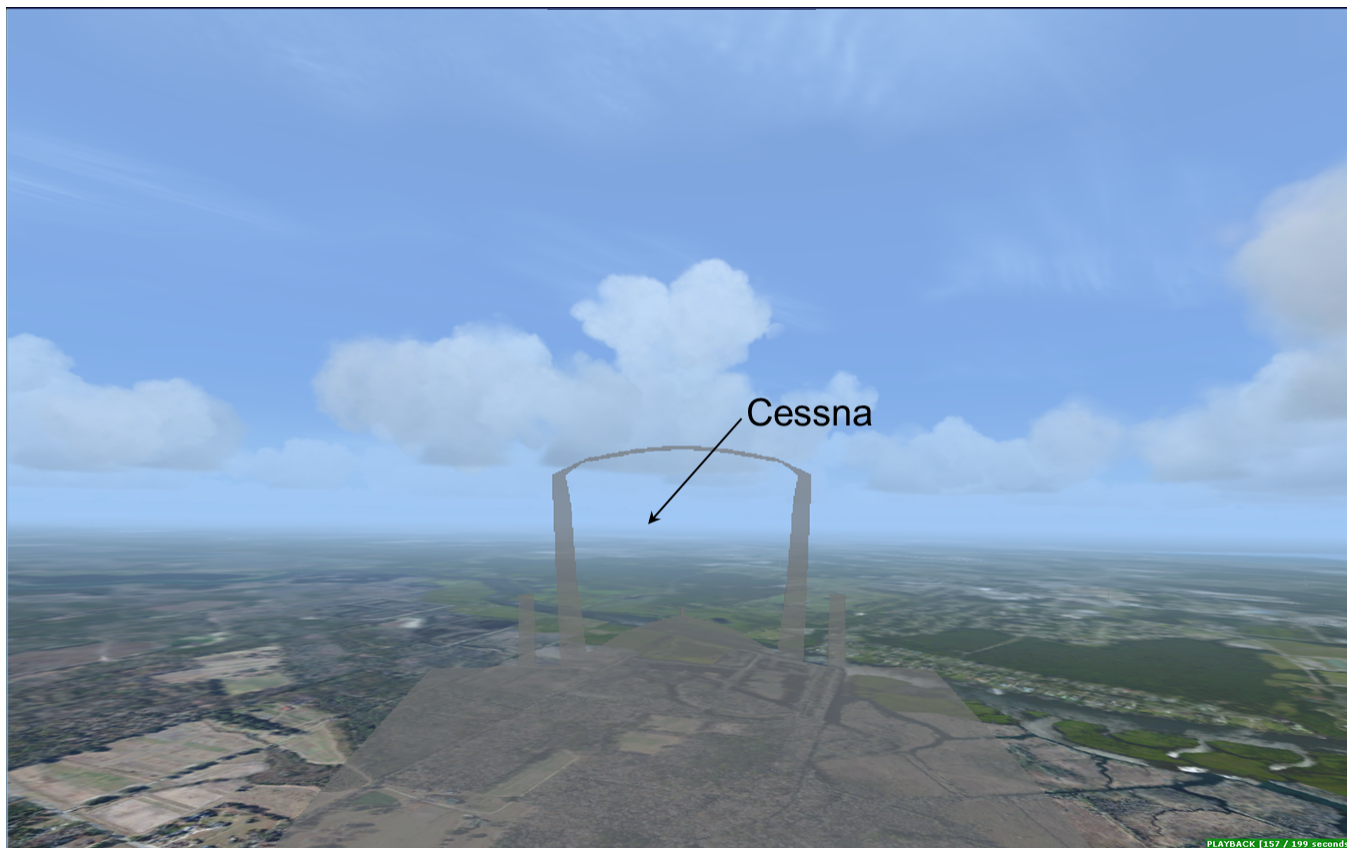
At 1100:16, when the controller provided the initial traffic advisory to the F-16 pilot, the F-16 was in a wings-level attitude, at an altitude of about 1,570 ft, on a ground track of 252°, and at a ground speed of 253 knots. The Cessna's calculated position was 3.25 nm from the F-16, at a position directly ahead (about 12 o'clock), and at an altitude of roughly 1,200 ft. The Cessna's ground track was 109°, and it was climbing at a rate of about 240 ft per minute. The aircraft performance and cockpit visibility study showed that, at 1100:18, the Cessna would have appeared to the F-16 pilot as a very small, stationary object just above the horizon and near the center of the airplane's heads up display (HUD) (see figure 3a); the F-16 would have appeared to the Cessna pilot as a small, stationary object just above the horizon, but outside of the left cockpit door window, near the forward vertical post of the door frame (see figure 3b).

Figure 3a. Simulated cockpit visibility from the F-16 at 1100:18, when the airplanes were 3.1 nm apart.

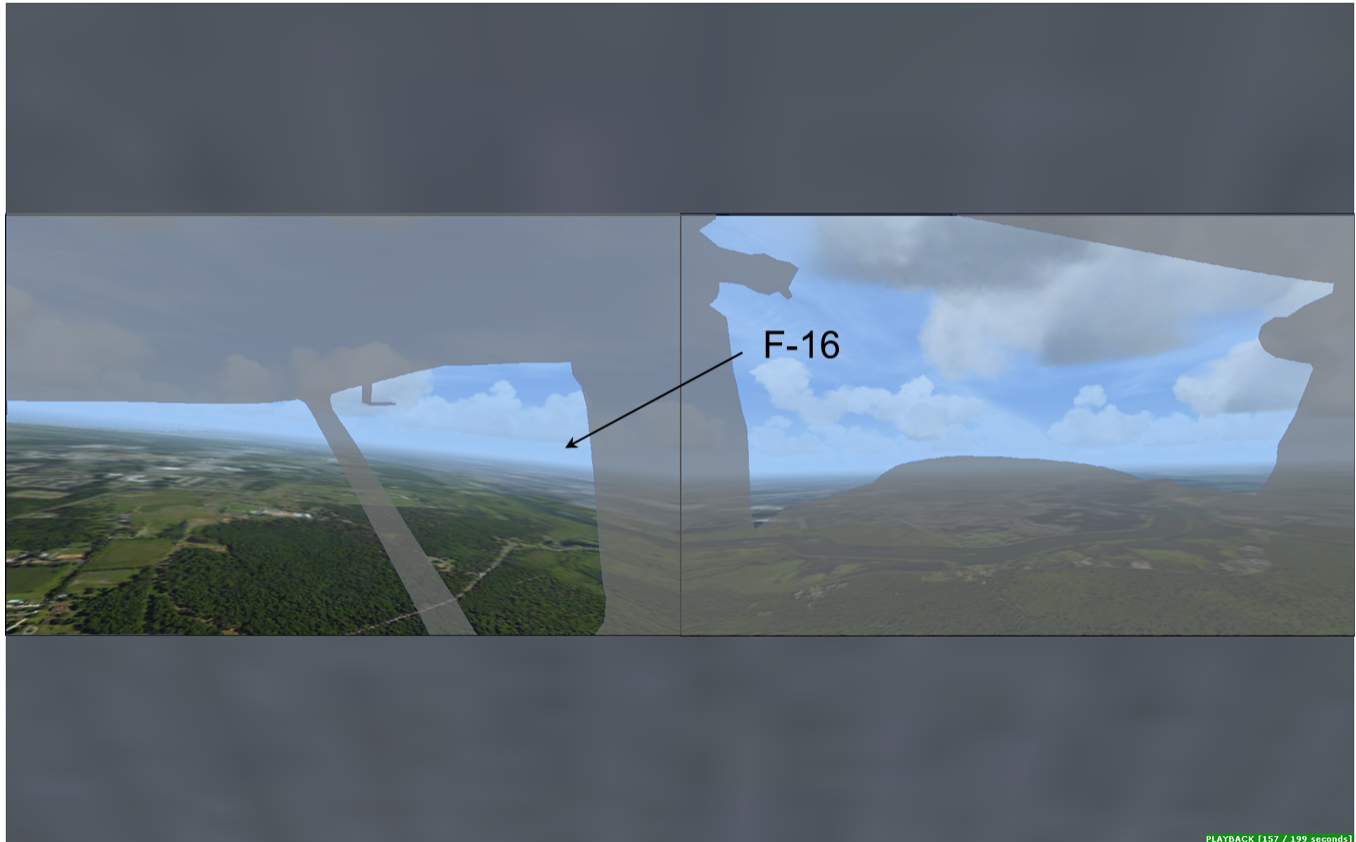
Figure 3b. Simulated cockpit visibility from the Cessna at 1100:18, when the airplanes were 3.1 nm apart. (Transparent shadow masks depict areas where visibility is obscured by airplane structure.)

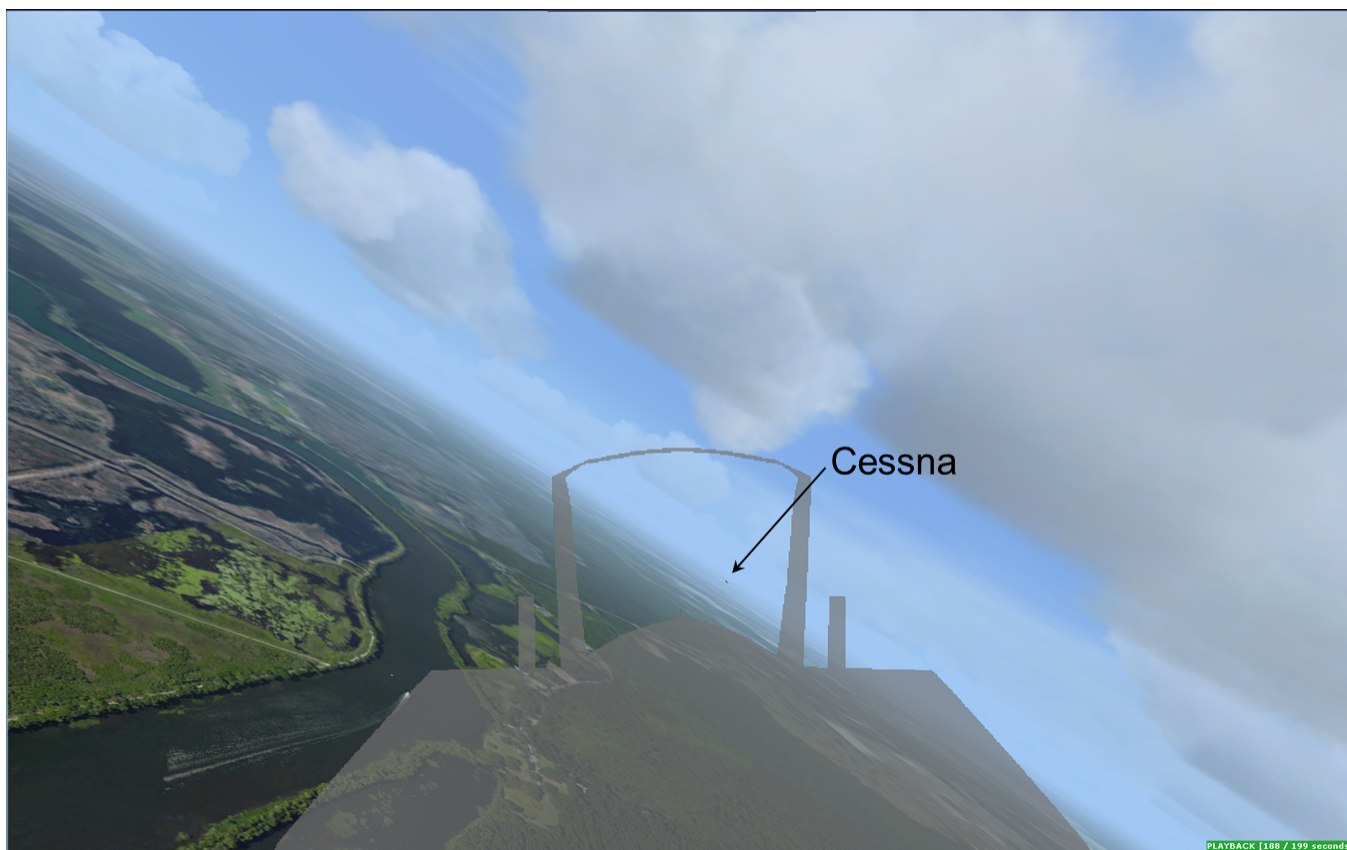
At 1100:49, as the F-16 was executing its left turn at a bank angle of 30°, the Cessna would have become more discernable in the lower right portion of the F 16 pilot's HUD (see figure 4a). The F-16 would also have become more discernable, visible through the Cessna pilot's left window at a point just

Figure 4a. Simulated cockpit visibility from the F-16 at 1100:49, when the airplanes were 0.6 nm apart.

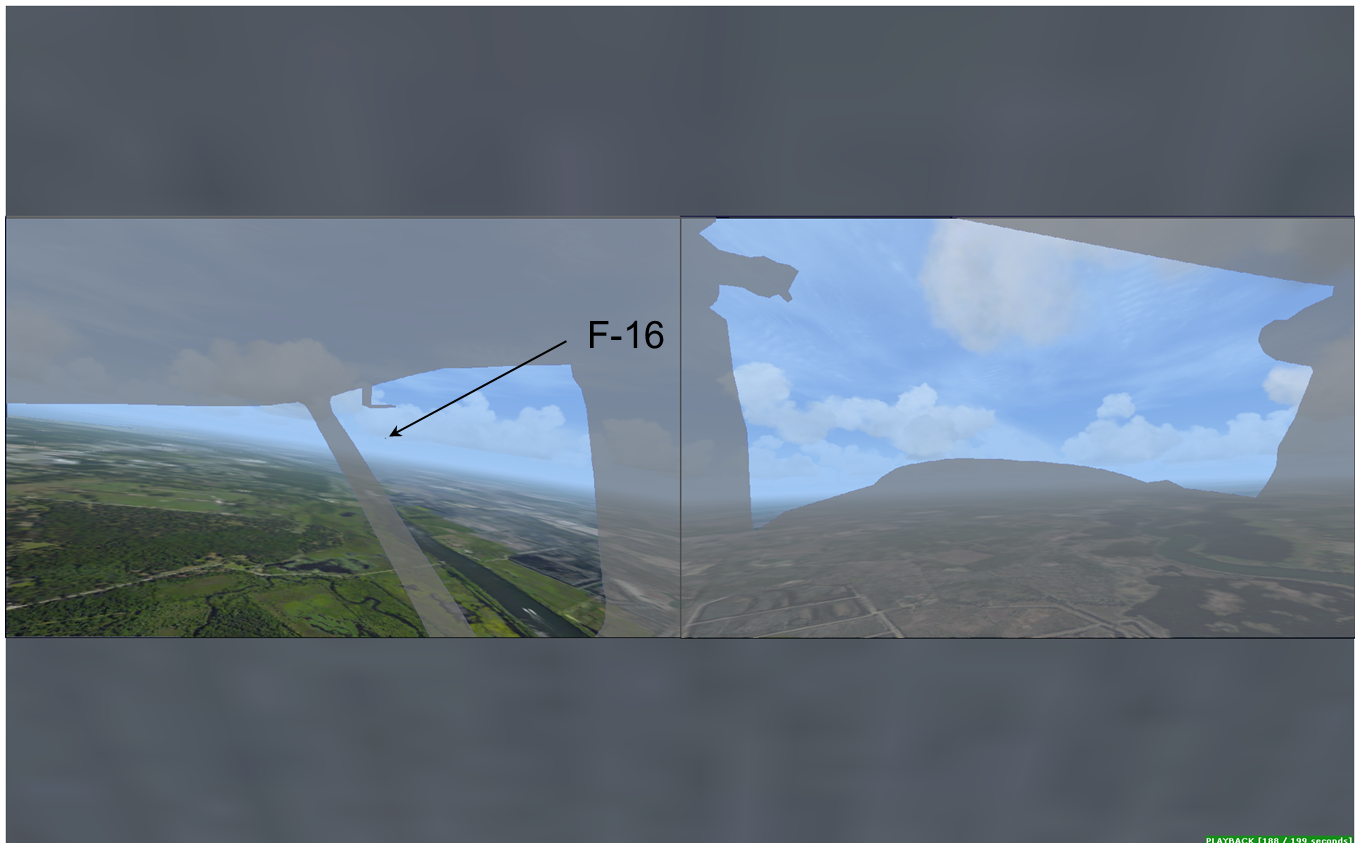
forward of the wing strut attachment point (see figure 4b).

Figure 4b. Simulated cockpit visibility from the Cessna at 1100:49, when the airplanes were 0.6 nm apart.

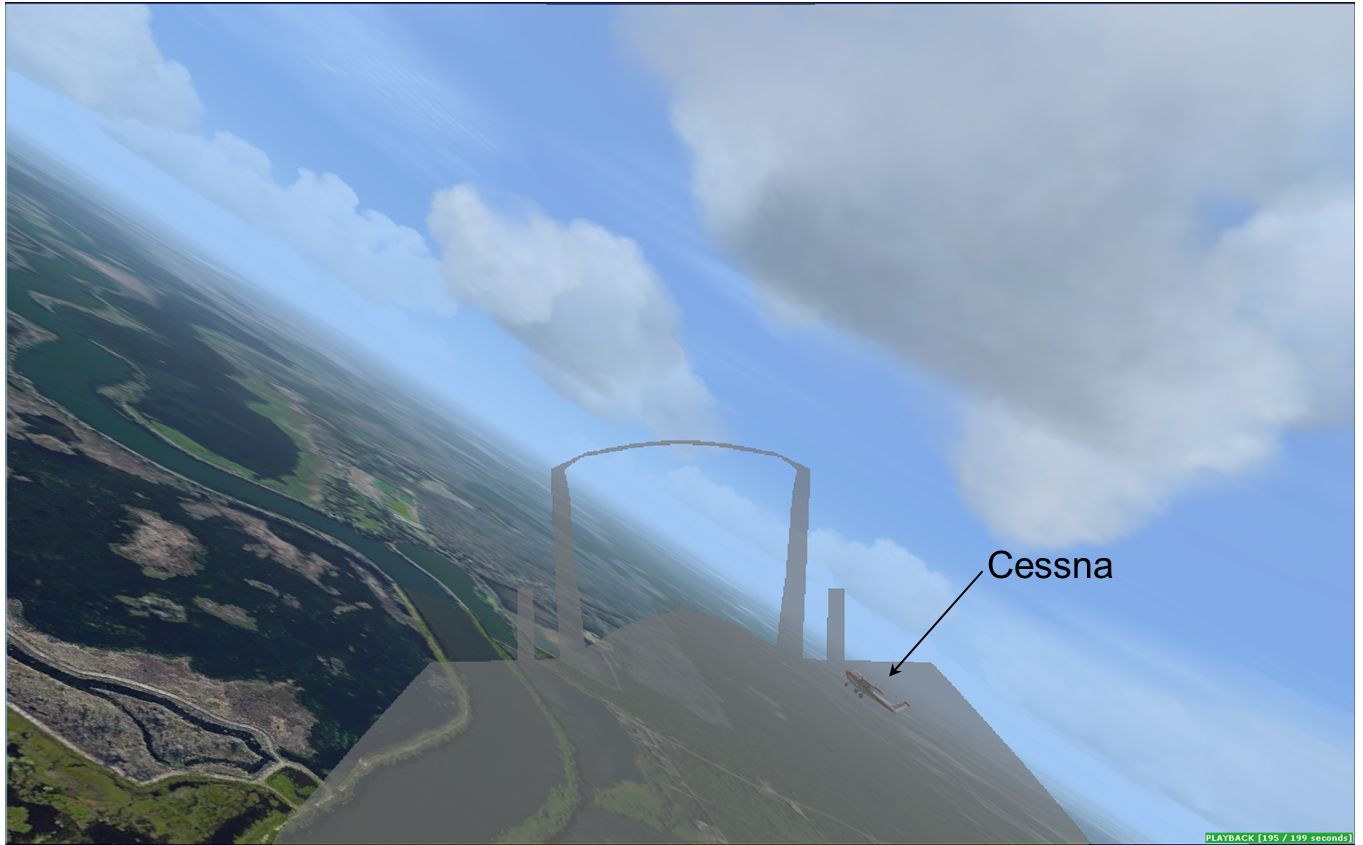
Over the next 3 seconds, the airplanes continued to approach each other, with the F-16 approaching the Cessna from its left and slightly above. The Cessna would have been completely obscured by the lower right cockpit structure of the F-16, as the airplane banked in its turn to the left (see figure 5a). The F 16 would have become partially obscured by the left wing strut (see figure 5b).

Figure 5a. Simulated cockpit visibility from the F-16 at 1100:56, when the airplanes were 260 ft apart.

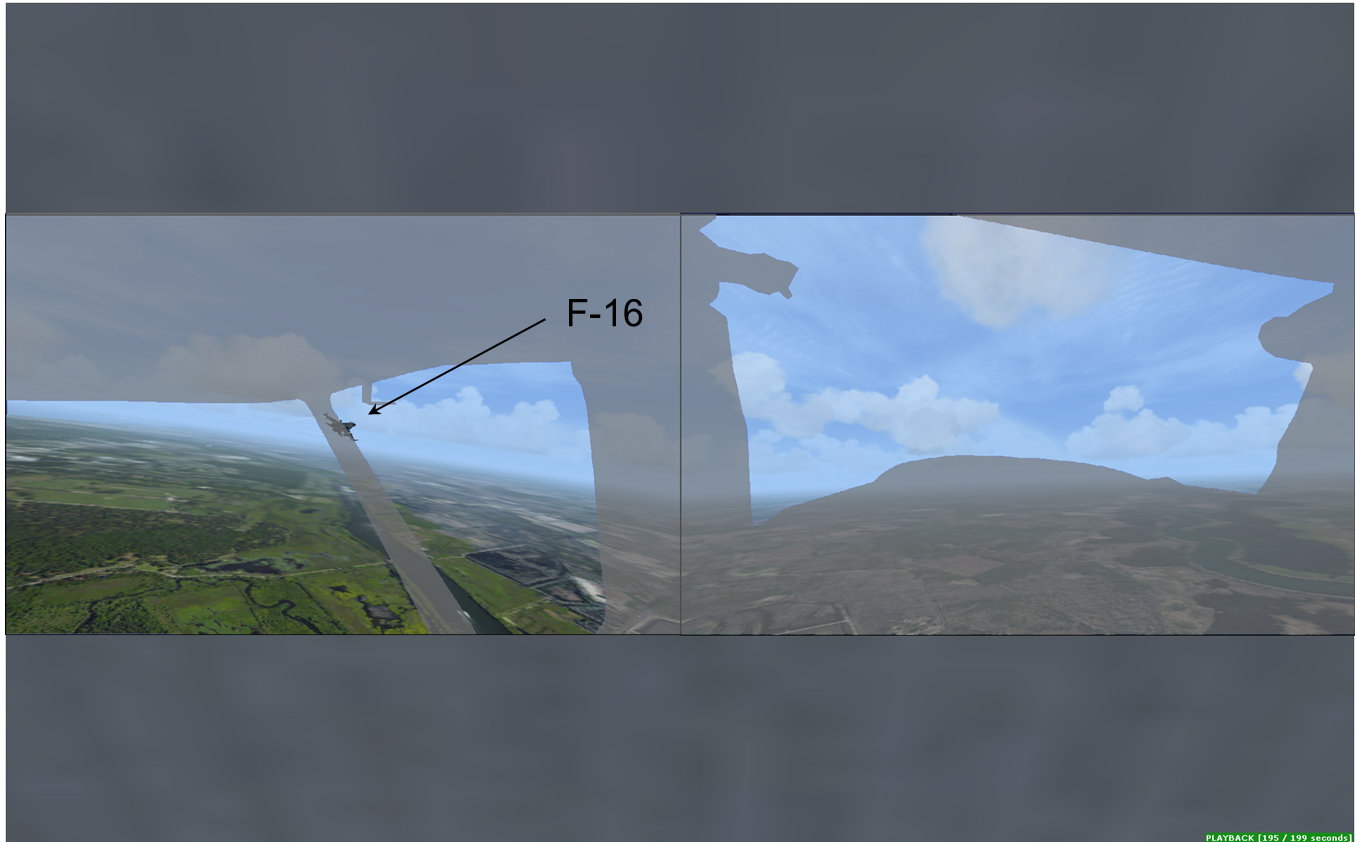
Figure 5b. Simulated cockpit visibility from the Cessna at 1100:56, when the airplanes were 260 ft apart.

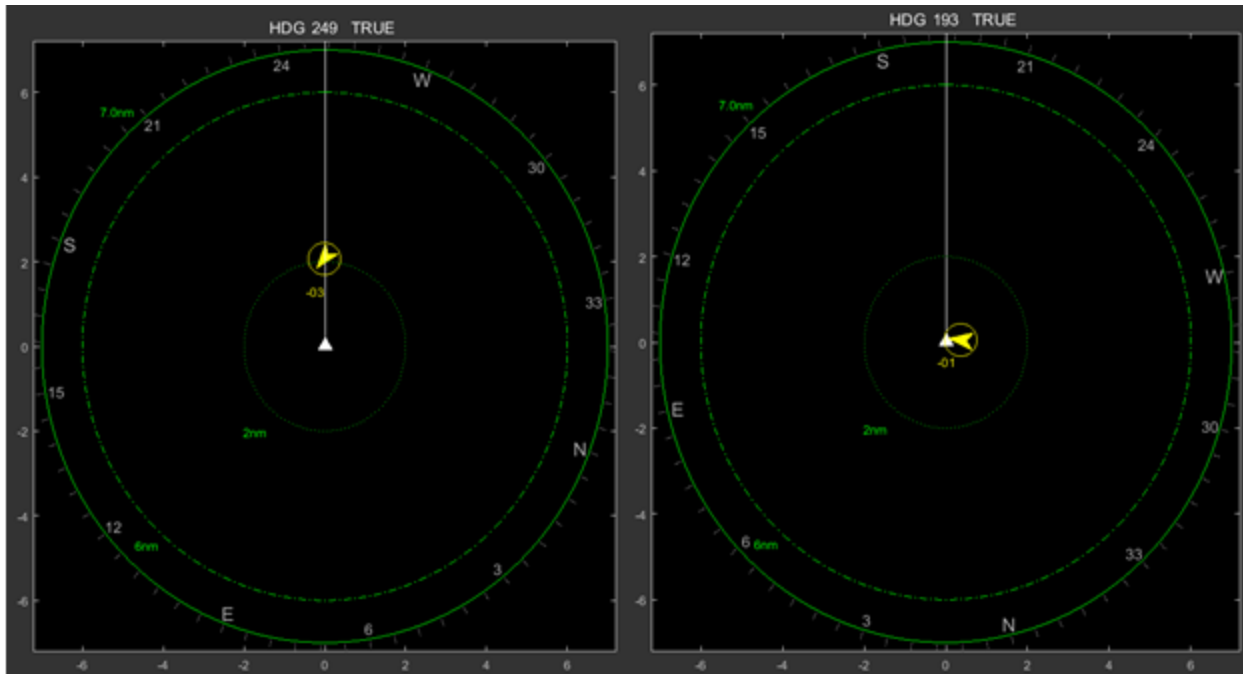
At 1100:35, as the F-16 banked into its left turn toward the south, the pilot would have received an aural alert associated with the Cessna, which by then had closed within 2 nm horizontally and 300 ft vertically. The aural alert would have advised, "Traffic, 12 o'clock, low, 2 miles." As shown in figure 6, the Cessna symbol would have changed to a filled yellow arrowhead, enclosed by a yellow circle. As the F-16 continued in its left turn, the Cessna target would have rotated to the right side of the F-16's projected course, with its heading still projected to intercept that course. At 1100:56, one second before the collision, the F-16 would have received a second aural alert of "Traffic, 2 o'clock, same altitude, zero miles." The symbol representing the Cessna would have depicted it 100 ft below the F-16 (see figure 6).

Figure 6. Simulated in-cockpit traffic display for the F-16 at 1100:35 (left) and 1100:56 (right)

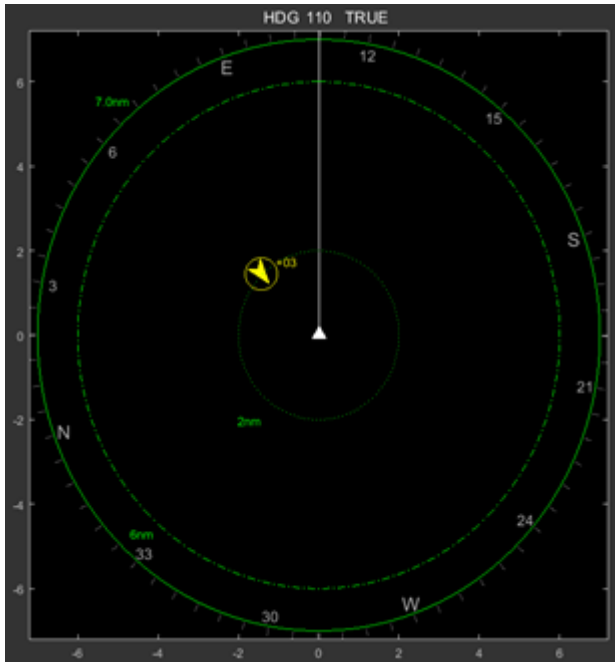
At 1100:35, as the F-16 banked into its left turn toward the south, the Cessna pilot would have received an aural alert associated with the F-16, which by then had closed within 2 nm horizontally and 300 ft vertically. The aural alert would have advised, "Traffic, 11 o'clock, high, 1 mile." As shown in figure 7, the F-16 symbol would have changed to a filled yellow arrowhead, enclosed by a yellow circle. The Cessna would not have received a second aural alert for the F-16, but the F-16 symbol would have remained in alert status (filled yellow arrowhead enclosed by a yellow circle) until the collision.

Figure 7. Simulated in-cockpit traffic display for the Cessna at 1100:35.

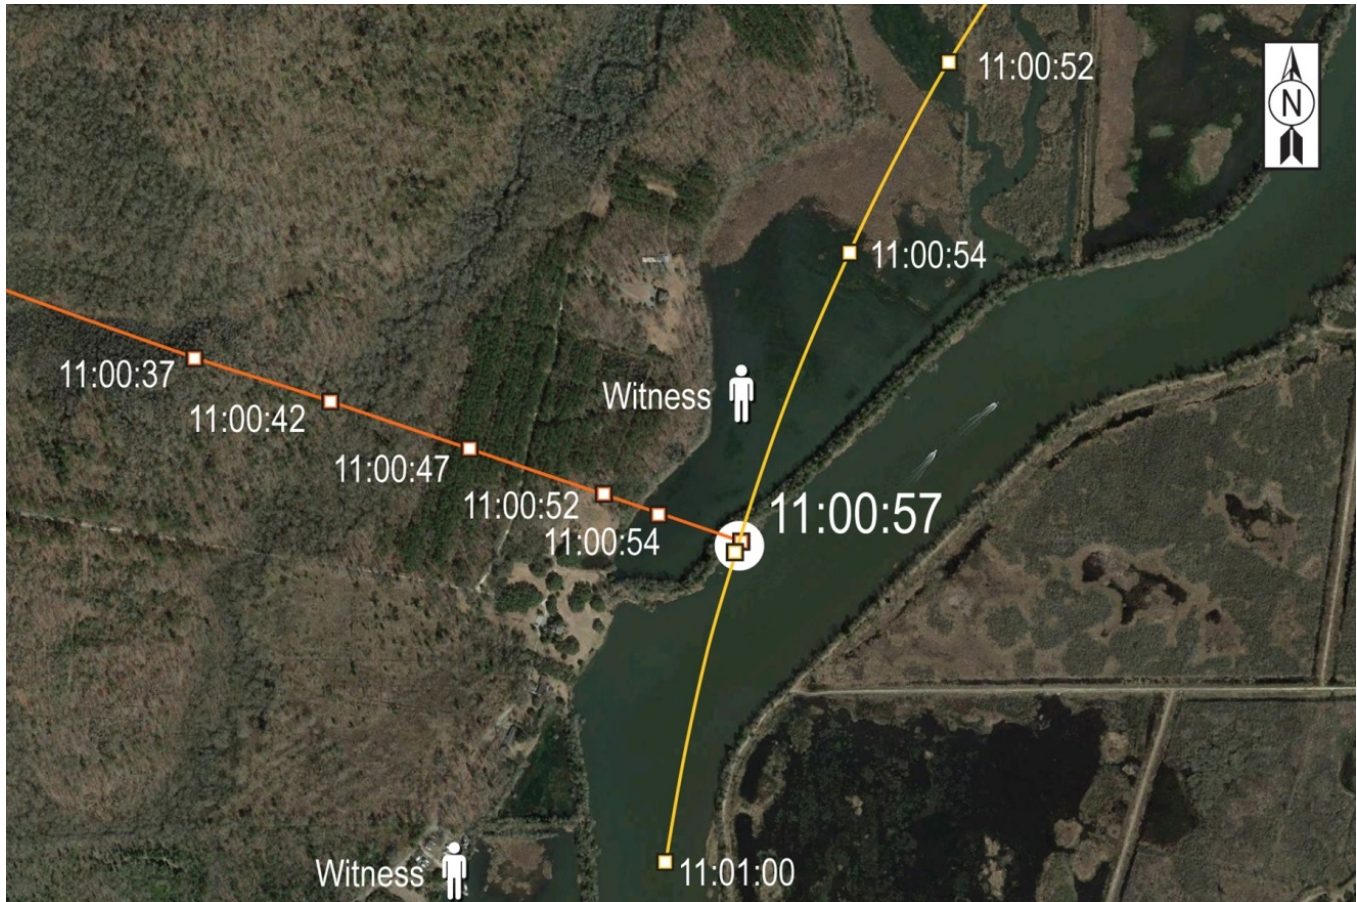
ft, radar contact was lost at 1103:17 in the vicinity of the F-16 crash site. The F-16 pilot used the airplane's emergency escape system (ejection seat) to egress, incurring minor injuries as he landed on the ground under canopy. He was subsequently met by first responders. Figure 1 shows the calculated flight track for the F-16 and the Cessna.

Figure 1. Calculated flight track for the F-16 (yellow) and the Cessna (orange). (The first witness is located north of the collision point, and the second witness is located southwest of the collision point.)

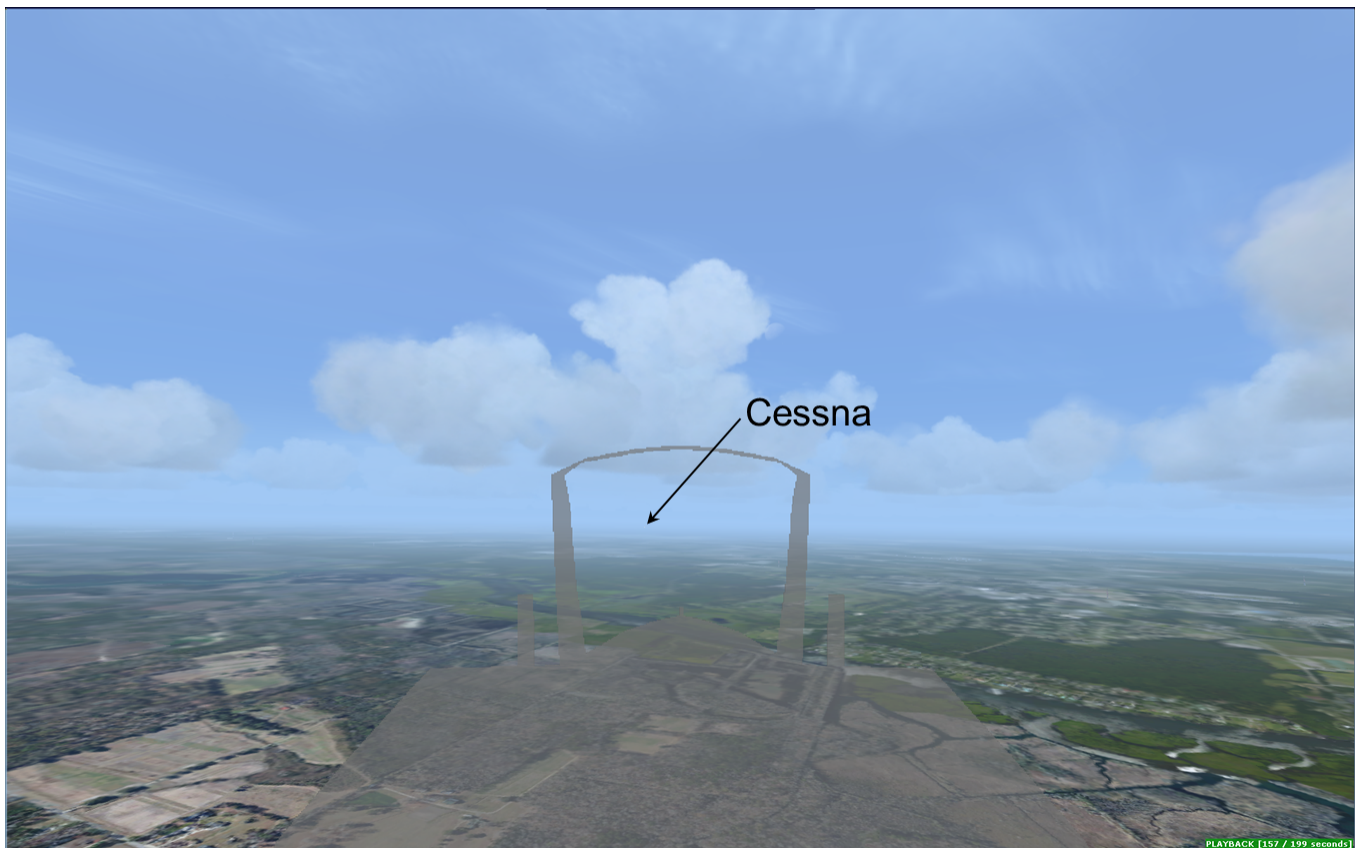
At 1100:16, when the controller provided the initial traffic advisory to the F-16 pilot, the F-16 was in a wings-level attitude, at an altitude of about 1,570 ft, on a ground track of 252°, and at a ground speed of 253 knots. The Cessna's calculated position was 3.25 nm from the F-16, at a position directly ahead (about 12 o'clock), and at an altitude of roughly 1,200 ft. The Cessna's ground track was 109°, and it was climbing at a rate of about 240 ft per minute. The aircraft performance and cockpit visibility study showed that, at 1100:18, the Cessna would have appeared to the F-16 pilot as a very small, stationary object just above the horizon and near the center of the airplane's heads up display (HUD) (see figure 3a); the F-16 would have appeared to the Cessna pilot as a small, stationary object just above the horizon, but outside of the left cockpit door window, near the forward vertical post of the door frame (see figure 3b).

Figure 3a. Simulated cockpit visibility from the F-16 at 1100:18, when the airplanes were 3.1 nm apart. (Transparent shadow masks depict areas where visibility is obscured by airplane structure.)

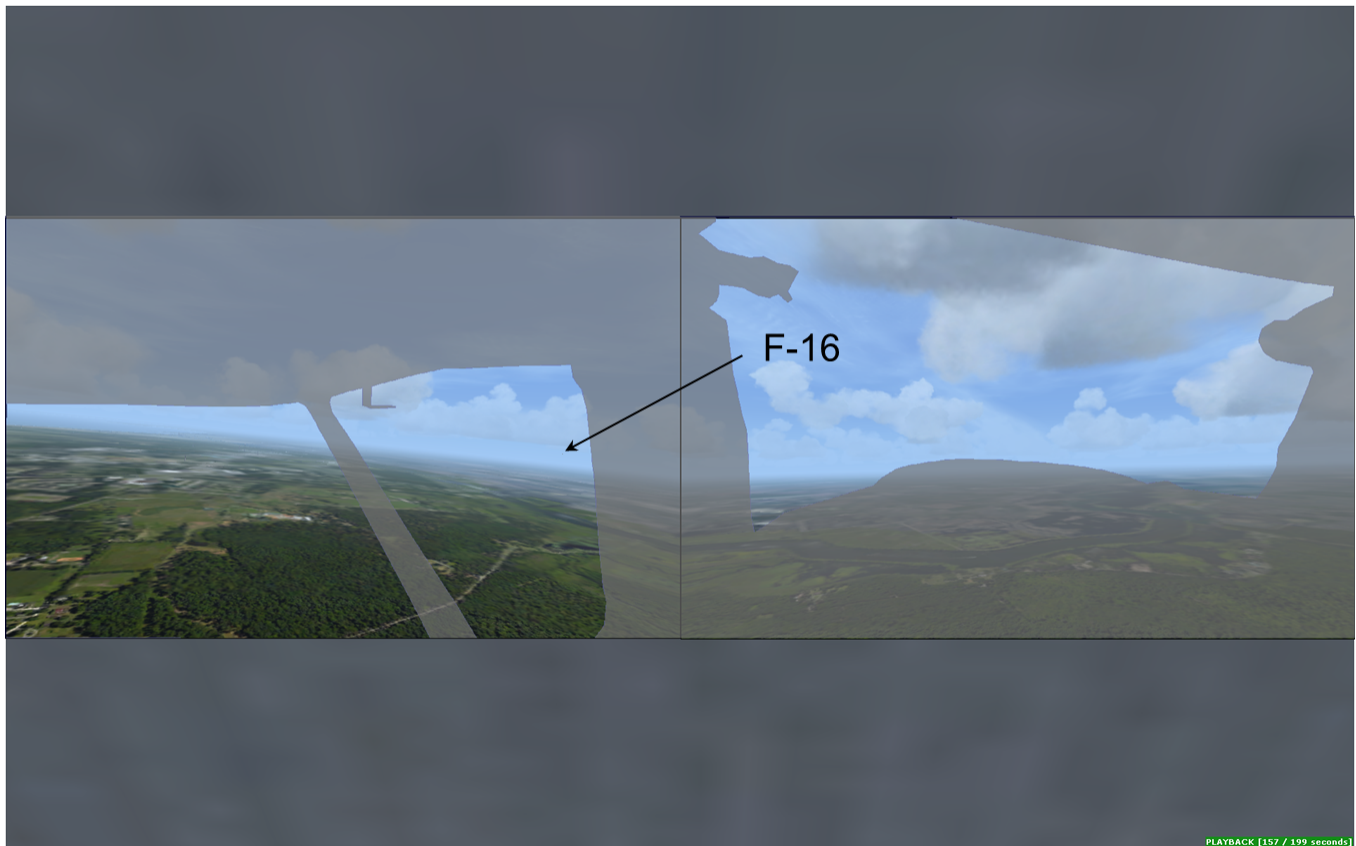
Figure 3b. Simulated cockpit visibility from the Cessna at 1100:18, when the airplanes were 3.1 nm apart. (Transparent shadow masks depict areas where visibility is obscured by airplane structure.)

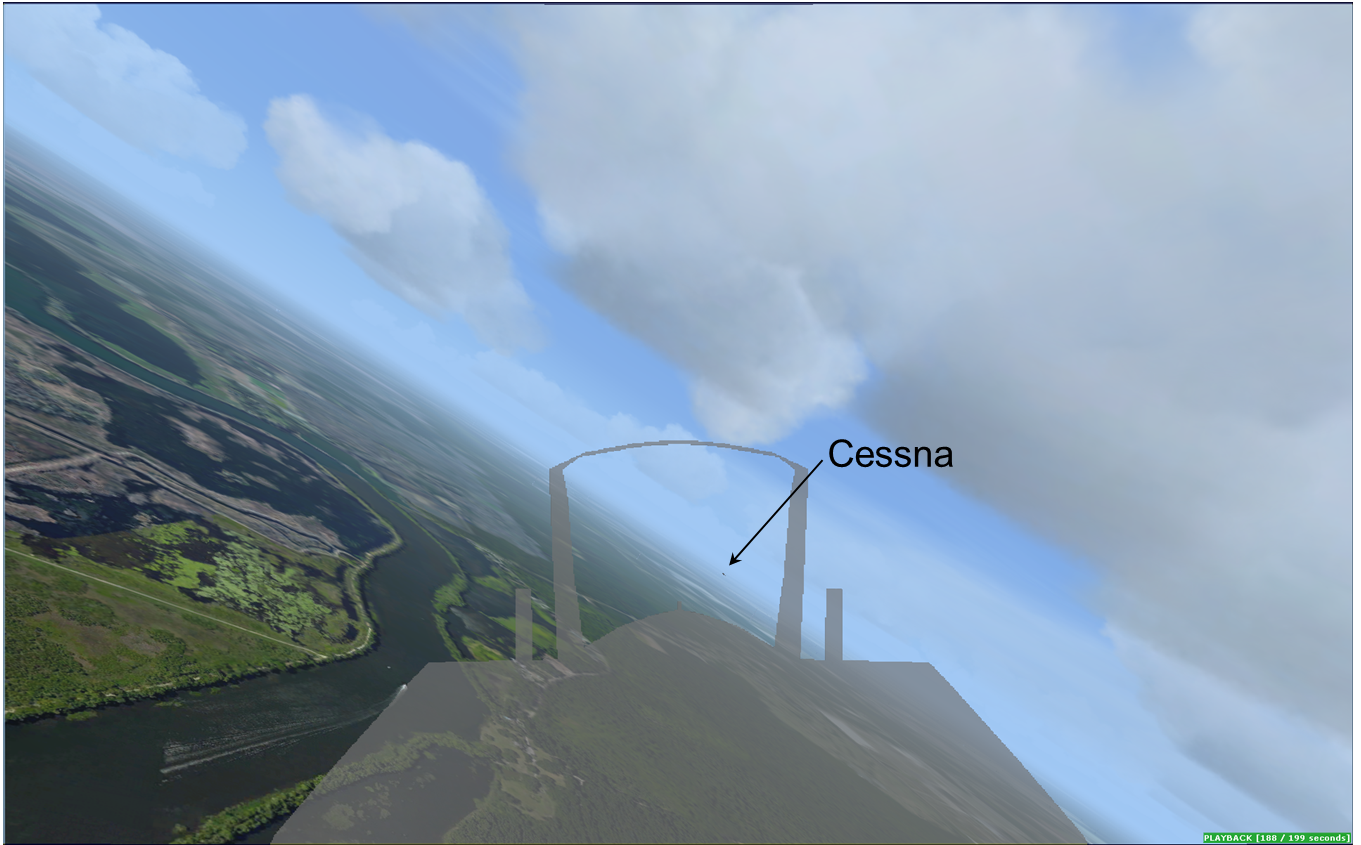
At 1100:49, as the F-16 was executing its left turn at a bank angle of 30°, the Cessna would have become more discernable in the lower right portion of the F 16 pilot's HUD (see figure 4a). The F-16 would also have become more discernable, visible through the Cessna pilot's left window at a point just forward of the wing strut attachment point (see figure 4b).

Figure 4a. Simulated cockpit visibility from the F-16 at 1100:49, when the airplanes were 0.6 nm apart.

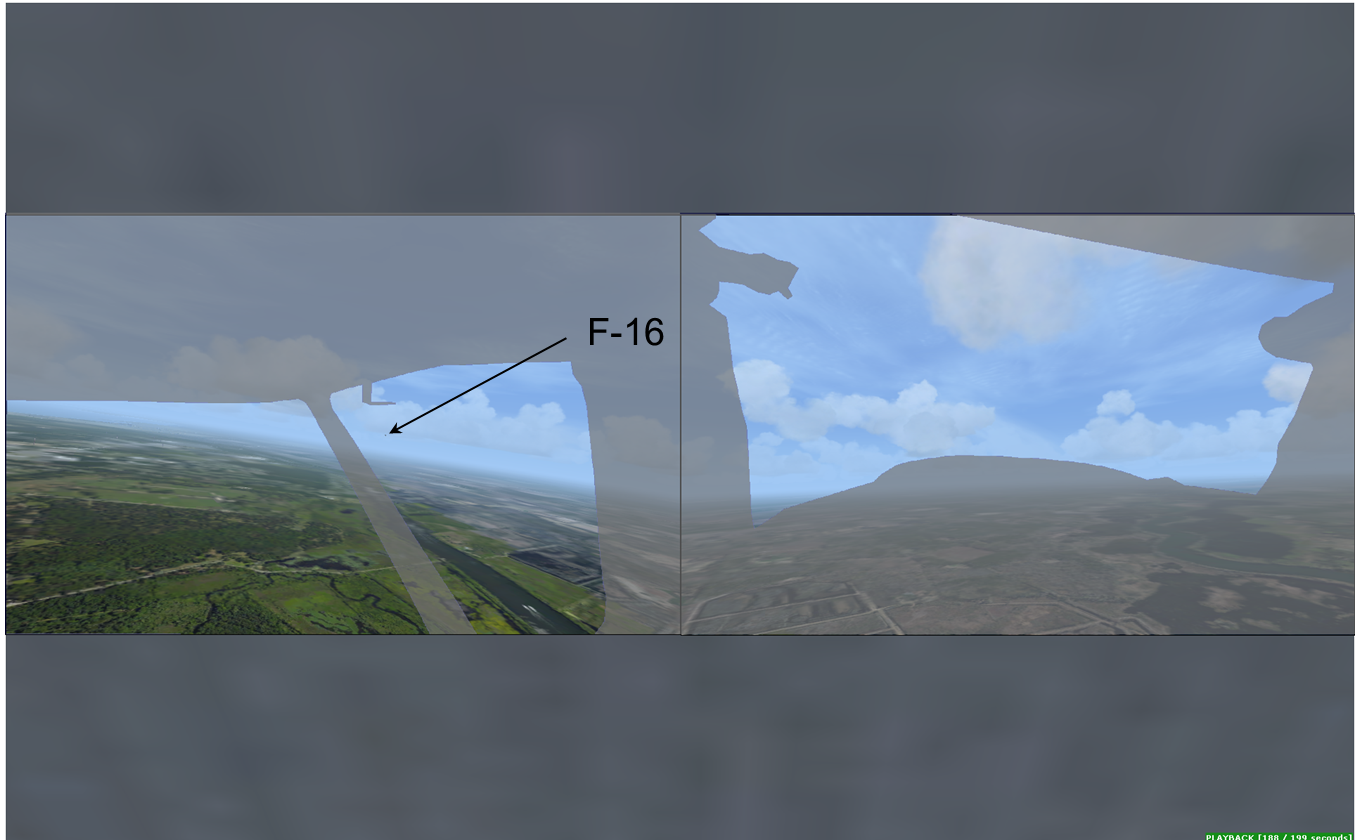
Figure 4b. Simulated cockpit visibility from the Cessna at 1100:49, when the airplanes were 0.6 nm apart.

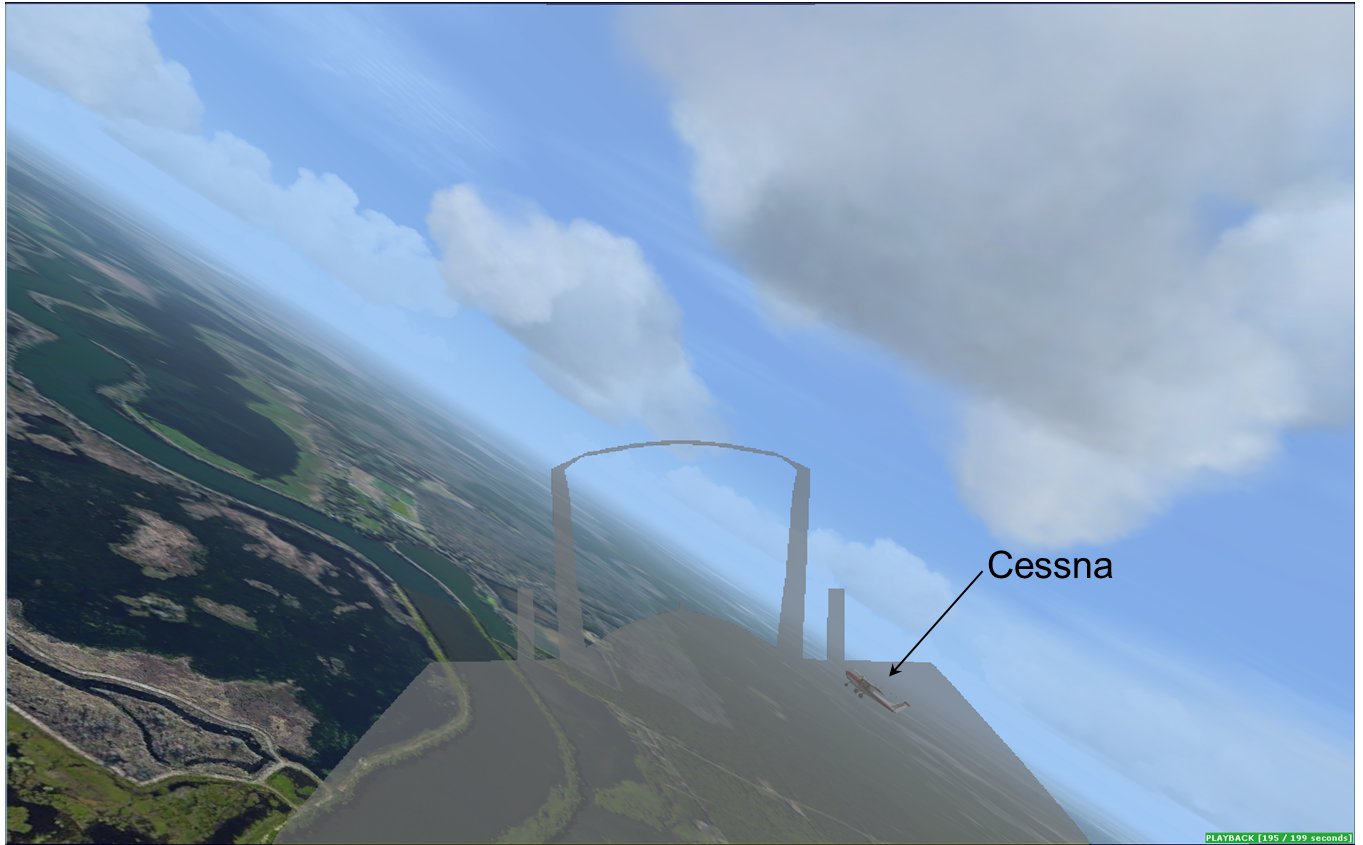
Over the next 3 seconds, the airplanes continued to approach each other, with the F-16 approaching the Cessna from its left and slightly above. The Cessna would have been completely obscured by the lower right cockpit structure of the F-16, as the airplane banked in its turn to the left (see figure 5a). The F 16 would have become partially obscured by the left wing strut (see figure 5b).

Figure 5a. Simulated cockpit visibility from the F-16 at 1100:56, when the airplanes were 260 ft apart.

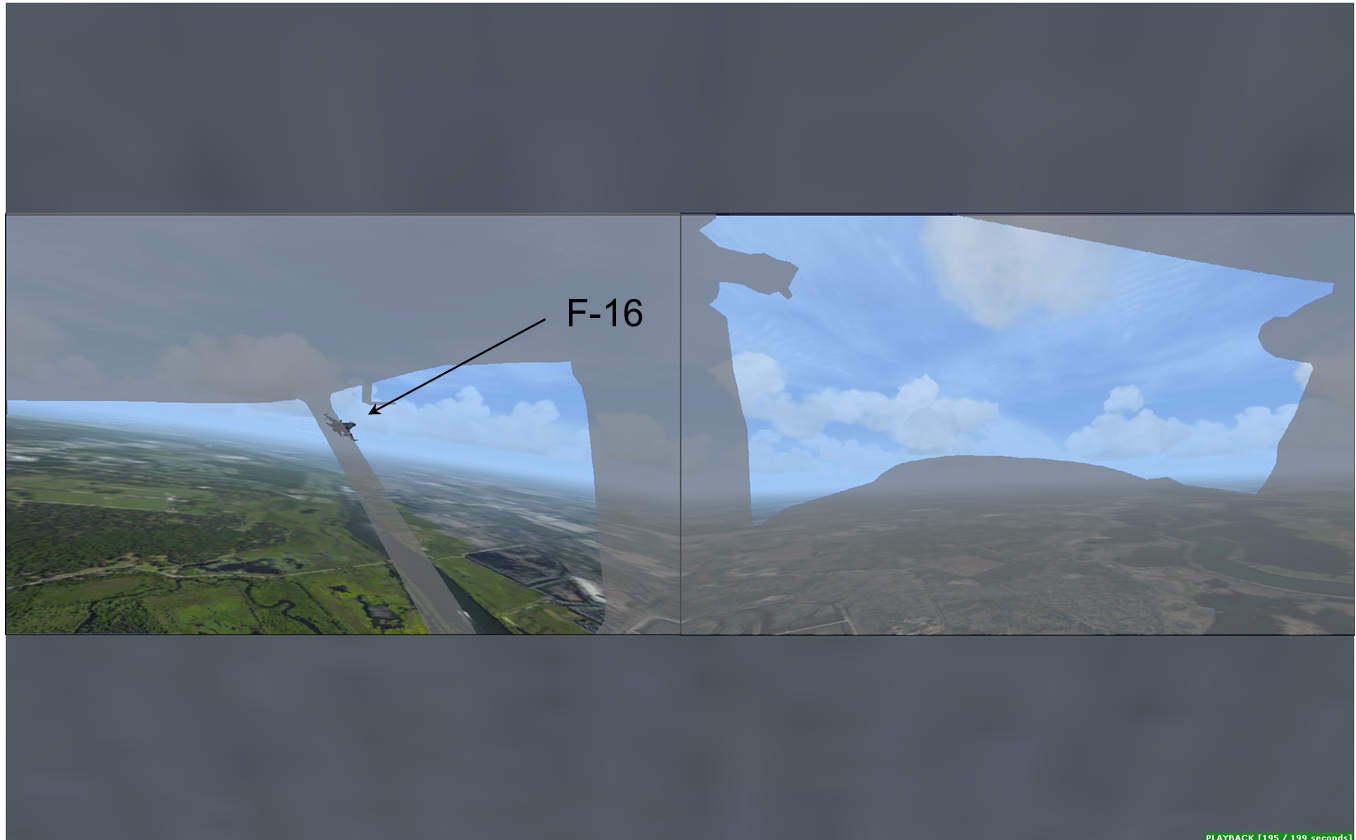
Figure 5b. Simulated cockpit visibility from the Cessna at 1100:56, when the airplanes were 260 ft apart.

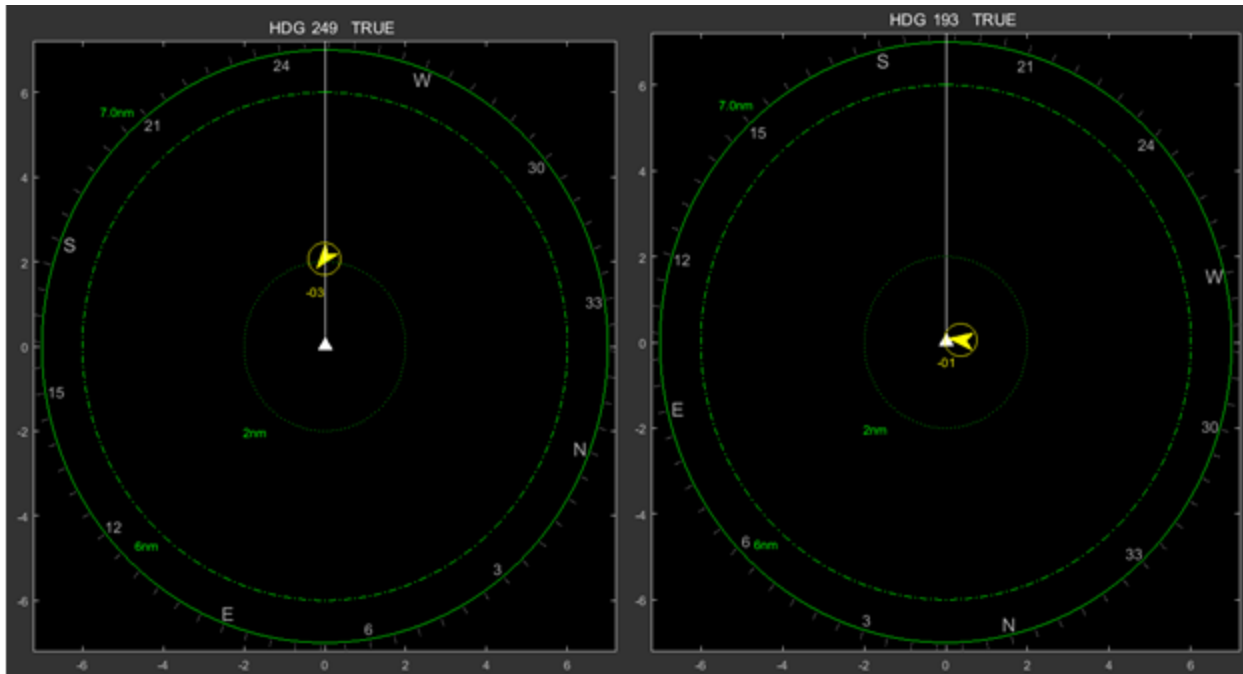
At 1100:35, as the F-16 banked into its left turn toward the south, the pilot would have received an aural alert associated with the Cessna, which by then had closed within 2 nm horizontally and 300 ft vertically. The aural alert would have advised, "Traffic, 12 o'clock, low, 2 miles." As shown in figure 6, the Cessna symbol would have changed to a filled yellow arrowhead, enclosed by a yellow circle. As the F-16 continued in its left turn, the Cessna target would have rotated to the right side of the F-16's projected course, with its heading still projected to intercept that course. At 1100:56, one second before the collision, the F-16 would have received a second aural alert of "Traffic, 2 o'clock, same altitude, zero miles." The symbol representing the Cessna would have depicted it 100 ft below the F-16 (see figure 6).

Figure 6. Simulated in-cockpit traffic display for the F-16 at 1100:35 (left) and 1100:56 (right).

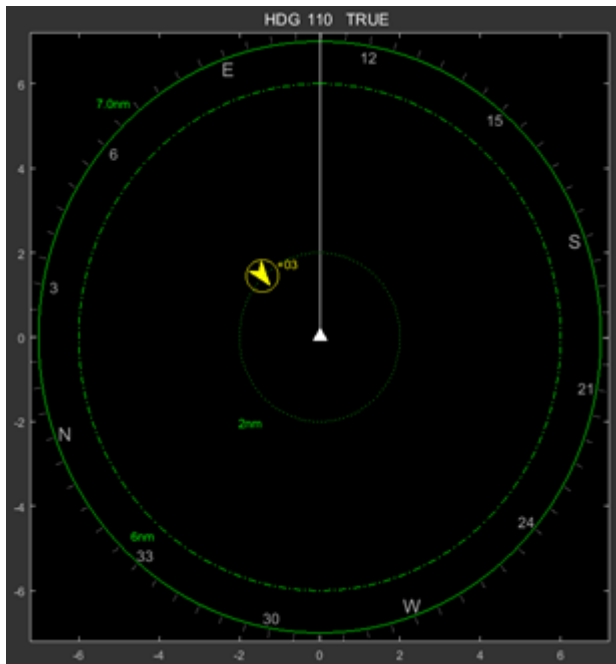
At 1100:35, as the F-16 banked into its left turn toward the south, the Cessna pilot would have received an aural alert associated with the F-16, which by then had closed within 2 nm horizontally and 300 ft vertically. The aural alert would have advised, "Traffic, 11 o'clock, high, 1 mile." As shown in figure 7, the F-16 symbol would have changed to a filled yellow arrowhead, enclosed by a yellow circle. The Cessna would not have received a second aural alert for the F-16, but the F-16 symbol would have remained in alert status (filled yellow arrowhead enclosed by a yellow circle) until the collision.

Figure 7. Simulated in-cockpit traffic display for the Cessna at 1100:35.
