Aviation Investigation Final Report

Location:	Juneau, Alaska	Accident Number:	ANC15FA049
Date & Time:	July 17, 2015, 13:18 Local	Registration:	N62AK
Aircraft:	Cessna 207A	Aircraft Damage:	Substantial
Defining Event:	Controlled flight into terr/obj (CFIT)	Injuries:	1 Fatal, 4 Serious
Flight Conducted Under:	Part 135: Air taxi & commuter - Scheduled

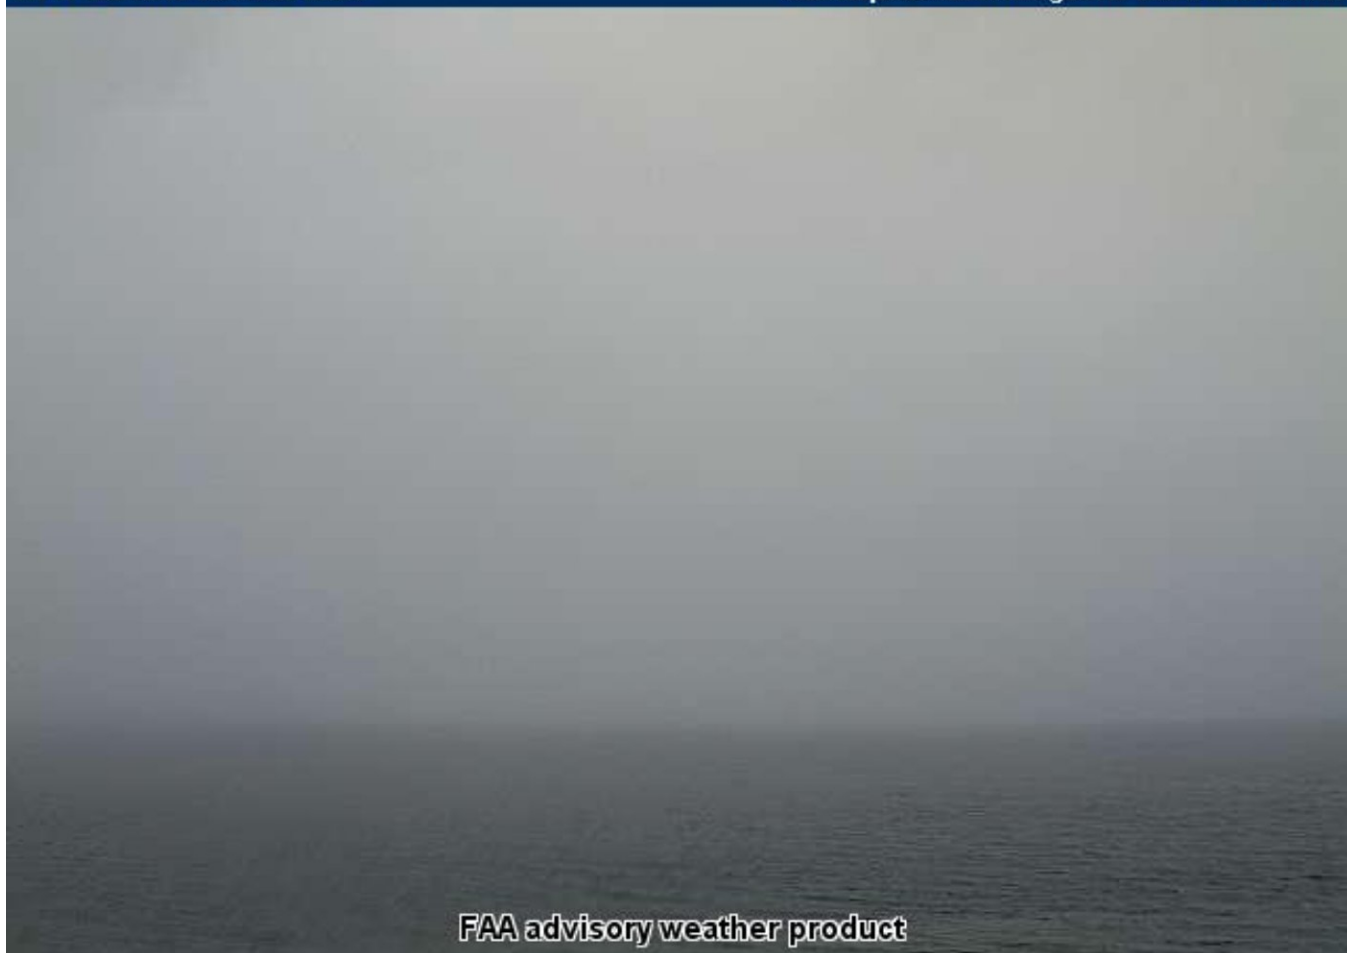
Sisters Island - NorthEast
See <http://avcams.faa.gov> for more information

Figure. A video camera image showing visibility conditions at Juneau Airport about 5 minutes before the estimated accident time, facing the direction of the accident location.
