# Aviation Investigation Final Report

<b>Location:</b>	Newburgh, New York	<b>Accident Number:</b>	ERA15FA331
<b>Date &amp; Time:</b>	August 28, 2015, 14:07 Local	<b>Registration:</b>	N18FJ
<b>Aircraft:</b>	CORNELL W F/SAHAKIAN J A JR GILES 202 (G202)	<b>Aircraft Damage:</b>	Destroyed
<b>Defining Event:</b>	Aircraft structural failure	<b>Injuries:</b>	1 Fatal
<b>Flight Conducted Under:</b>	Part 91: General aviation - Air race/show

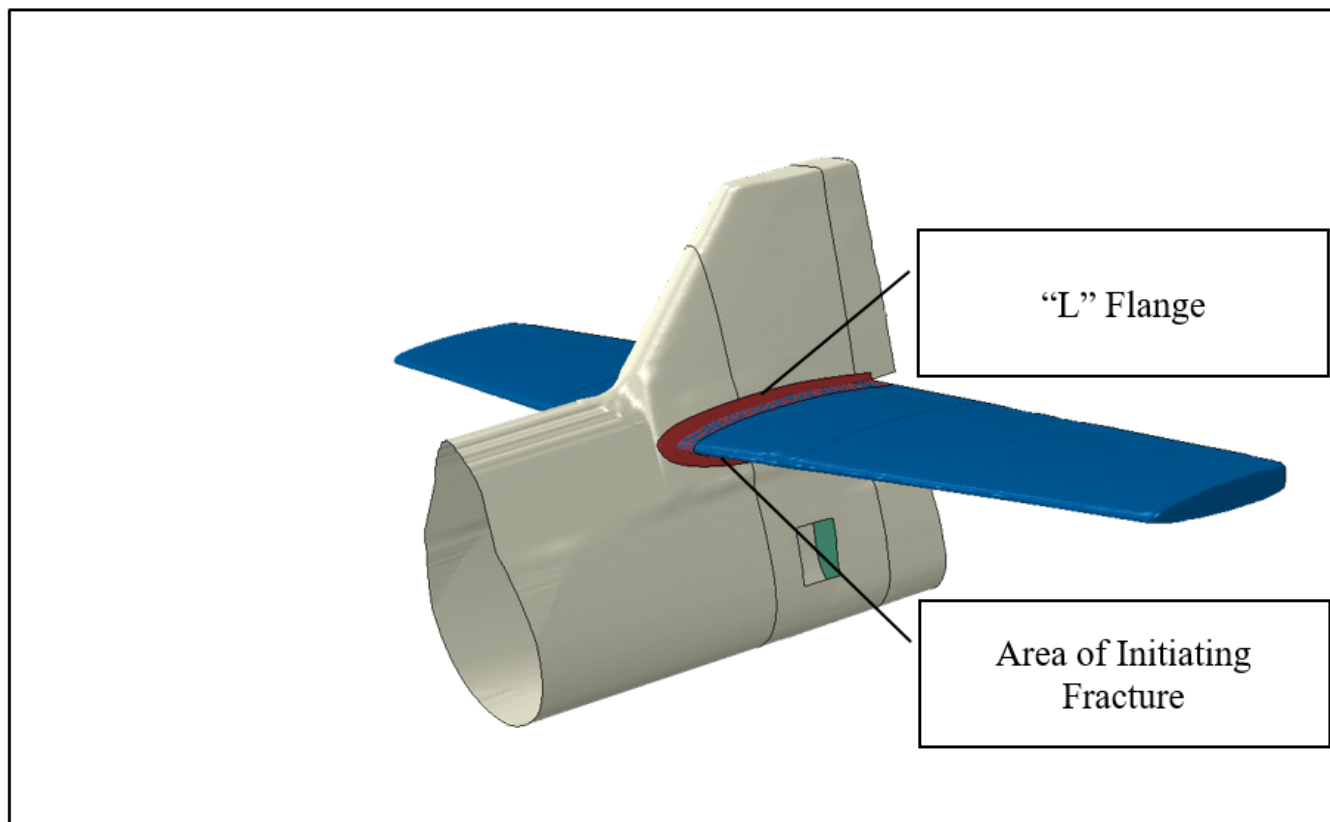
Figure 1 - Horizontal and Vertical Stabilizer Joint

Follow-up examinations of the airframe revealed that the horizontal and vertical stabilizer had fractured from the remainder of the airplane in several locations: along the lower side of the horizontal stabilizer at the bonds between the skin panels and the "L" shaped flanges attaching the lower side of the horizontal stabilizer to the vertical stabilizer and fuselage skin panels, at the bond between the upper end of the banjo bulkhead and the lower skin of the horizontal stabilizer, through the fuselage skin forward of the vertical stabilizer, and through the vertical spar at the aft end of the vertical stabilizer (See Figure 1).

Further examination revealed that the bonds between both right and left "L" flanges, which were constructed of glass-fiber-reinforced cloth and epoxy, were fractured from their mating surfaces on both legs of the "L" (the legs mating to the lower horizontal stabilizer skin and to the fuselage skin) in several locations. The bond between the banjo bulkhead and the horizontal stabilizer lower skin was fractured entirely. Most of the bond surface area in all locations exhibited evidence of fiber pullout and resin transfer; however, two areas that showed limited fiber or resin transfer were located on the left flange where it had mated to the lower skin of the horizontal stabilizer near its leading edge.

A study examining all the fractures in the tail area determined that the first fracture to occur was the bond fracture in the left flange at the bottom of the horizontal stabilizer near its leading edge. The fracture features in this area were consistent with tensile opening, which translates to a relative upward motion of the left side of the horizontal stabilizer (or, relative downward motion of the lower fuselage skin on the left side of the tail). There was no clear evidence of progressive crack growth on any of the fracture surfaces. Some contact damage on the fracture surface was present.
