Aviation Investigation Final Report

Location:	Kewanee, Illinois	Accident Number:	CEN15FA388
Date & Time:	August 30, 2015, 09:18 Local	Registration:	N765CD
Aircraft:	CIRRUS DESIGN CORP SR22	Aircraft Damage:	Substantial
Defining Event:	Loss of control in flight	Injuries:	2 Fatal, 1 Serious
Flight Conducted Under:	Part 91: General aviation - Personal

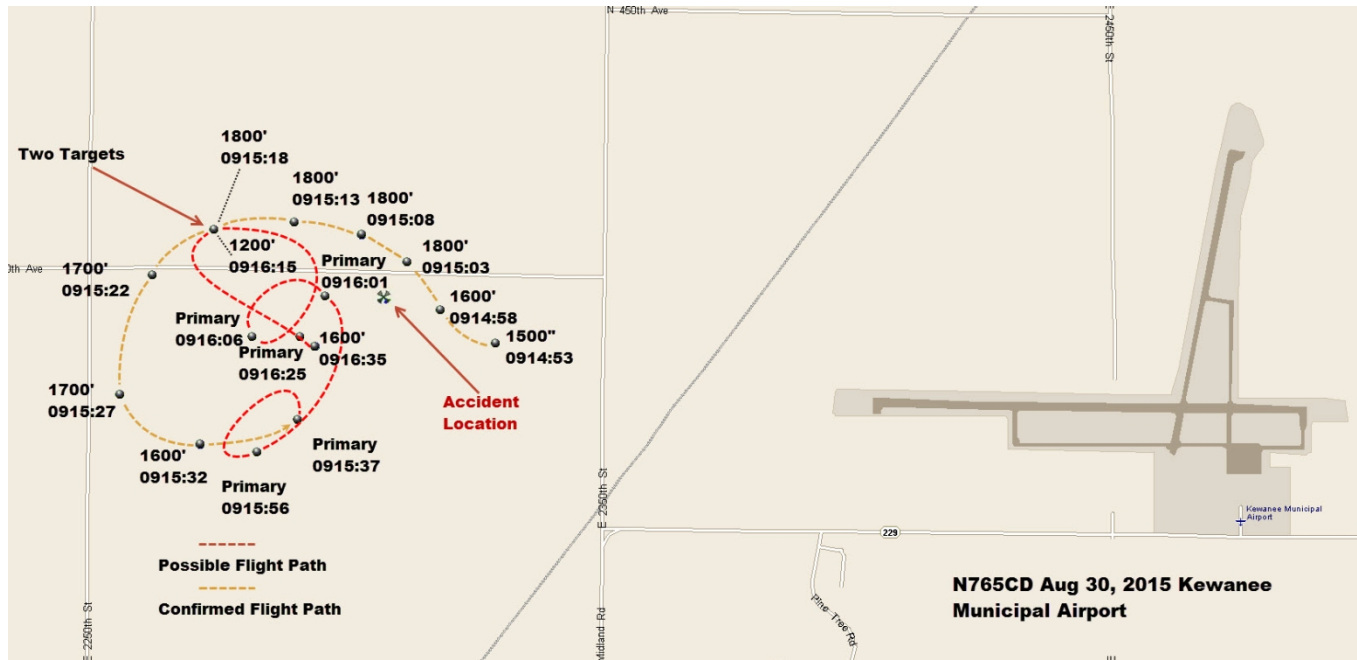
Figure 1. Flight track after takeoff

primary radar returns consistent with the accident airplane begin at 0915:37 and continued until the last associated target at 0916:35 and an altitude of 1,600 ft. EZI airport elevation was 858 ft. A flight path superimposed between the primary targets suggested that the pilot made three nearly 360° left turns in close succession before impacting the ground. See figure 1.
