# Aviation Investigation Final Report

<b>Location:</b>	Hancock, Wisconsin	<b>Accident Number:</b>	CEN15LA399
<b>Date &amp; Time:</b>	August 26, 2015, 11:30 Local	<b>Registration:</b>	N2005C
<b>Aircraft:</b>	Weatherly Aviation Company Inc 620B	<b>Aircraft Damage:</b>	Destroyed
<b>Defining Event:</b>	Part(s) separation from AC	<b>Injuries:</b>	1 Fatal
<b>Flight Conducted Under:</b>	Part 137: Agricultural

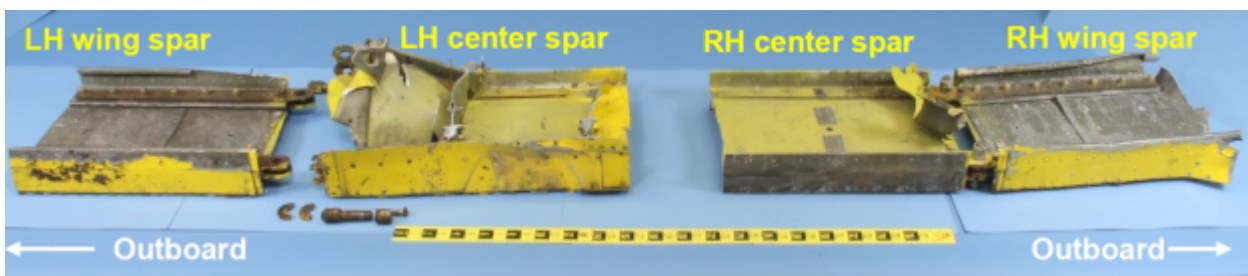
Examination revealed that the left center section forward spar lower hinge brackets were fractured vertically through the pin holes (Figure 1). The pin remained installed through the left wing forward spar lower hinge brackets with the fractured ends of the center section brackets captured by the pin. All the remaining spar attach points on the left and right wings were intact. The left wing spars, interspar structure, and skins were recovered at the main wreckage site with varying amounts of damage. The left wing leading edge, left wing tip and left fixed trailing edge section separated during the accident sequence and were recovered in the field. There was mechanical damage and deformation noted on the left wing and center section upper spar caps adjacent to the forward spar attach point. The damage was consistent with the outboard wing having rotated up more than 120° with respect to the center wing. The left wing rear spar was fractured through the outboard wing hinge bracket holes even though the brackets remained intact. The left wing structure was crushed downward between the spars and curled upward with yellow paint transfer noted on the internal wing ribs. The left aileron control tubes and left wing spray bar displayed significant upward deformation.

Figure: The sections of the left and right forward wing spar assembly sections, viewed aft looking forward angled from below, as received. The figure shows the separated pieces of the left center section forward spar lower hinge brackets, which are placed at the bottom of the left wing spar and left center section spar for the photo.

The left center section forward spar lower forward hinge bracket exhibited a visible, flat, thumbnail-shaped crack containing crack arrest marks consistent with progressive fracture, which was determined to be fatigue. The crack arrest marks emanated from the aft corner of the pin hole. The fatigue crack measured 0.15 inch on the aft (inside) face, 0.19 inch along the pin hole, and 0.24 inch deep from the crack initiation corner. Examination of the crack in a scanning electron microscope revealed fatigue striations. The areas outside of the fatigue crack exhibited dimple rupture, consistent with subsequent overstress fracture.

A closer view of the initiation site revealed a small corrosion pit containing non-conductive deposits. Examination of the rest of the pin hole found multiple features consistent with corrosion pits along the surface, as well as shallow circumferential gouging. The upper side of the lower forward hinge bracket revealed a small flat region, absent shear lips, in the aft corner, as well as microscopic thumbnail cracks. These small fatigue cracks exhibited striations and ratchet marks consistent with multiple crack initiation sites on the pin hole surface. Cross-sectional metallographic inspection found corrosion pits on the pin hole surface.
