Aviation Investigation Final Report

Location:	Silverton, Colorado	Accident Number:	CEN15FA400
Date & Time:	September 5, 2015, 14:08 Local	Registration:	N1099Q
Aircraft:	Cessna 310H	Aircraft Damage:	Destroyed
Defining Event:	Controlled flight into terr/obj (CFIT)	Injuries:	4 Fatal
Flight Conducted Under:	Part 91: General aviation - Personal

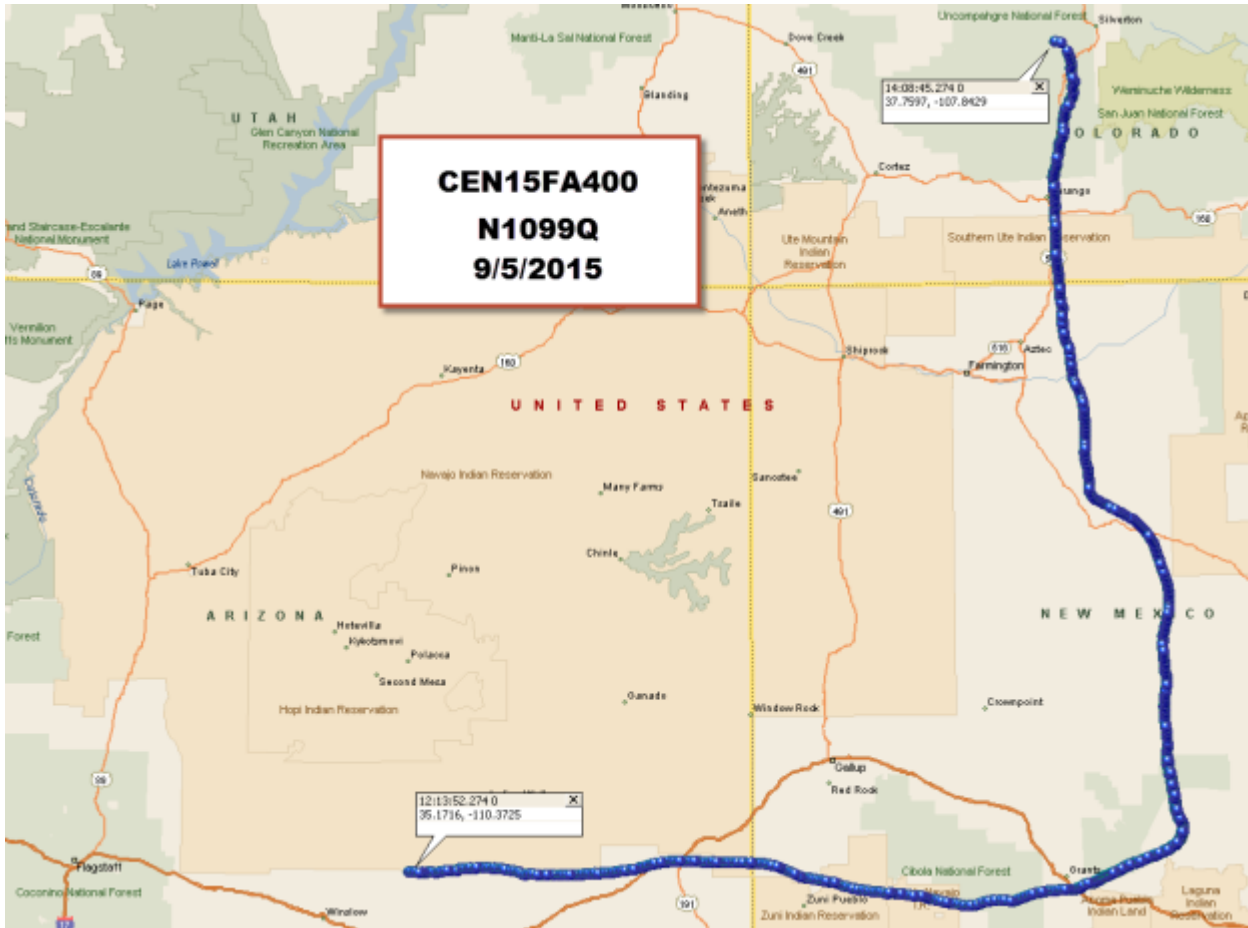
The flight was not receiving ATC services and was not assigned a transponder squawk code. The airplane used a squawk code of 1200 based upon ATC recordings and the arrival/departure times to and from FLG. The radar track of an airplane with a squawk code correlating to those times was plotted to provide an overview of the flight and is shown in figure 1.

Figure 1. A radar plot of an airplane flight track consistent with the accident airplane. The plot shows a turn toward the north.

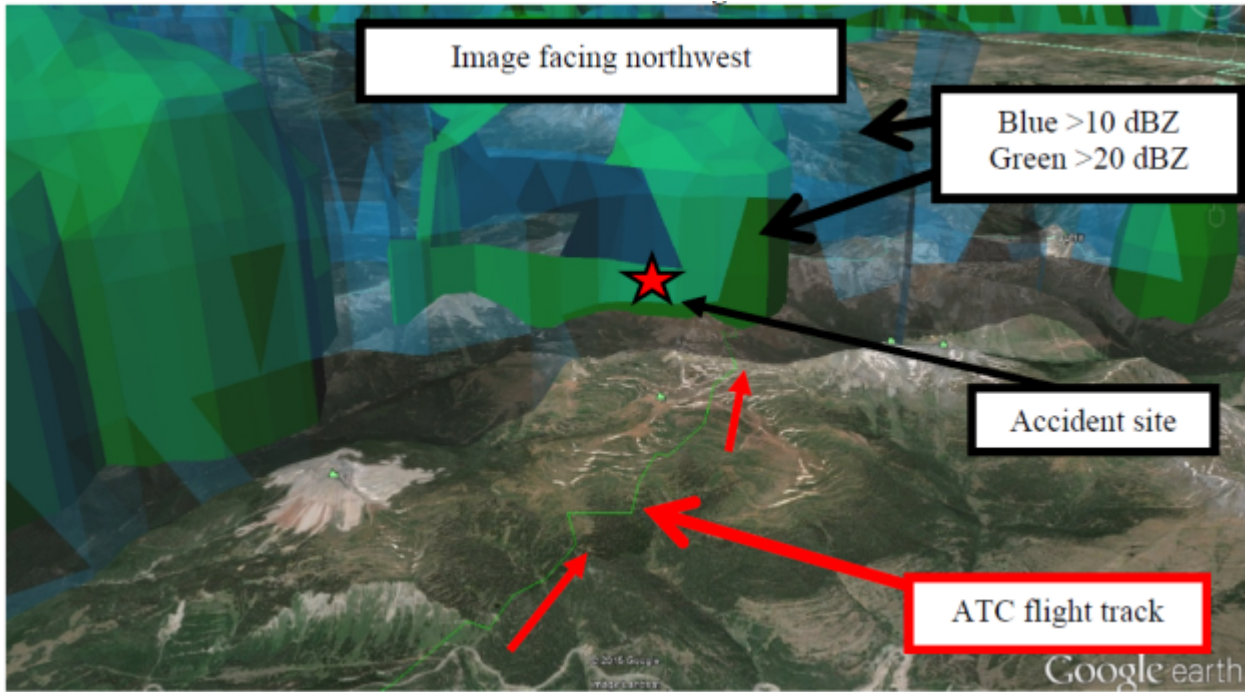
Closer to the accident site, observations from the nonofficial surface stations within 12 miles of the accident site reported gusting wind between 8 and 39 mph. The strongest wind was at the nonofficial surface stations closest to the accident site altitude and near the tops of the mountains between 10,000 and 12,000 ft. In addition, these stations reported rain showers in the vicinity and had relative humidity values greater than 80 percent around the accident time. These stations were above 10,000 ft, and the high relative humidity values were consistent with cloud cover at or above 10,000 ft and mountain obscuration due to clouds, precipitation, and mist. Figure 2 shows the three-dimensional Grand Junction, Colorado, weather surveillance radar-88 Doppler base reflectivity from the scan initiated at 1406 and the ATC Flight Track.

Figure 2. Three-dimensional Grand Junction, Colorado, weather surveillance radar-88 Doppler base reflectivity from the scan initiated at 1406 and the ATC Flight Track. Blue and green colored areas depict reflectivity of greater than 10 decibels (dBZ) and greater than 20 dBZ, respectively.

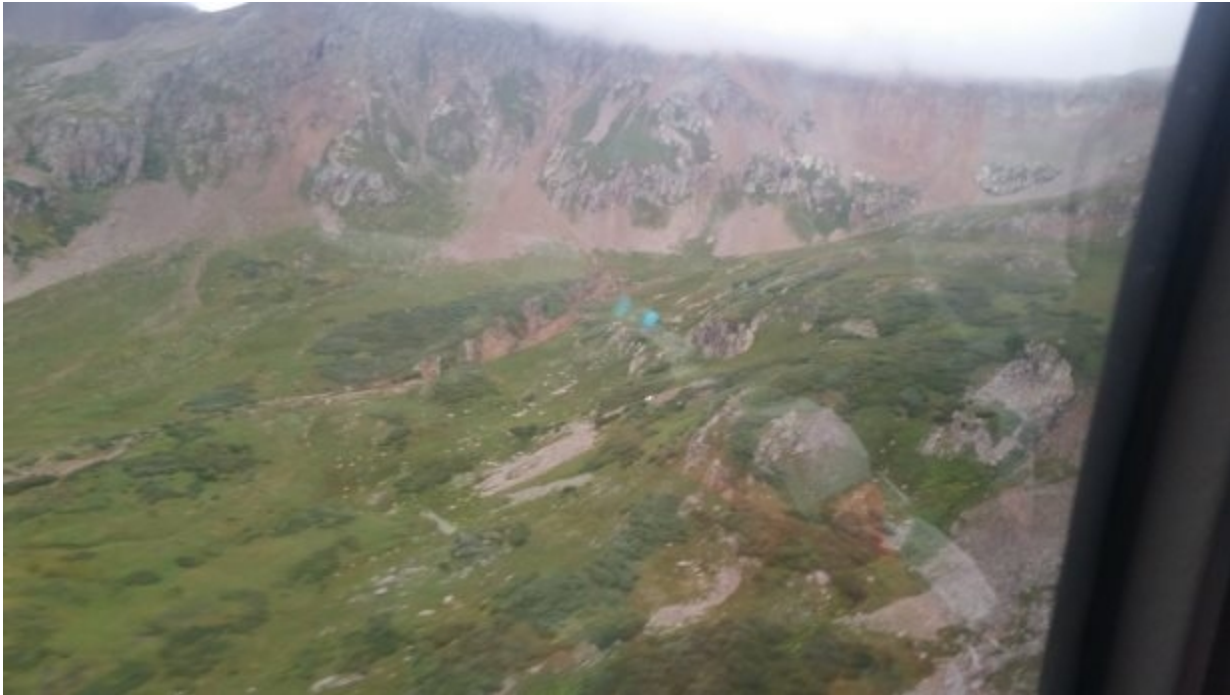
The accident site was located at latitude 37.76° north, longitude 107.84° west at an elevation of 11,500 ft. The wreckage path was estimated to be about 1,050 ft long along an estimated northerly direction in up-sloping mountainous terrain. See figures 4 and 5 for photographs of the wreckage.

Figure 4. Aerial view taken the day after the accident by first responders showing a white-colored object, which was a portion of the aircraft fuselage, resting on the face of up-sloping terrain. The photo also shows the cloud height at the time first responders arrived on-scene. The view of the western ridgeline averaged about 12,000 ft msl.

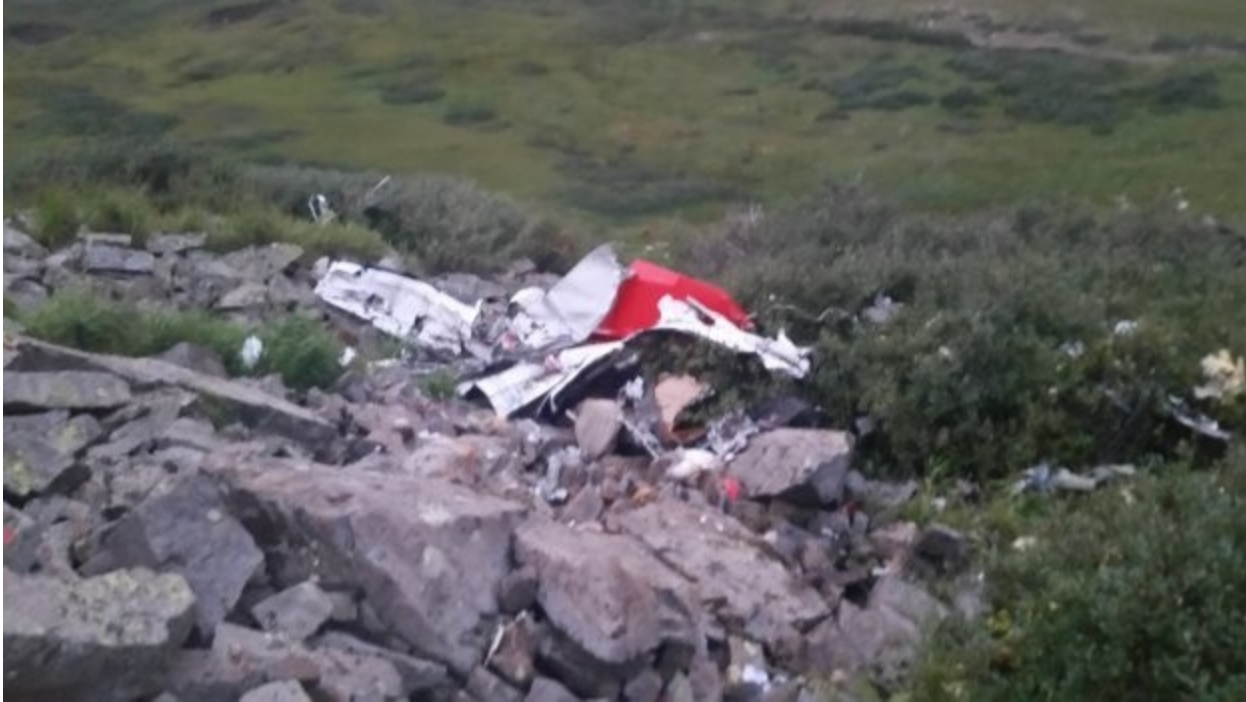
Figure 5. A photograph of the main wreckage, which was destroyed by impact forces with no evidence of soot or fire. The airplane wings, horizontal and vertical stabilizers, engines, and propellers were located at accident site.

The largest piece of recovered wreckage was the tail section, which had the horizontal and vertical stabilizers attached. There was no evidence of soot or fire on the pieces of wreckage. Both engines were separated from the airframe. The propellers from both engines were separated from their hubs and displayed chordwise gouging/scratching and S-shaped bending/twisting. Accident impact damage to the airframe, accessories, and both engines precluded functional operational testing of these components/systems.
