Aviation Investigation Final Report

Location:	Las Vegas, Nevada	Accident Number:	DCA15FA185
Date & Time:	September 8, 2015, 16:13 Local	Registration:	G-VII0
Aircraft:	BOEING COMPANY BOEING 777-236	Aircraft Damage:	Substantial
Defining Event:	Uncontained engine failure	Injuries:	1 Serious, 19 Minor, 150 None
Flight Conducted Under:	Part 129: Foreign

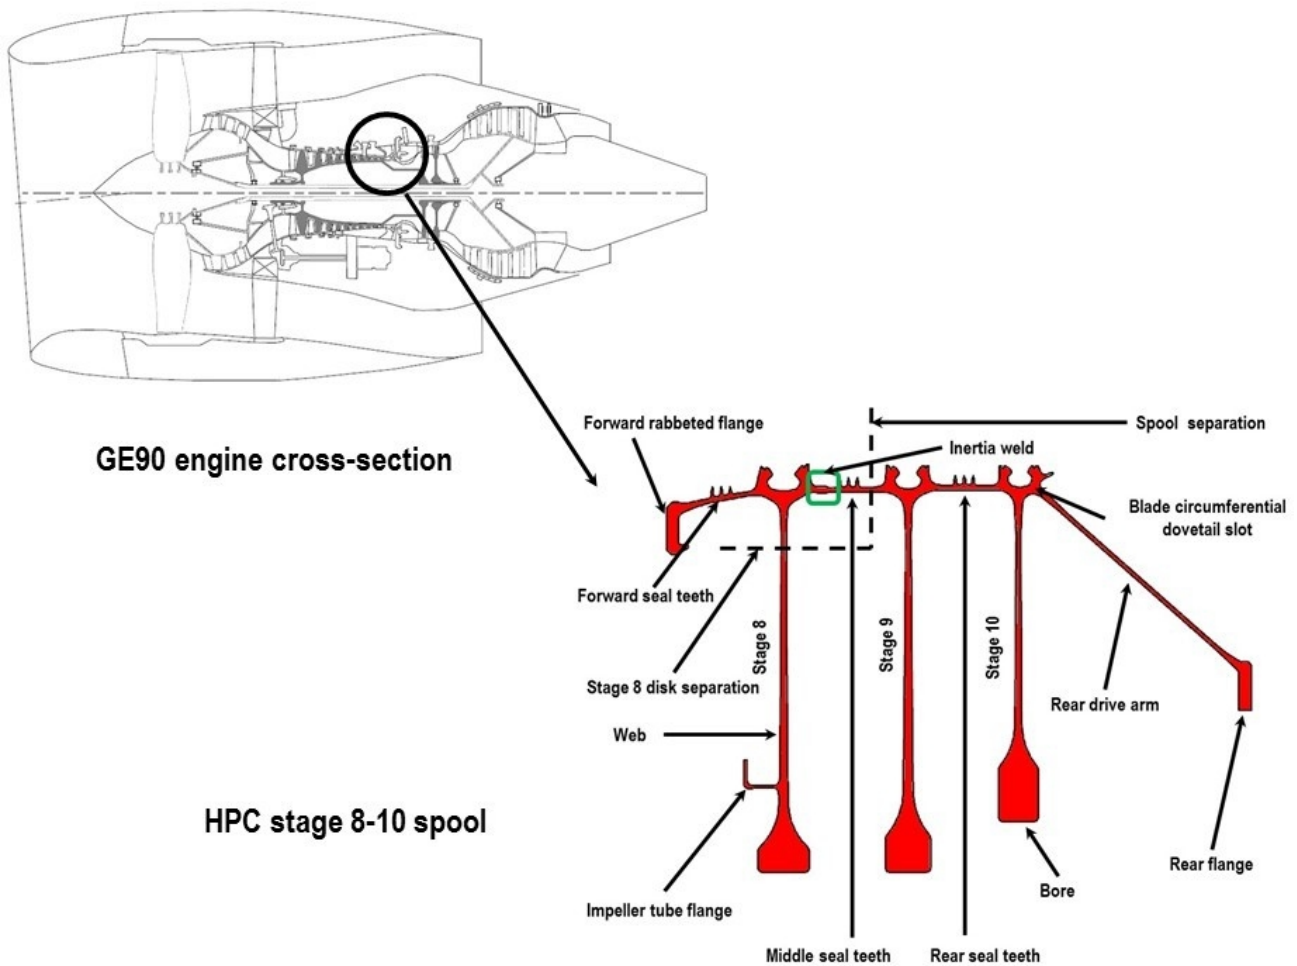
On-scene examination of the left engine revealed that the HPC aft extension case was breached from about the 11:30 to the 5:00 position (58 inches circumferentially), exposing the internal HPC parts. The examination also found that the HPC stage 8-10 spool separated aft of the middle seal teeth between the stage 8 and 9 disks and that the stage 8 disk separated below the circumferential blade slot, as shown in figure 1. Other noteworthy damage included the following:

Figure 1: GE90 engine cross-section with the locations of the HPC stage 8-10 spool separation and stage 8 disk separation.

and 9 disks and was fractured about 200° circumferentially at the transition radius of the web to the blade circumferential dovetail slot rim. About 37 inches of the dovetail slot rim remained attached to the stage 8 disk. The impeller tube assembly was fractured and detached from the front side of the stage 8 disk, and the impeller tubes were fractured, splayed open, or mostly intact. Most, but not all, of the stage 8 disk forward rabbeted flange had fractured from the stage 8 disk and remained attached to the stage 7 disk. The rear drive arm of the HPC stage 8-10 spool was fractured and had fully separated near the compressor discharge pressure seal land.
