# Aviation Investigation Final Report

| <b>Location:</b> | Las Vegas, Nevada | <b>Accident Number:</b> | DCA15FA185 |
| <b>Date &amp; Time:</b> | September 8, 2015, 16:13 Local | <b>Registration:</b> | G-VIIO |
| <b>Defining Event:</b> | Uncontained engine failure | <b>Injuries:</b> | 1 Serious, 19 Minor, 150 None |

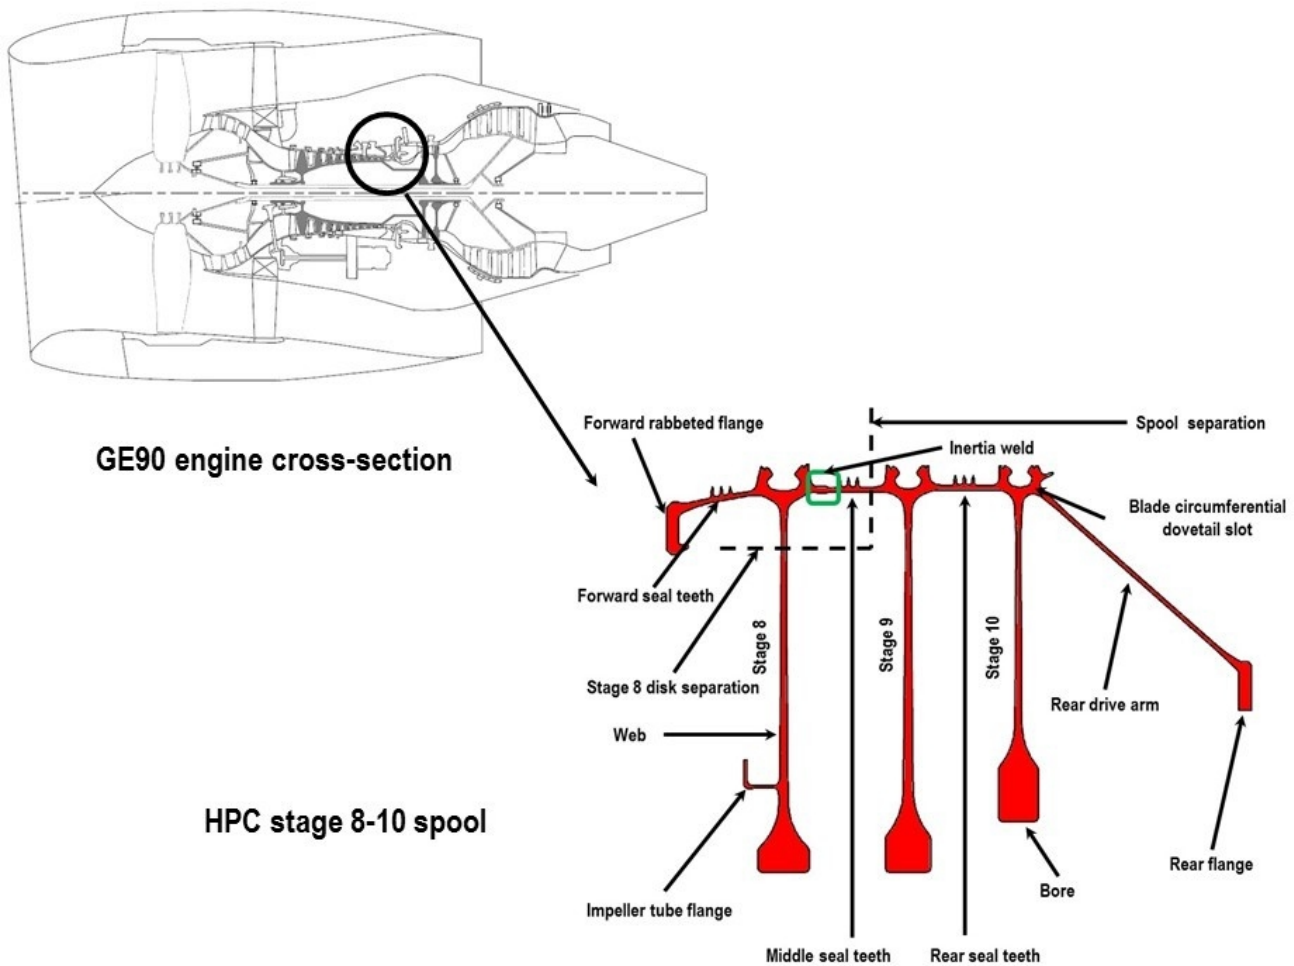
On-scene examination of the left engine revealed that the HPC aft extension case was breached from about the 11:30 to the 5:00 position (58 inches circumferentially), exposing the internal HPC parts. The examination also found that the HPC stage 8-10 spool separated aft of the middle seal teeth between the stage 8 and 9 disks and that the stage 8 disk separated below the circumferential blade slot, as shown in figure 1. Other noteworthy damage included the following:

Figure 1: GE90 engine cross-section with the locations of the HPC stage 8-10 spool separation and stage 8 disk separation.

and 9 disks and was fractured about 200° circumferentially at the transition radius of the web to the blade circumferential dovetail slot rim. About 37 inches of the dovetail slot rim remained attached to the stage 8 disk. The impeller tube assembly was fractured and detached from the front side of the stage 8 disk, and the impeller tubes were fractured, splayed open, or mostly intact. Most, but not all, of the stage 8 disk forward rabbeted flange had fractured from the stage 8 disk and remained attached to the stage 7 disk. The rear drive arm of the HPC stage 8-10 spool was fractured and had fully separated near the compressor discharge pressure seal land.

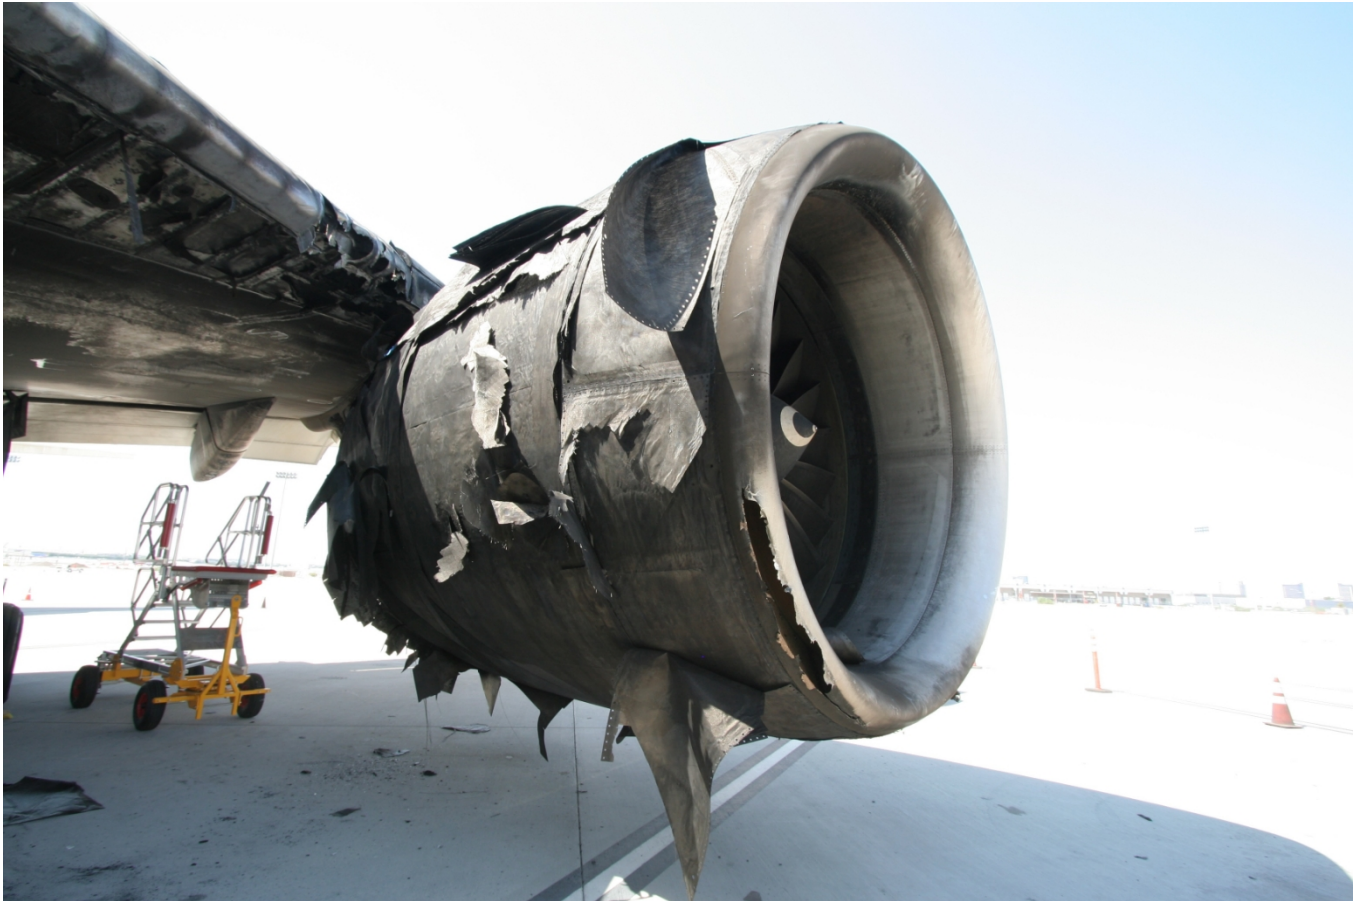
Thermal damage on the exterior of the airplane was concentrated along its midsection, from the left engine to the right side of the fuselage. On the left engine, the cowling was thermally damaged from the 4:00 to 12:00 positions (as viewed from the front of the engine). The thermal damage between the 6:00 and 12:00

positions (the inboard side of the left engine, as shown in figure 2) caused the composite cowling to delaminate and the aluminum leading edge of the cowling to partially melt along the 7:00 to 8:00 positions. The interior of the left engine had soot on some surfaces but no significant thermal degradation to the components.

Figure 2. Inboard side of left engine

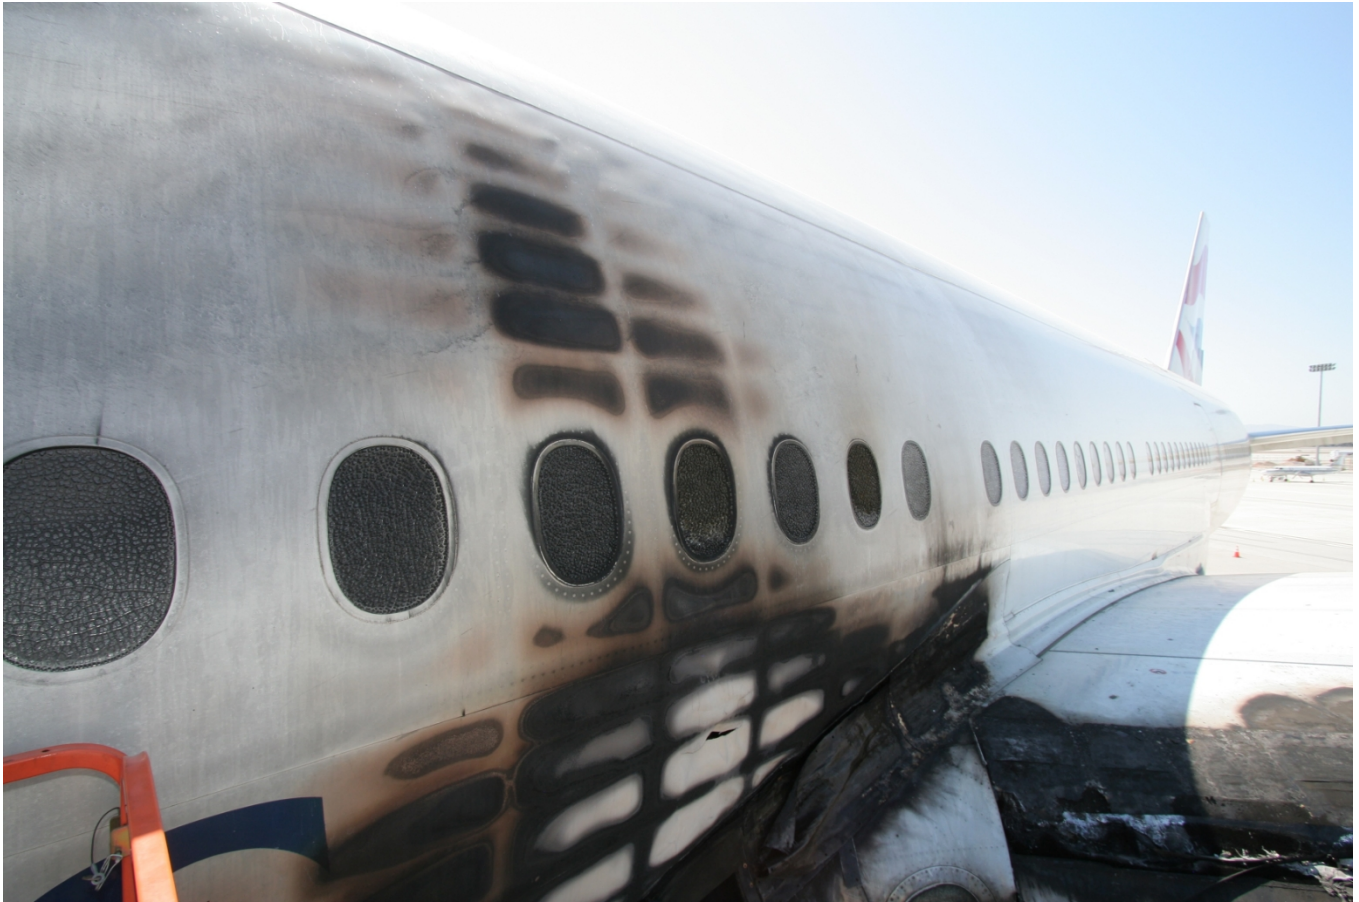
The left-side fuselage skin exhibited thermal damage (missing and charred paint) from just aft of the 2L door to just past the wing leading edge, and the center of this thermally damaged area exhibited buckling and cracks in the skin, the longest of which was about 12 inches. The cracks in the skin coincided with the area of most severe thermal damage to the wall panels in the interior of the airplane. There were 13 thermally crazed windows on the fuselage that extended from the 2L door to about mid-span of the wing, as shown in figure 3.

Figure 3. Thermally damaged fuselage skin and thermally crazed windows

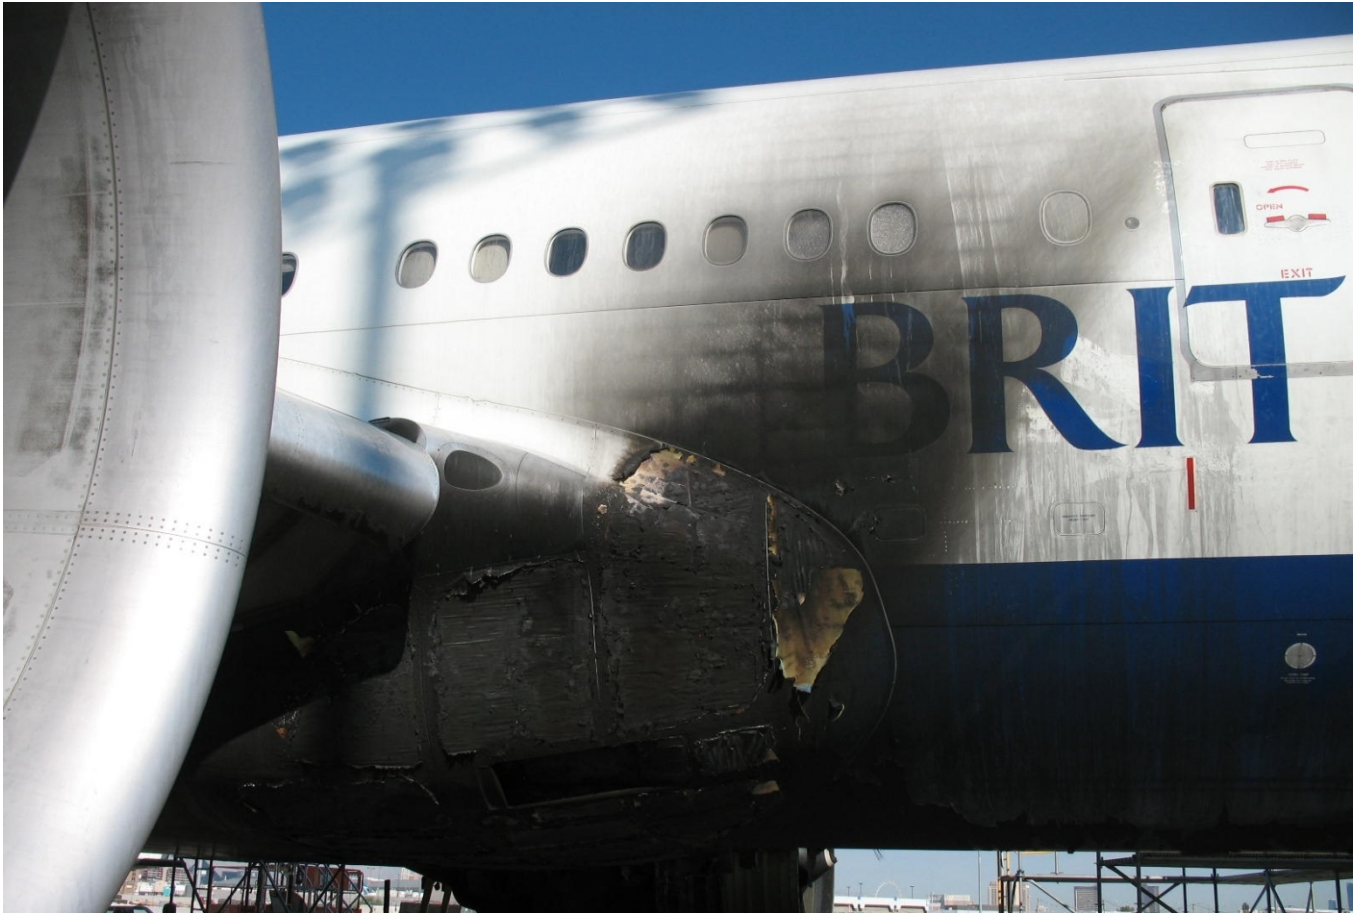
Soot appeared on the right-side fuselage above the wing-to-body fairing, as shown in figure 4. Buckling that created a tactile waviness to the aluminum skin was found in the area. Two of the windows above this area exhibited thermal crazing.

Figure 4. Soot and thermal damage to the right-side fuselage

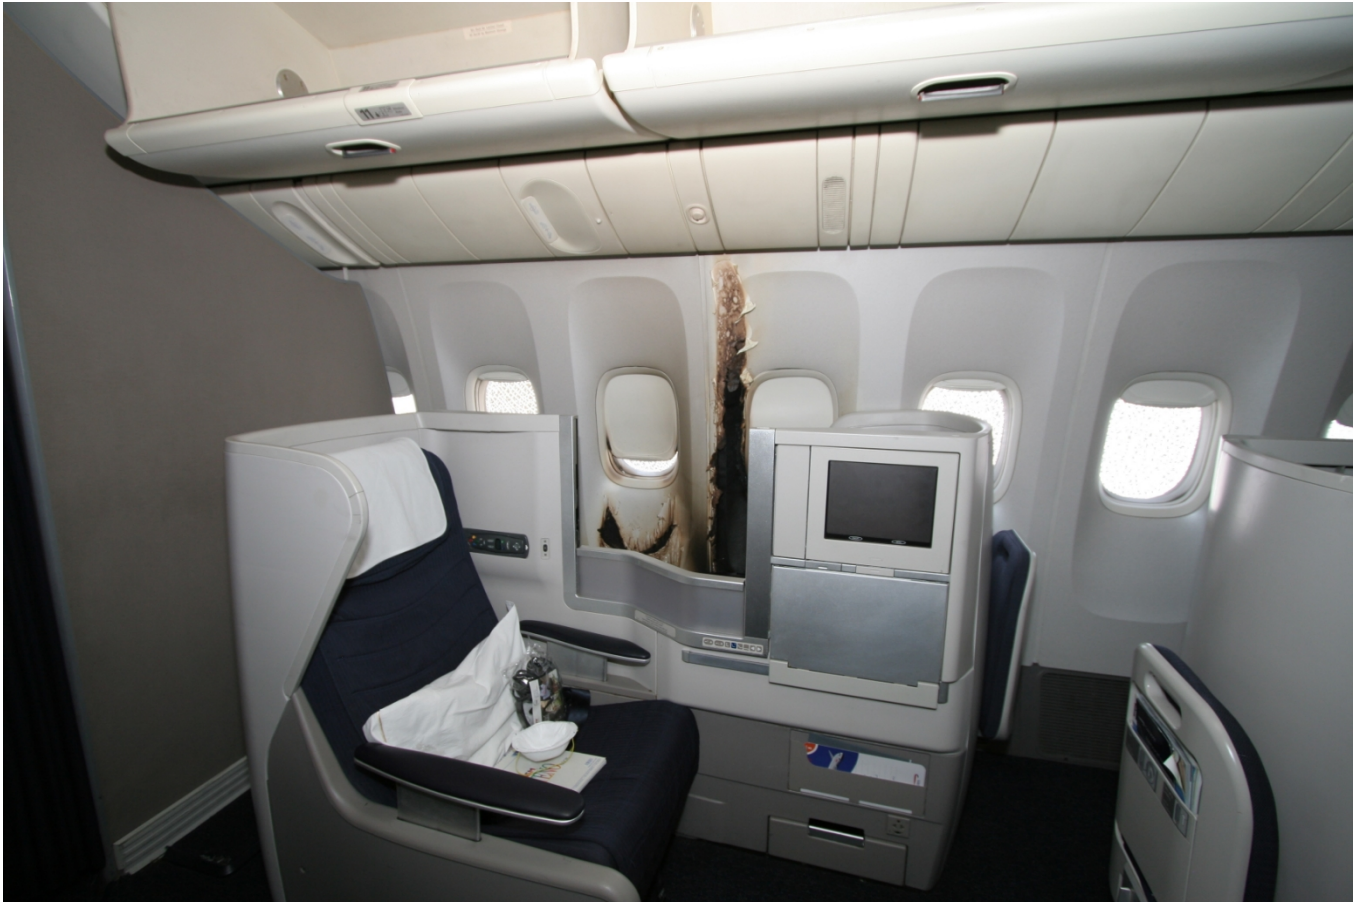
Thermal damage to the interior cabin was confined to the wall panels at the location of seat 11A, as shown in figure 5. The thermal damage consisted of blistering and charring on the wall panels; no soot was observed on any adjacent surfaces. The damage was consistent with thermal decomposition and charring and not flaming combustion on the inboard surfaces of the damaged panels.

Figure 5. Cabin interior at seat row 11

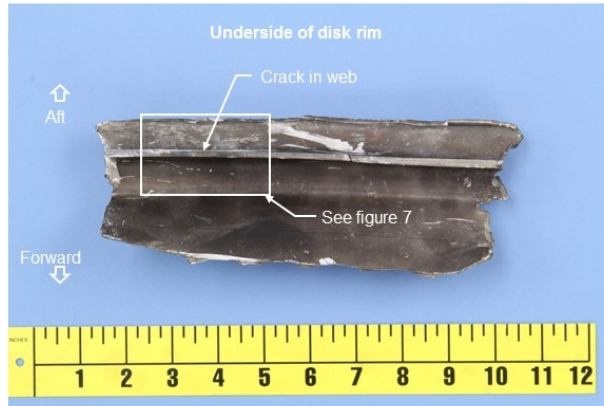
The fracture surfaces of the fragments were examined to determine where the engine failure initiated. The web of one of the stage 8 disk rim fragments had a feature, located about 0.90 inch inboard of the blade slot bottom at the thinnest (about 0.12 inch) part of the web, that indicated the presence of a tinted/discolored flat fracture region. This region was about 0.63 inch wide in the circumferential direction and extended from the aft face of the web to within 0.004 inch of the forward face of the web. The orientation of the fracture region was consistent with a crack initiating on the aft face of the web, and the tinted appearance was consistent with high-temperature oxidation of the fracture surface. Figure 6 shows the underside of the disk rim and the location of the crack. The flat fracture region transitioned to a 45°-inclined tinted/discolored region that was consistent with cyclic tensile loading. The region with cyclic tensile loading extended circumferentially from both sides of the flat fracture region over a total length of about 1.7 inches, after which the appearance of the fracture surface was consistent with tensile overstress.

Figure 6. Location of crack in HPC stage 8 disk web

The results of the examination at GE were consistent with the NTSB's findings. Metallurgical examination determined that the stage 8-10 spool fracture resulted from a crack that initiated in the web aft face of the stage 8 disk. SEM examination of the stage 8 disk found that the crack initially propagated with intergranular features with local variation, which was consistent with hold-time, high alternating stress, low-cycle fatigue (also referred to as sustained-peak low-cycle fatigue). Sustained-peak low-cycle fatigue

is an environmentally assisted failure mode in which a cyclic stress profile with an extended hold time, combined with an oxidizing atmosphere and elevated temperature, leads to oxidation of grain boundaries, which become brittle and eventually crack along an intergranular path. The examination also found that the crack transitioned to transgranular, striated areas that decreased in density as the crack progressed through the web thickness, which was consistent with low-cycle fatigue.

On February 12, 2016, GE issued SB 72-1146, which indicated that a one-time on-wing ultrasonic inspection of the stage 8 web needed to be performed on all HPC stage 8-10 spools with the same part number as the accident spool that were not covered by SB 72-1145. On June 10, 2016, GE superseded SB 72-1146 with SB 72-1151, which expanded the inspection population to include HPC stage 8-10 spools with a different part number than the accident spool. SB 72-1151 also recommended a repetitive inspection within every 500 cycles until an ECI was performed instead of a one-time on-wing ultrasonic inspection. On June 24, 2016, the FAA issued AD 2016-13-05, which required an ultrasonic inspection or ECI of the stage 8 aft web upper face between 8,000 and 9,000 cycles since new or within 500 cycles in service after the effective date of the AD (July 29, 2016), whichever occurred later.

In addition, due to the shot peening irregularity found on the event part (and the examination of two similar spools that found the same irregularity), GE issued SB 72-1149, "HPC Stage 8-10 Spool Web and Spacer Arm Shotpeen Repair," on March 29, 2016, to provide a one-time shot peen repair for all GE90 stage 8-10 spools to address possible shot peening inconsistencies. (According to GE, this repair was not incorporated into the engine manual because the repair was to be conducted one time only.) Also, GE modified the print drawing for HPC stage 8-10 spools in production to include a check of the shot peen intensity in the outer web areas. This change became effective in February 2016.

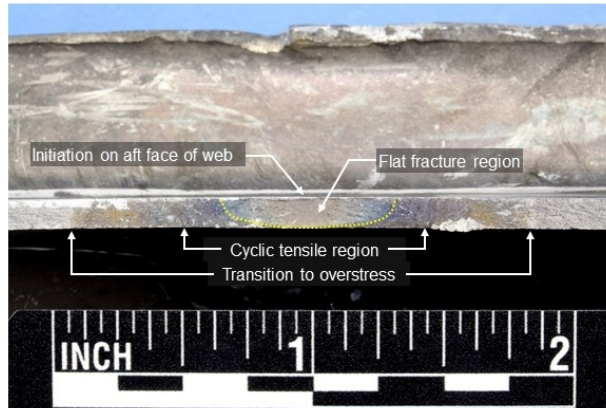
Examination of the flat fracture region using a scanning electron microscope (SEM) showed that the region had an intergranular appearance near the crack initiation site (the aft face of the web) and a transgranular appearance farther away from the initiation site. (The disk material, made from a nickel-based superalloy, had an internal structure that consisted of microscopic crystals called grains. The planar intersection of two grains is called a grain boundary. Cracks that follow grain boundaries are intergranular and cracks that cut across grains are transgranular.) The transgranular regions exhibited striations (linear features on a fatigue fracture surface that indicate how far a crack advanced with each stress cycle) consistent with low-cycle fatigue crack growth. (In airplane engines, low-cycle fatigue is associated with one striation per flight cycle.) Figure 7 shows an image of the underside of the HPC stage 8 disk rim at the location shown in figure 6.

Figure 7. Optical image of underside of HPC stage 8 disk rim
