Aviation Investigation Final Report

Location:	Iliamna, Alaska	Accident Number:	ANC15FA071
Date & Time:	September 15, 2015, 06:06 Local	Registration:	N928RK
Aircraft:	DEHAVILLAND DHC 3T	Aircraft Damage:	Substantial
Defining Event:	Loss of control in flight	Injuries:	3 Fatal, 5 Serious, 2 Minor
Flight Conducted Under:	Part 91: General aviation - Other work use

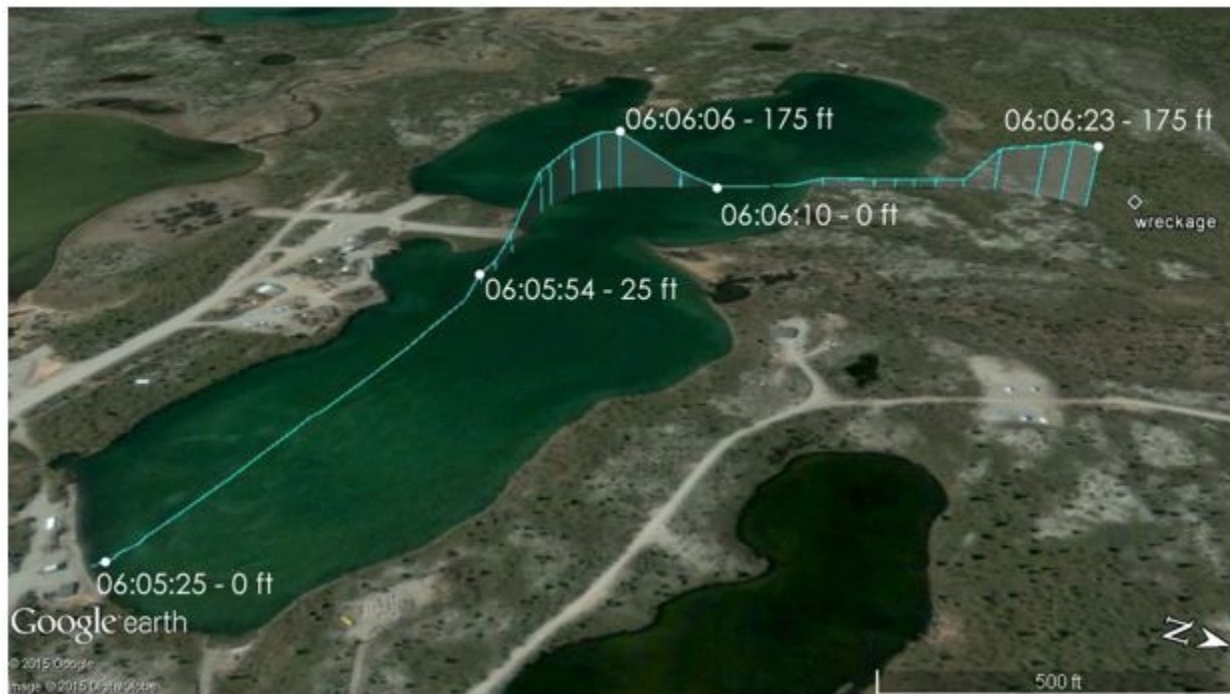
Figure 1. Airplane's flightpath from ADS-B data.

Data from the accident airplane's ADS-B, as shown in figure 1, show the airplane's flightpath. Airspeeds were calculated using the ADS-B position data and the reported wind information. Airplane orientation was calculated from these data and a basic aerodynamic model of the airplane. Calculations made from ADS-B and weather data are subject to uncertainty; therefore, airspeeds and attitude values should not be considered exact.

During the initial climb, the airplane remained below the recommended airspeed per the Texas Turbine Conversions, Inc., AFM. The data show the airplane initially gaining altitude at 0605:54 and reaching 56 mph, as recommended in the AFM. After the initial climb with a 10° bank angle, the airplane made a descending right turn at 57 mph and lost 175 ft of altitude, which placed the airplane at or near the

water's surface. Subsequently, the airplane began regaining altitude with a 30° bank angle, and then it made another right turn at less than 57 mph. The airplane's stall speed is 57 mph at a 0° bank angle, 59 mph at a 20° bank angle, and 65 mph at a 40° bank angle.
