Aviation Investigation Final Report

Location:	Russian airspace,	Incident Number:	ENG161A001
Date & Time:	October 2, 2015, 05:10 UTC	Registration:	N662US
Aircraft:	Boeing 747	Aircraft Damage:	Minor
Defining Event:	Loss of engine power (partial)	Injuries:	367 None
Flight Conducted Under:	Part 121: Air carrier - Scheduled

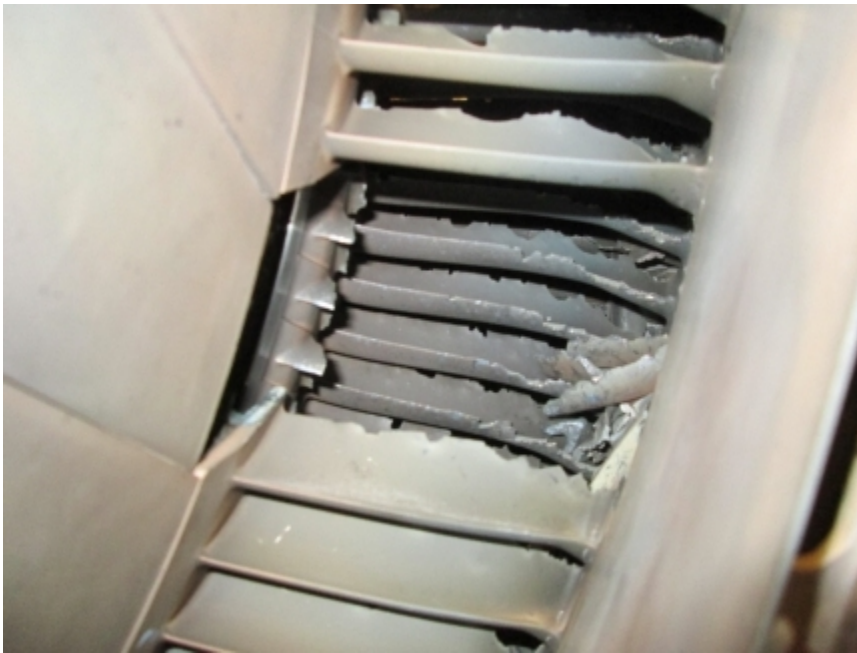
The engine was removed from the airplane and shipped to Delta's Technical Operations Center, Atlanta, Georgia for disassembly and examination in the presence of the Powerplants Group. The disassembly revealed one 3rd stage turbine vane cluster, No. 29 that was located at about 8 o'clock, was missing. (Photo No. 1) A portion of the missing vane cluster's inner shroud was found at the bottom of the engine in the 3rd stage turbine blades' plane of rotation. (Photo No. 2) The piece of the 3rd stage turbine vane cluster inner shroud had three circumferential grooves that corresponded to the geometry of the 3rd stage turbine rotating inner air seal.

Photo No. 1: View of missing 3rd stage turbine vane cluster from front of LPT. (Delta)

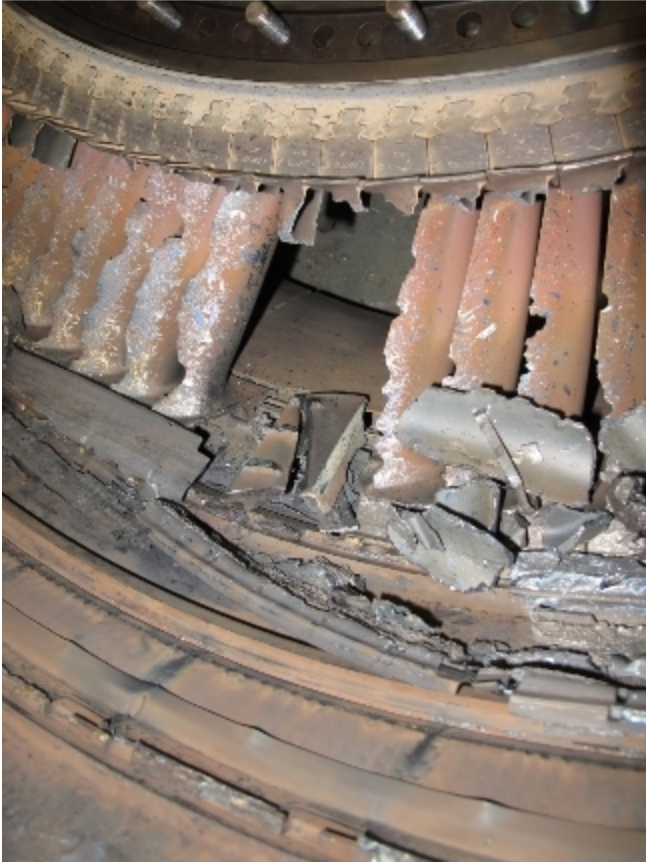
The disassembly of the engine revealed one 3rd stage turbine vane cluster, No. 29, was missing although the cluster's bolt hole tab with the retaining nut were still in place on the inner transition duct. The missing cluster's inner shroud was found in the bottom of the engine in the path of the 3rd stage turbine blades. The metallurgical examination of the inner shroud revealed fatigue, however the full extent of the fatigue could not be determined because the end of the fracture surface was smeared.

Photo No. 2: View of missing 3rd stage turbine vane cluster with piece of 3rd stage turbine vane cluster inner shroud lying in bottom of engine in location of missing cluster. (P&W)

The remaining 3rd stage turbine vane clusters' were all in place and the airfoils were heavily battered with nicks and dents on the trailing edges. (Refer to Photo No. 2)

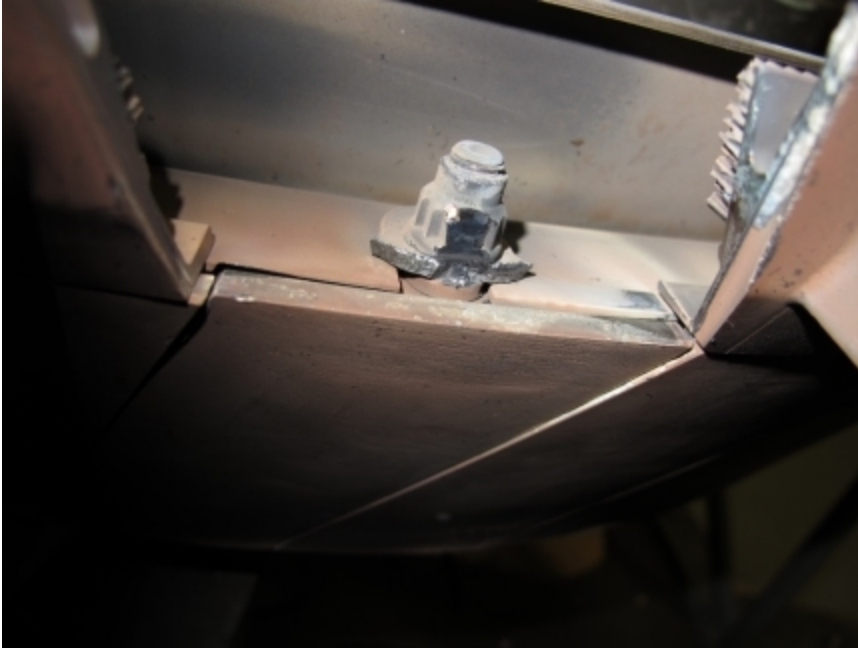
Although the vane cluster was missing, the cluster's bolt hole tab with the nut remained in place attached to the inner transition duct. (Photo No. 3) During the disassembly of the 3rd stage turbine vane area, the torque on the retaining nuts were checked and all including that for the missing vane cluster were found to be tight.

Photo No. 3: Close up of the bolt hole tab with the retaining nut in place for the No. 29 3rd stage turbine vane cluster. (P&W)
