Aviation Investigation Final Report

Location:	Russian airspace,	Incident Number:	ENG16IA001
Date & Time:	October 2, 2015, 05:10 UTC	Registration:	N662US
Aircraft:	Boeing 747	Aircraft Damage:	Minor
Defining Event:	Loss of engine power (partial)	Injuries:	367 None
Flight Conducted Under:	Part 121: Air carrier - Scheduled

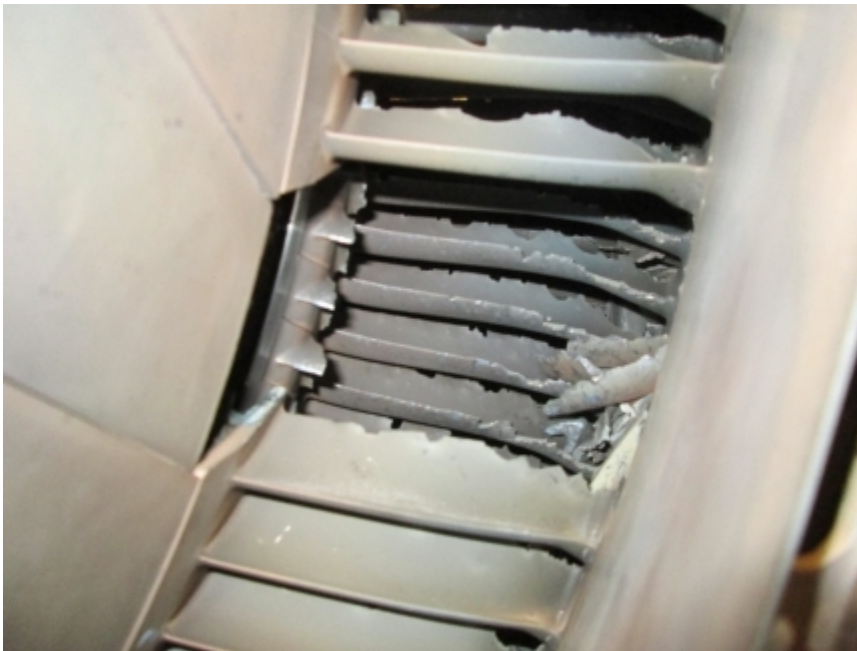
The disassembly of the engine revealed one 3rd stage turbine vane cluster, No. 29, was missing although the cluster's bolt hole tab with the retaining nut were still in place on the inner transition duct. The missing cluster's inner shroud was found in the bottom of the engine in the path of the 3rd stage turbine blades. The metallurgical examination of the inner shroud revealed fatigue, however the full extent of the fatigue could not be determined because the end of the fracture surface was smeared.

The engine was removed from the airplane and shipped to Delta's Technical Operations Center, Atlanta, Georgia for disassembly and examination in the presence of the Powerplants Group. The disassembly revealed one 3rd stage turbine vane cluster, No. 29 that was located at about 8 o'clock, was missing. (Photo No. 1) A portion of the missing vane cluster's inner shroud was found at the bottom of the engine in the 3rd stage turbine blades' plane of rotation. (Photo No. 2) The piece of the 3rd stage turbine vane cluster inner shroud had three circumferential grooves that corresponded to the geometry of the 3rd stage turbine rotating inner air seal.

Photo No. 1: View of missing 3rd stage turbine vane cluster from front of LPT. (Delta)

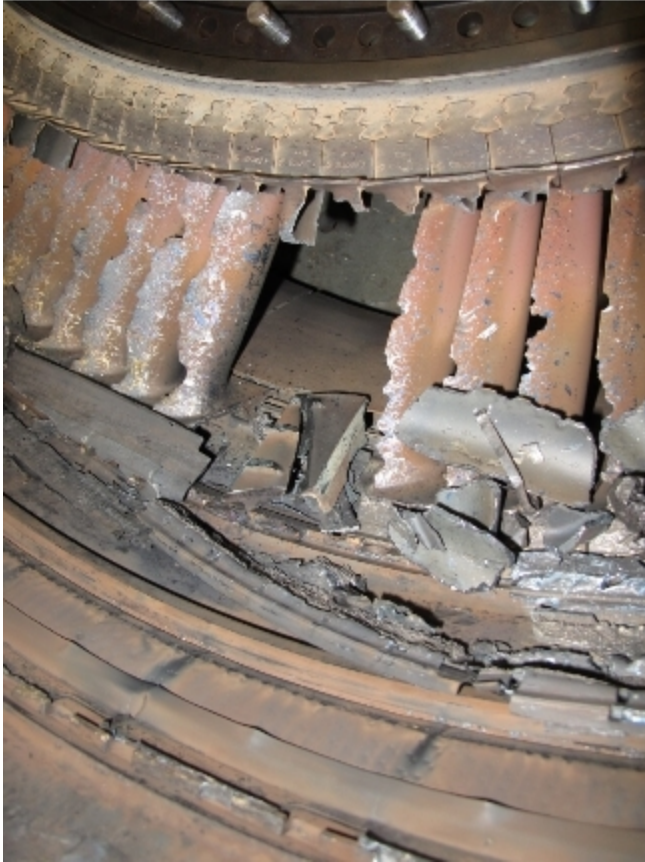
Photo No. 2: View of missing 3rd stage turbine vane cluster with piece of 3rd stage turbine vane cluster inner shroud lying in bottom of engine in location of missing cluster. (P&W)

The remaining 3rd stage turbine vane clusters' were all in place and the airfoils were heavily battered with nicks and dents on the trailing edges. (Refer to Photo No. 2)

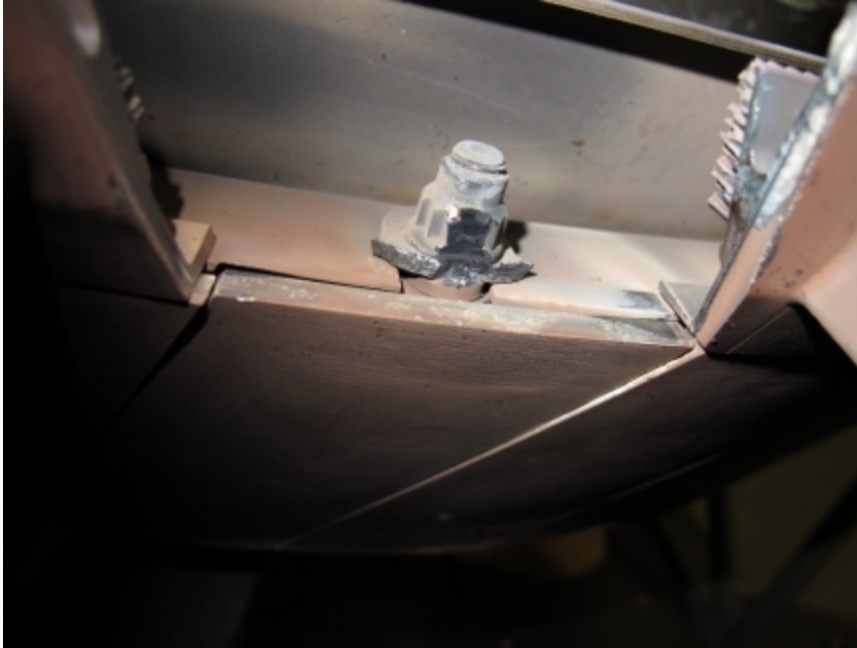
Although the vane cluster was missing, the cluster's bolt hole tab with the nut remained in place attached to the inner transition duct. (Photo No. 3) During the disassembly of the 3rd stage turbine vane area, the torque on the retaining nuts were checked and all including that for the missing vane cluster were found to be tight.

Photo No. 3: Close up of the bolt hole tab with the retaining nut in place for the No. 29 3rd stage turbine vane cluster. (P&W)
