Aviation Investigation Final Report

Location:	Folsom, California	Accident Number:	WPR16LA019
Date & Time:	October 24, 2015, 16:33 Local	Registration:	N911WL
Aircraft:	AMERICAN EUROCOPTER LLC AS350B3	Aircraft Damage:	Substantial
Defining Event:	Loss of control in flight	Injuries:	3 None
Flight Conducted Under:	Public aircraft

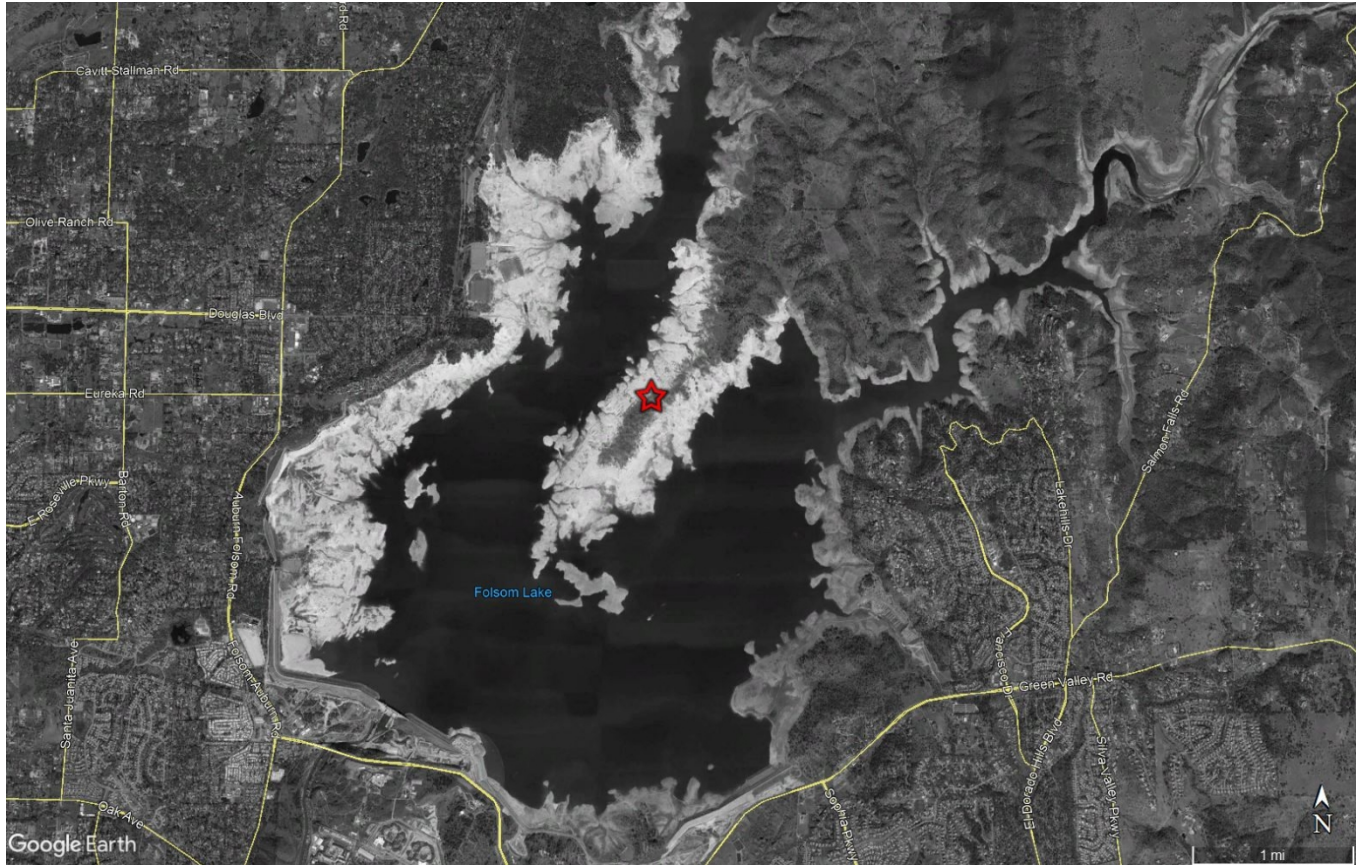
After landing, he exited the helicopter and discovered that the aft airframe was wrinkled, and the tailboom had bent downwards at its intersection with the aft bulkhead. He was surprised the helicopter had sustained this damage because while the landing was hard, it did not feel hard enough to cause structural damage. He recounted having performed many autorotation's before, all without anomalies, and that this time the engine sound did not match his throttle control inputs.

The accident site was composed of rolling hills, covered in dry grass, and interspersed with rocks. The intended landing zone was on a pinnacle, about 100 ft from where the helicopter came to rest. The terrain from the top of the pinnacle to the resting location was on a downward slope of about 4°, and the site was at an elevation of about 455 ft above sea level. The site was about 2 miles across the lake from the City of Folsom, however, the closest access via automobile from Folsom would have required a drive of about 27 miles on paved and unpaved roads, followed by an off-road drive of about 1 mile.
