Aviation Investigation Final Report

Location:	Carlsbad, California	Accident Number:	WPR16FA029
Date & Time:	November 18, 2015, 16:23 Local	Registration:	N711BE
Aircraft:	Airbus Helicopters AS350B3E	Aircraft Damage:	Substantial
Defining Event:	Loss of control in flight	Injuries:	2 Fatal
Flight Conducted Under:	Part 91: General aviation - Personal

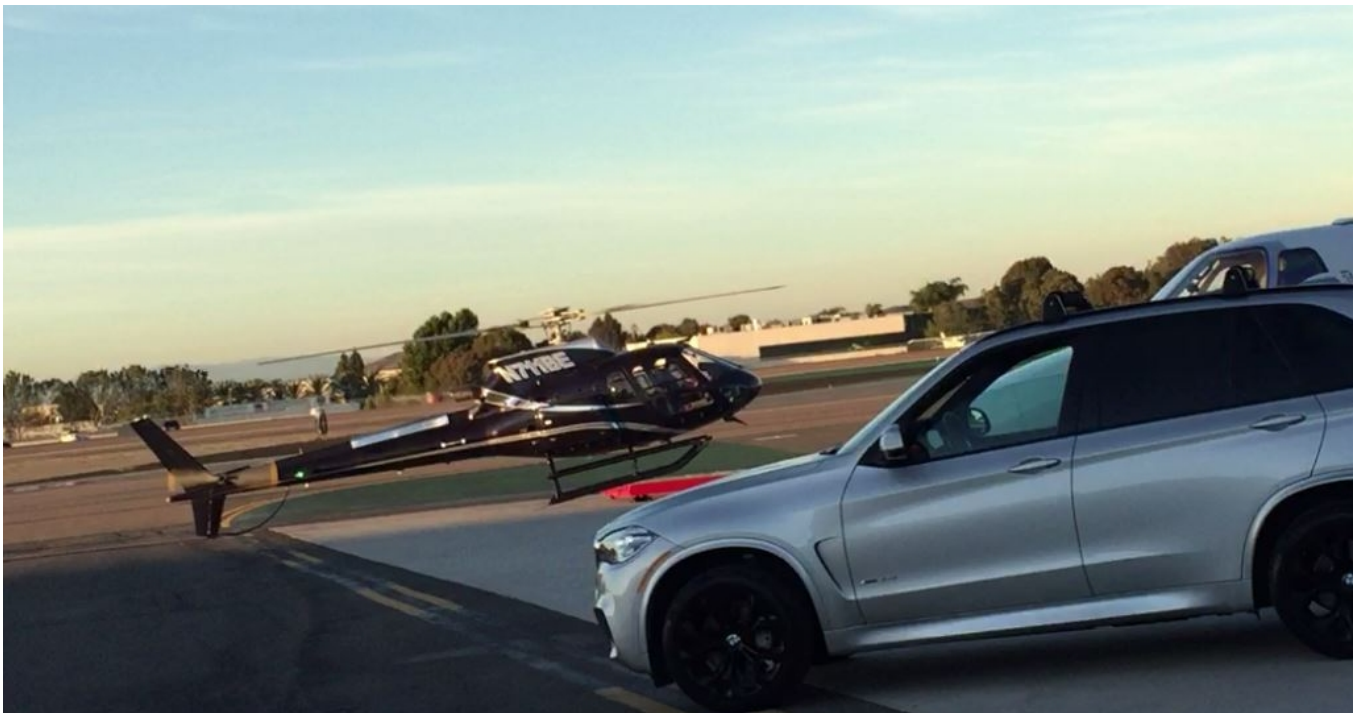
The video revealed that the helicopter hovered over the dolly for about 60 seconds and then landed short, teetering on the aft edge of the dolly (Image 1). The tailskid almost struck the ground, and the helicopter then rapidly pitched forward (Image 2) and then aft again. The tailskid then struck the ground (Image 3), and the helicopter pitched forward, rolled right (Images 4 and 5), and climbed out of view behind the hangar. Security cameras revealed that the helicopter then spun 180° to the left, and the nose pitched up to a 45° attitude. The tail rotor and vertical stabilizer assembly then struck the ground and separated, and the helicopter hit the ground left side low, bounced, and rotated another 360° before landing hard on its belly. Once on the ground, the main rotor blades continued to spin, while the helicopter started spinning on its belly, as the engine continued to operate (Image 6).

Image 1 - Helicopter Landing Short of the Dolly

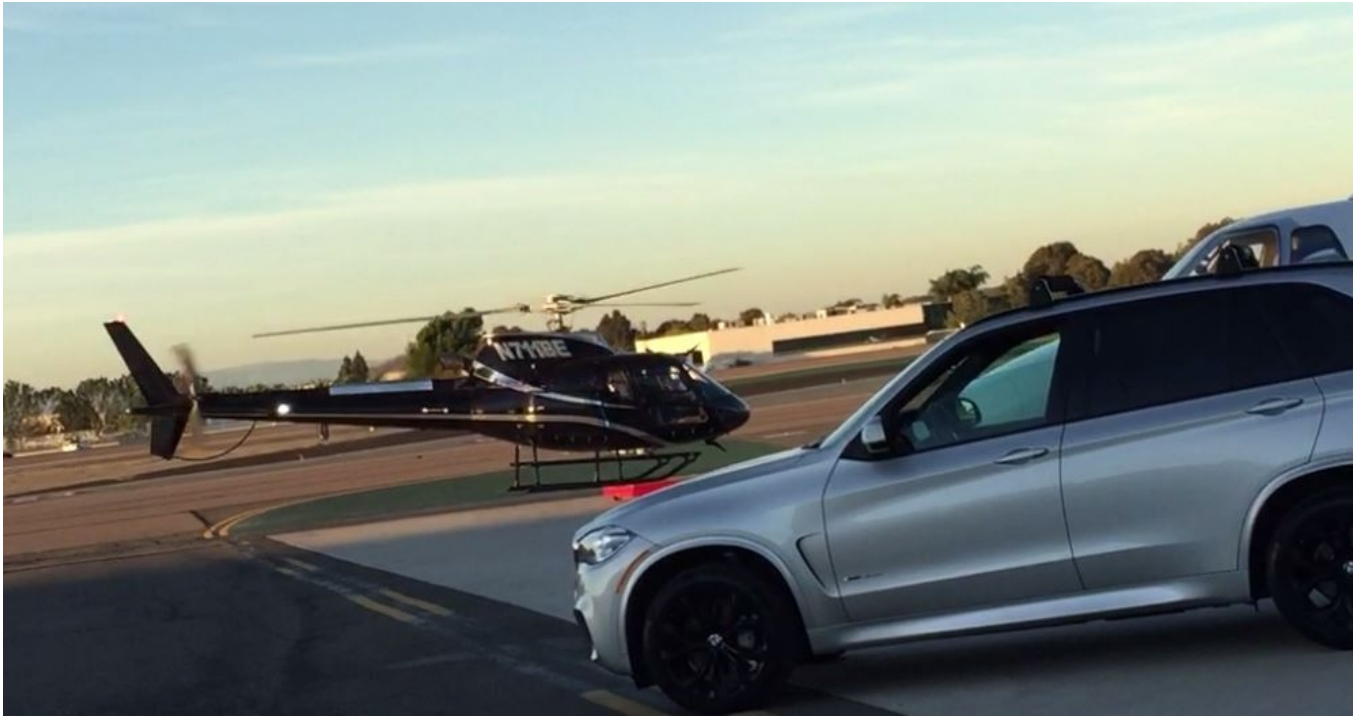
Image 2 - Helicopter Landing Short of the Dolly

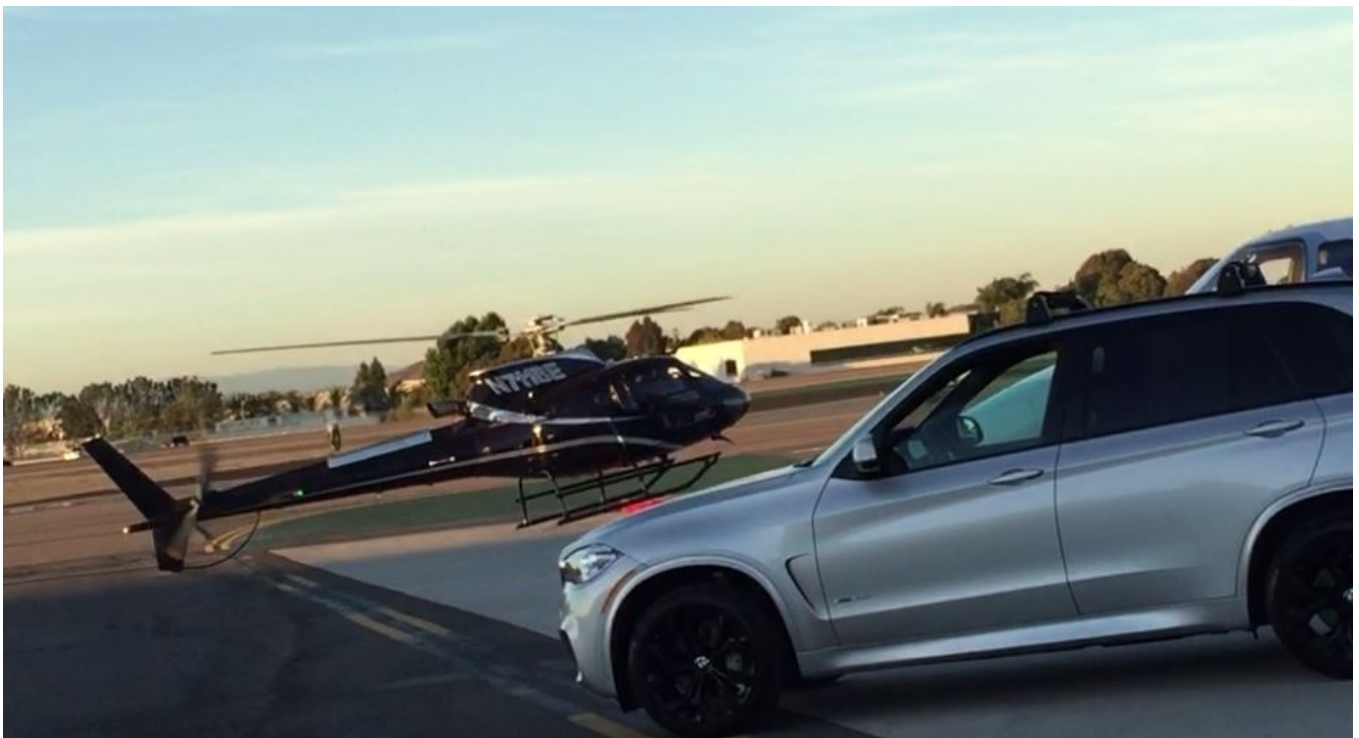
Image 3 - Helicopter Tail Striking the Ground

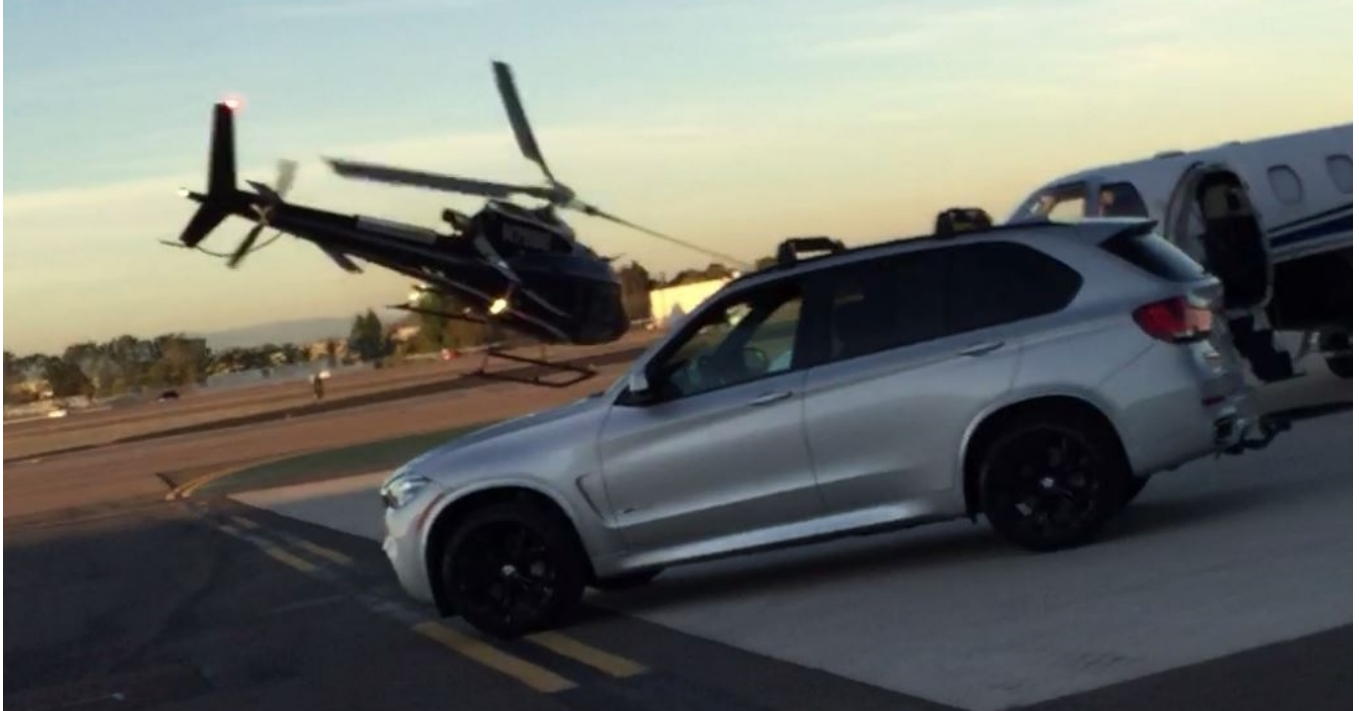
Image 4 - Helicopter Rolling Right over the Dolly

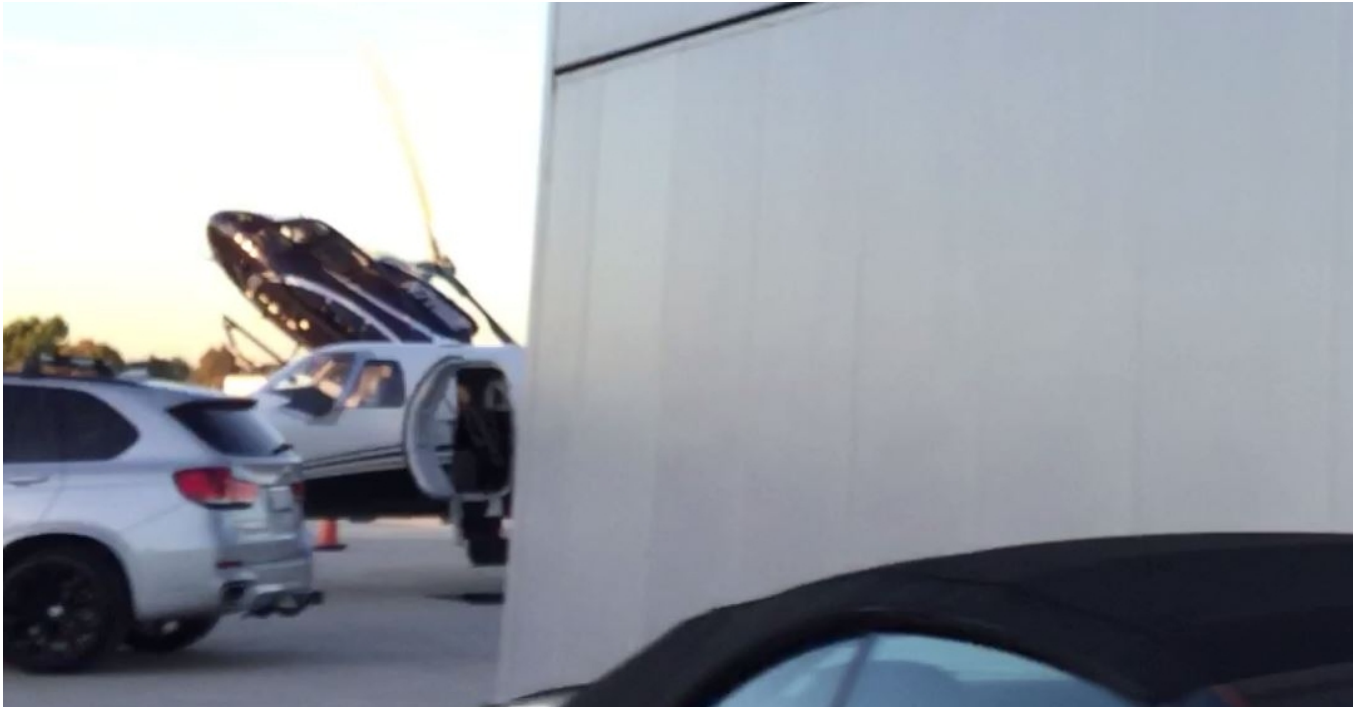
Image 5 - Helicopter Spinning 180 degrees, with Tail Striking the Ground

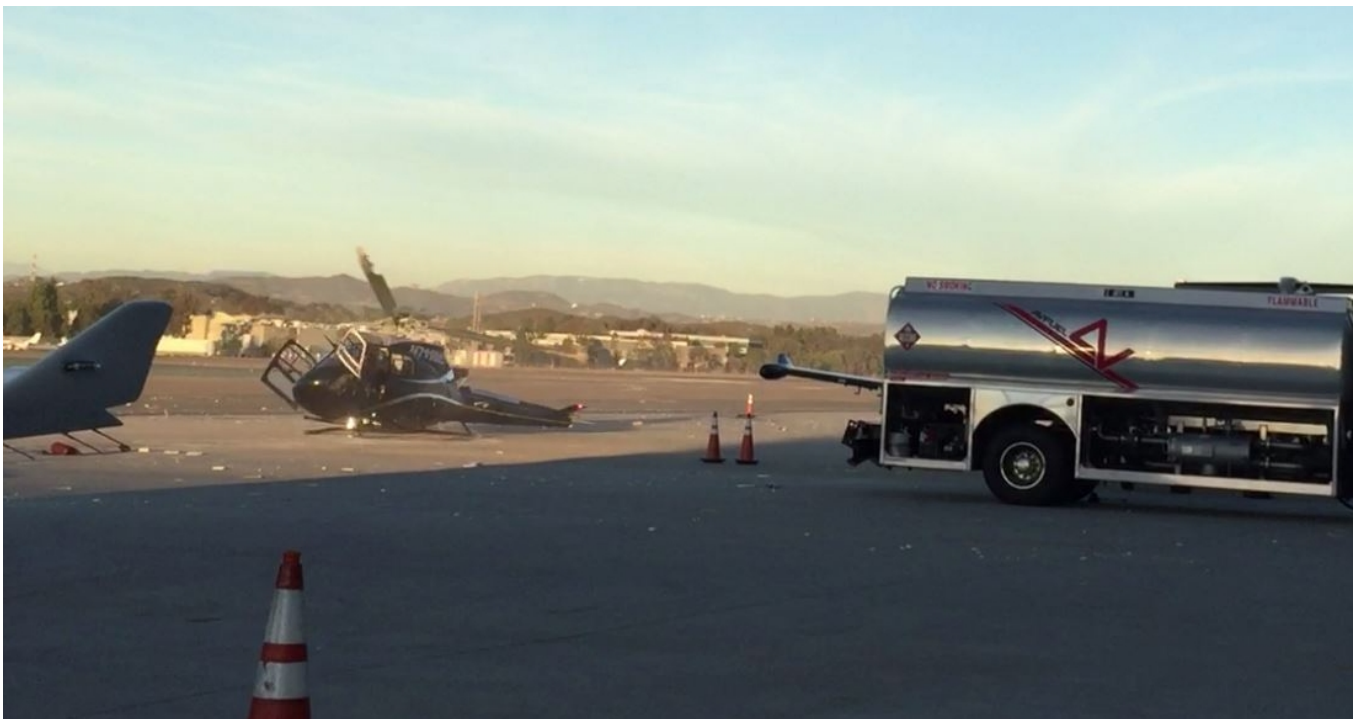
Image 6 - Helicopter Spinning after Ground Collision
