# Aviation Investigation Final Report

<b>Location:</b>	Farmington, Pennsylvania	<b>Accident Number:</b>	ERA16FA064
<b>Date &amp; Time:</b>	December 11, 2015, 14:22 Local	<b>Registration:</b>	N72054
<b>Aircraft:</b>	Beech A36	<b>Aircraft Damage:</b>	Destroyed
<b>Defining Event:</b>	Loss of control in flight	<b>Injuries:</b>	3 Fatal
<b>Flight Conducted Under:</b>	Part 91: General aviation - Personal

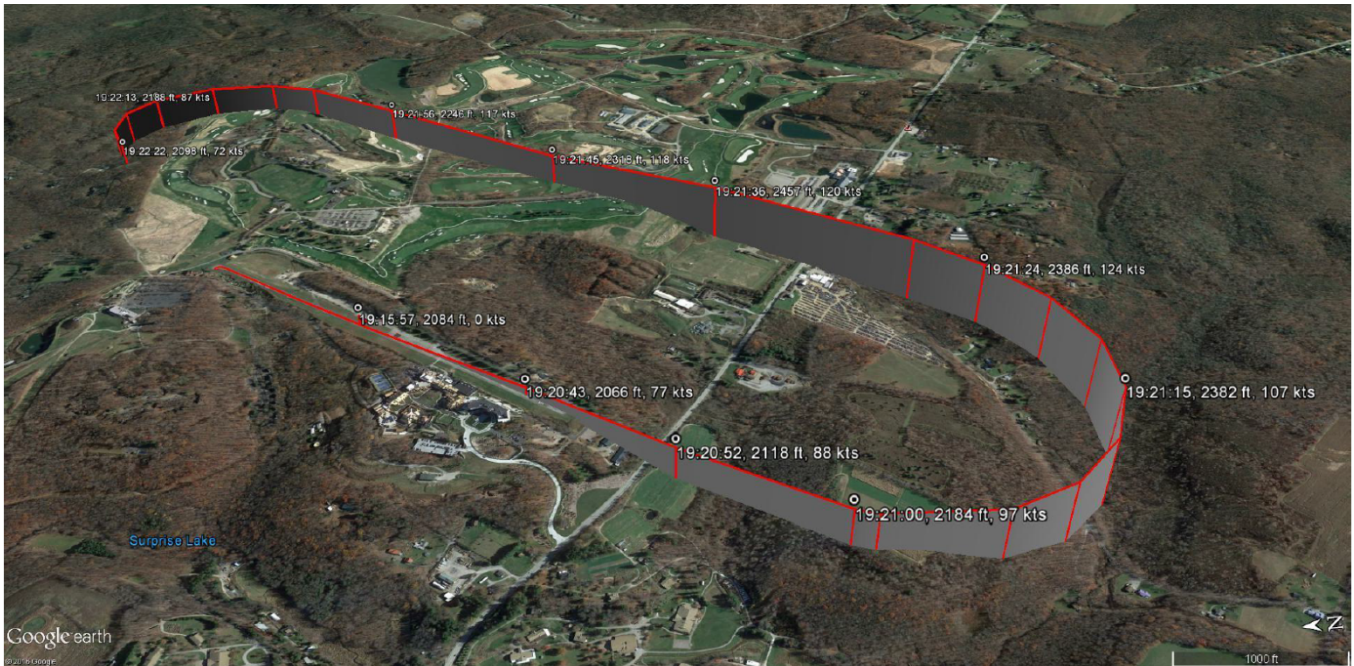
**Figure 1. Plotted GPS Data – Complete Accident Flight.**

An onboard GPS recorded data for the accident flight. The recording began at 1415:57 near the airport parking area. The airplane subsequently taxied to the end of runway 23 for takeoff. Recorded GPS altitude at this time was about 1,975 ft. The takeoff roll began at 1420:18. At 1421:00, at a GPS altitude of 2,184 ft and about 2,500 ft from the departure end of the runway, the airplane began a left, climbing turn. The turn continued, and the airplane reached a maximum recorded altitude of 2,457 ft at 1421:36. At this time, its position was consistent with a left downwind for runway 23. The airplane descended as it continued the downwind leg, then began a left turn about 1422. Shortly thereafter, the airplane descended through 2,150 ft at 69 knots groundspeed. The last recorded data point was at 1422:22.

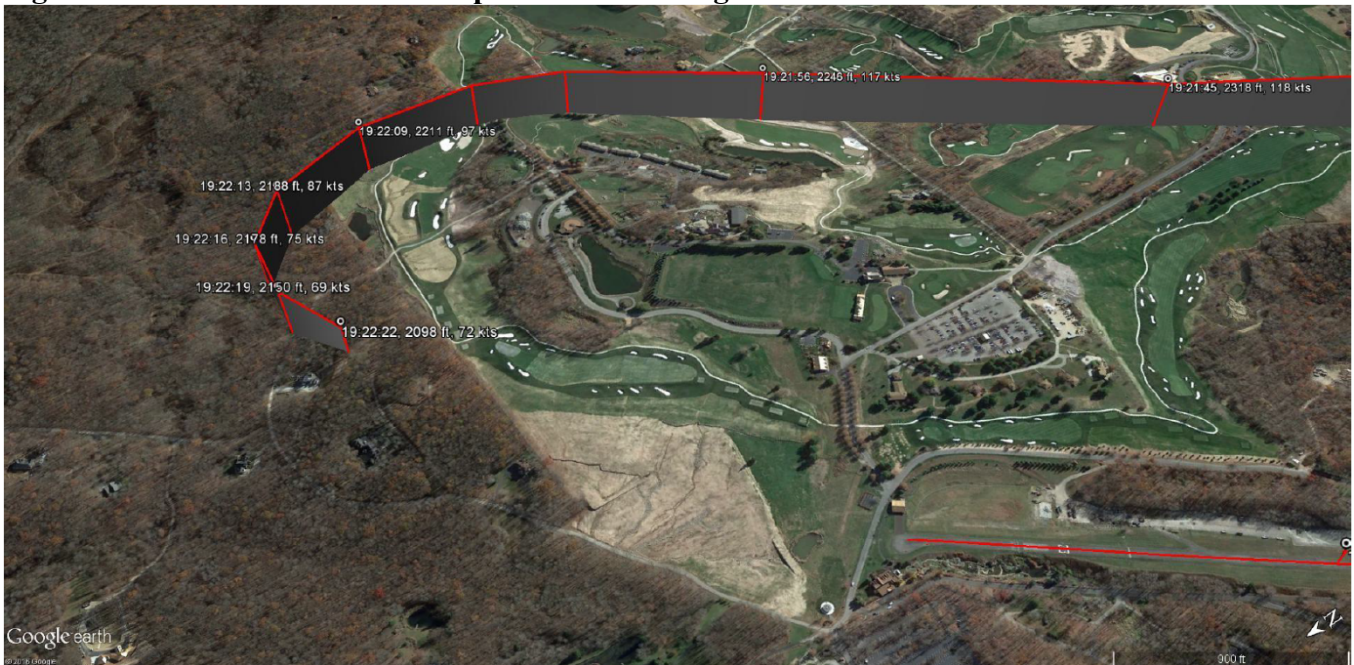
**Figure 2. Plotted GPS Data – End of Accident Flight.**

Review of the GPS data showed that the airplane's groundspeed dropped to 69 knots prior to its rapid descent. Calculations using the wind vector solutions function of an E6-B flight computer indicated that the true airspeed of the airplane at that point, would have been about 79 knots, which was below the published stall speed in the Beechcraft Bonanza Pilot's Operating Handbook (POH) for banked turns in excess of about 45°.
