Aviation Investigation Final Report

| Location: | Superior, Arizona | Accident Number: | WPR16FA040 |
| Date & Time: | December 15, 2015, 17:23 Local | Registration: | N74317 |
| Aircraft: | AIRBUS Helicopters AS350 | Aircraft Damage: | Substantial |

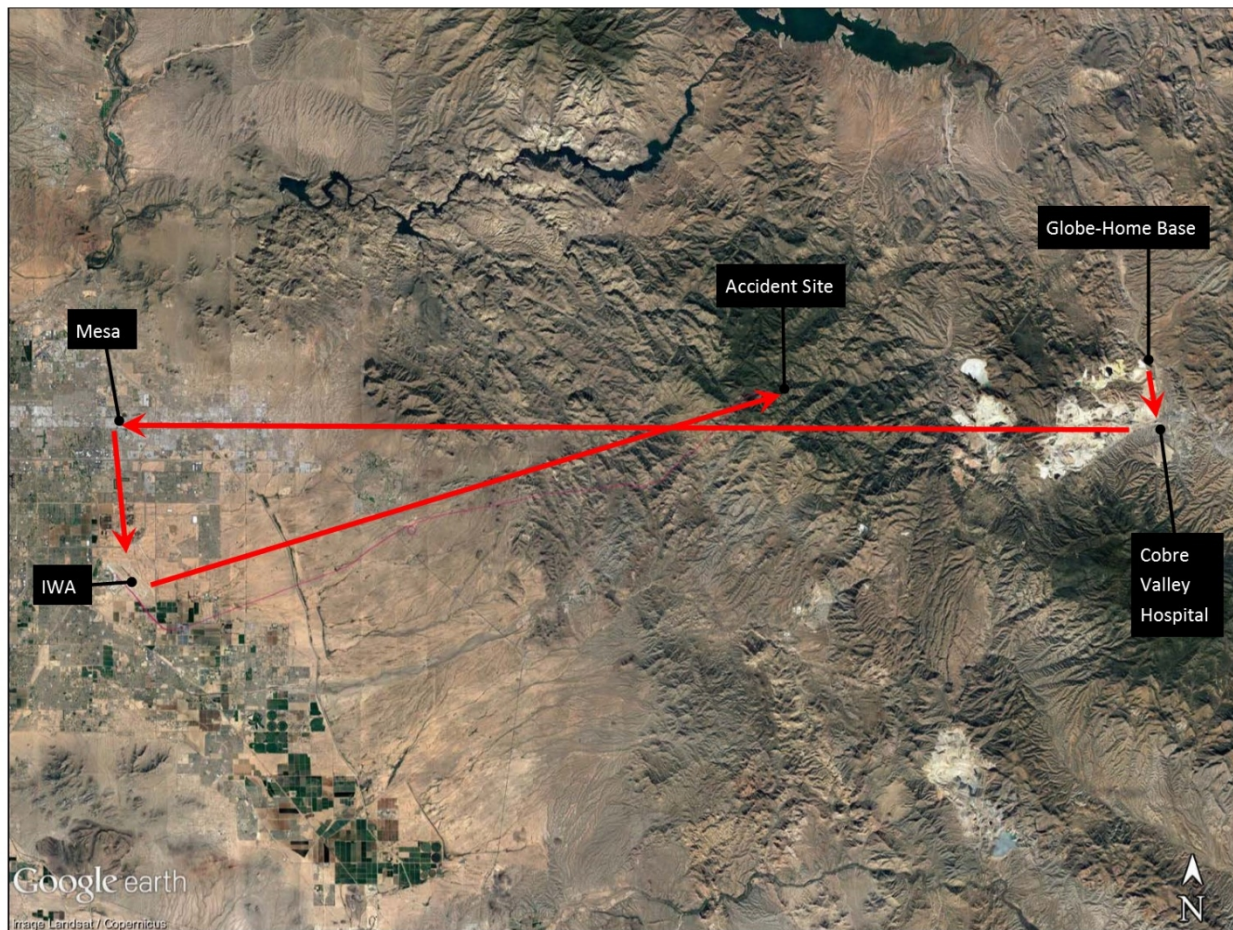
Figure 1-Overview of Flights

According to the operator, the helicopter was based in Globe and had transported a patient from the Cobre Valley Community Hospital in Globe to the Baywood Heart Hospital in Mesa. After transporting the patient, the pilot flew the helicopter to IWA for refueling before the return flight to Globe. (See figure 1)

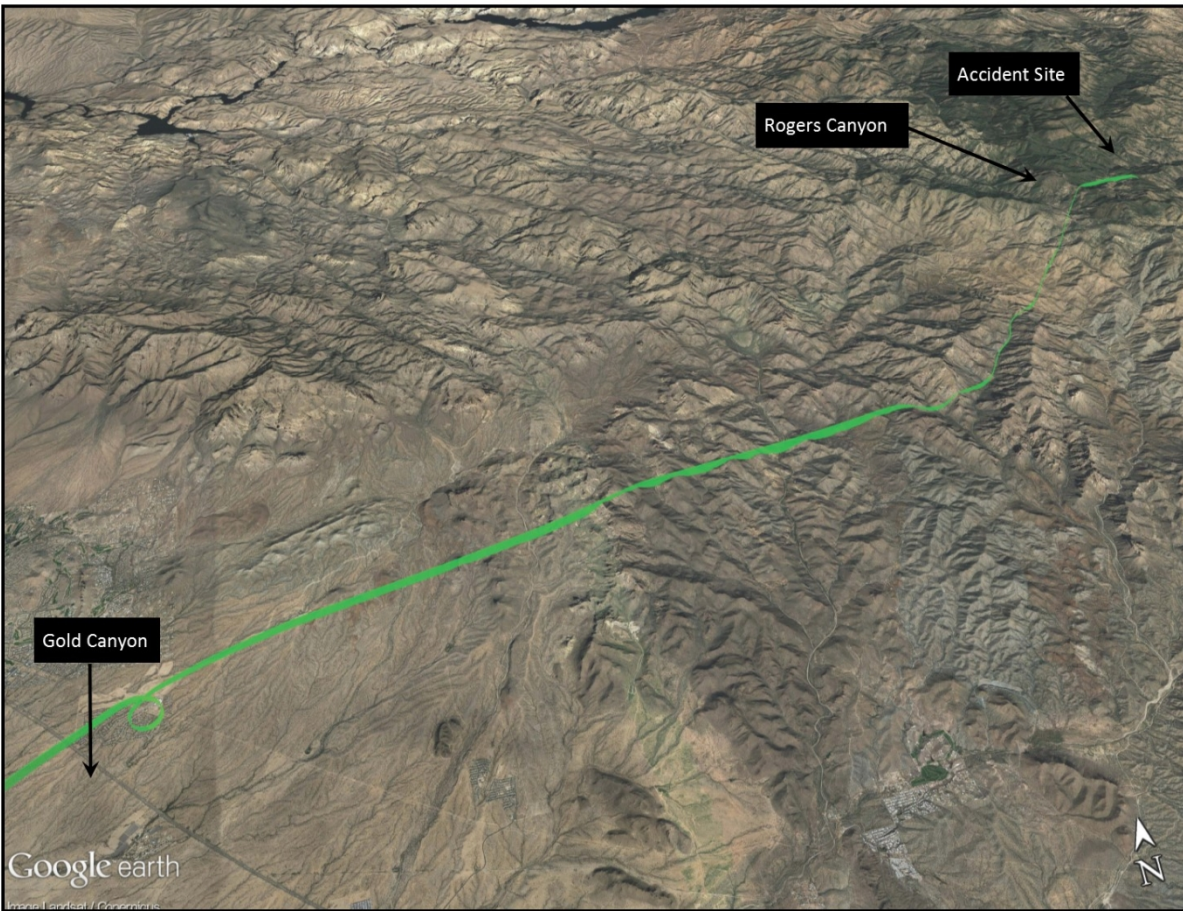
Figure 2-Aerial View of Accident Flight

About 1719, the helicopter entered mountainous terrain, and the height of the helicopter above the terrain began to vary as the terrain elevation rose and fell. Between 1718 and 1720, the altitude varied between 240 ft agl and 1,150 ft agl. Between 1720 and the end of the flight, the altitude varied between 30 ft agl and 770 ft agl. About 1721, the helicopter turned from a heading of about 80° to a heading of about 45° and followed a canyon beneath its ridgelines. (See figure 2)

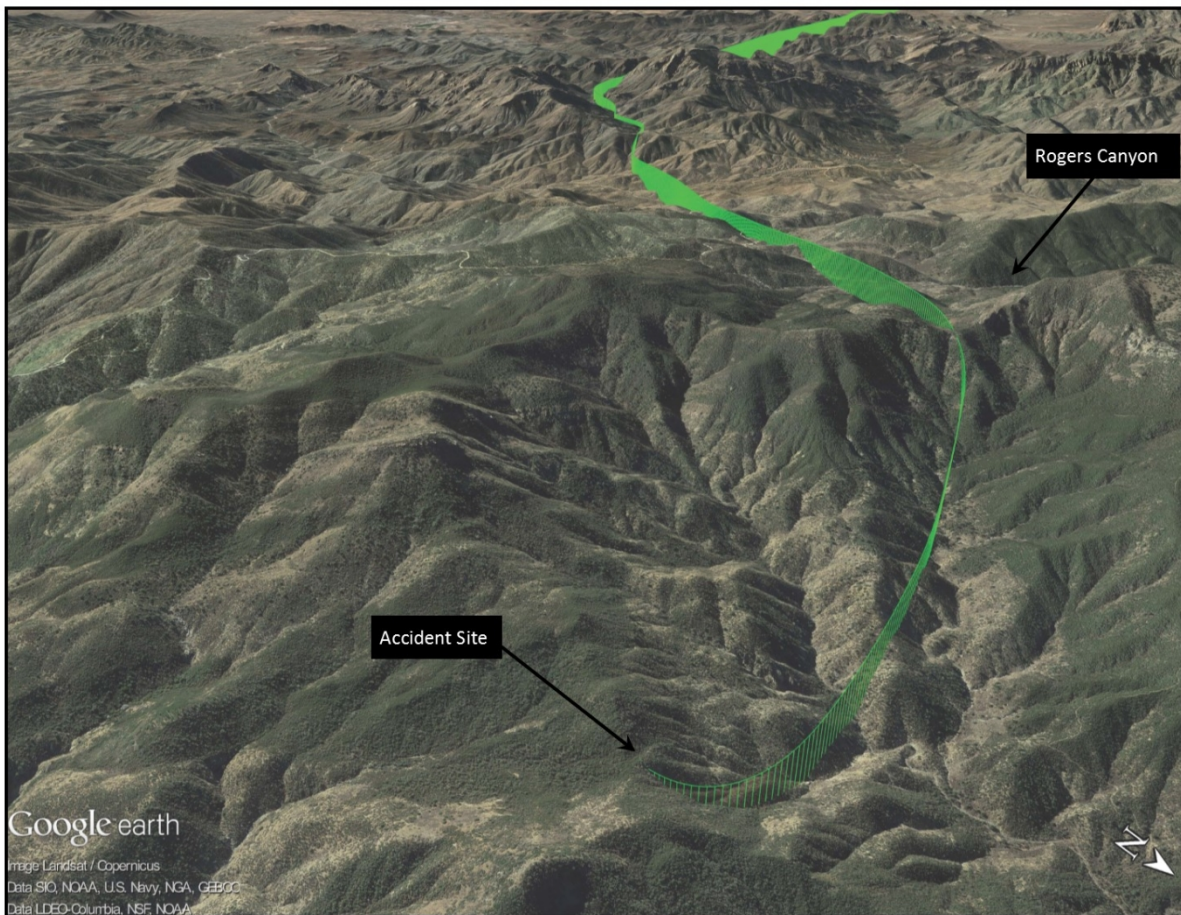
Figure 3-Aerial View of the Accident Flight and Accident Flight

The helicopter flew nearly perpendicularly over the north-south oriented Rogers Canyon, and at 1723:07, it continued through a saddle on the canyon's east wall, clearing the terrain by about 30 ft. As it passed over the eastern ridgeline, the helicopter banked to the right, changing from a ground track of about 43° to 76° , and reached a ground speed of about 120 knots. After the helicopter cleared the ridge, it started to descend and accelerate. The ground speed reached a maximum of 148 knots at 1723:21. The helicopter banked right (about 5° to 10° of roll), and its heading changed from 76° at 1723:18 to about 90° at 1723:32. (See figure 3)
