# Aviation Investigation Final Report

<b>Location:</b>	Superior, Arizona	<b>Accident Number:</b>	WPR16FA040
<b>Date &amp; Time:</b>	December 15, 2015, 17:23 Local	<b>Registration:</b>	N74317
<b>Aircraft:</b>	AIRBUS Helicopters AS350	<b>Aircraft Damage:</b>	Substantial
<b>Defining Event:</b>	Low altitude operation/event	<b>Injuries:</b>	2 Fatal, 1 Serious
<b>Flight Conducted Under:</b>	Part 135: Air taxi & commuter - Non-scheduled - Air Medical (Discretionary)

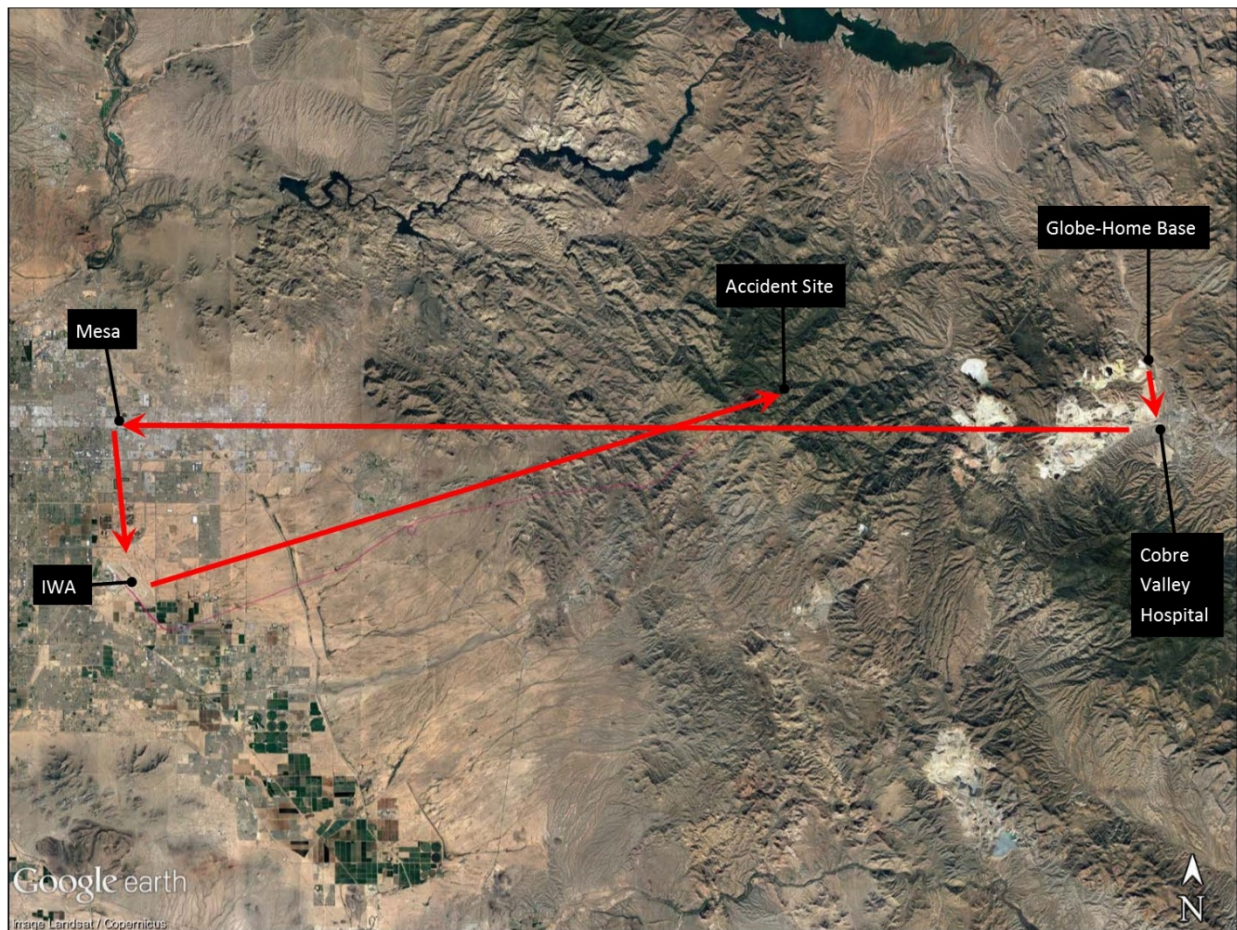
Figure 1-Overview of Flights

According to the operator, the helicopter was based in Globe and had transported a patient from the Cobre Valley Community Hospital in Globe to the Baywood Heart Hospital in Mesa. After transporting the patient, the pilot flew the helicopter to IWA for refueling before the return flight to Globe. (See figure 1)

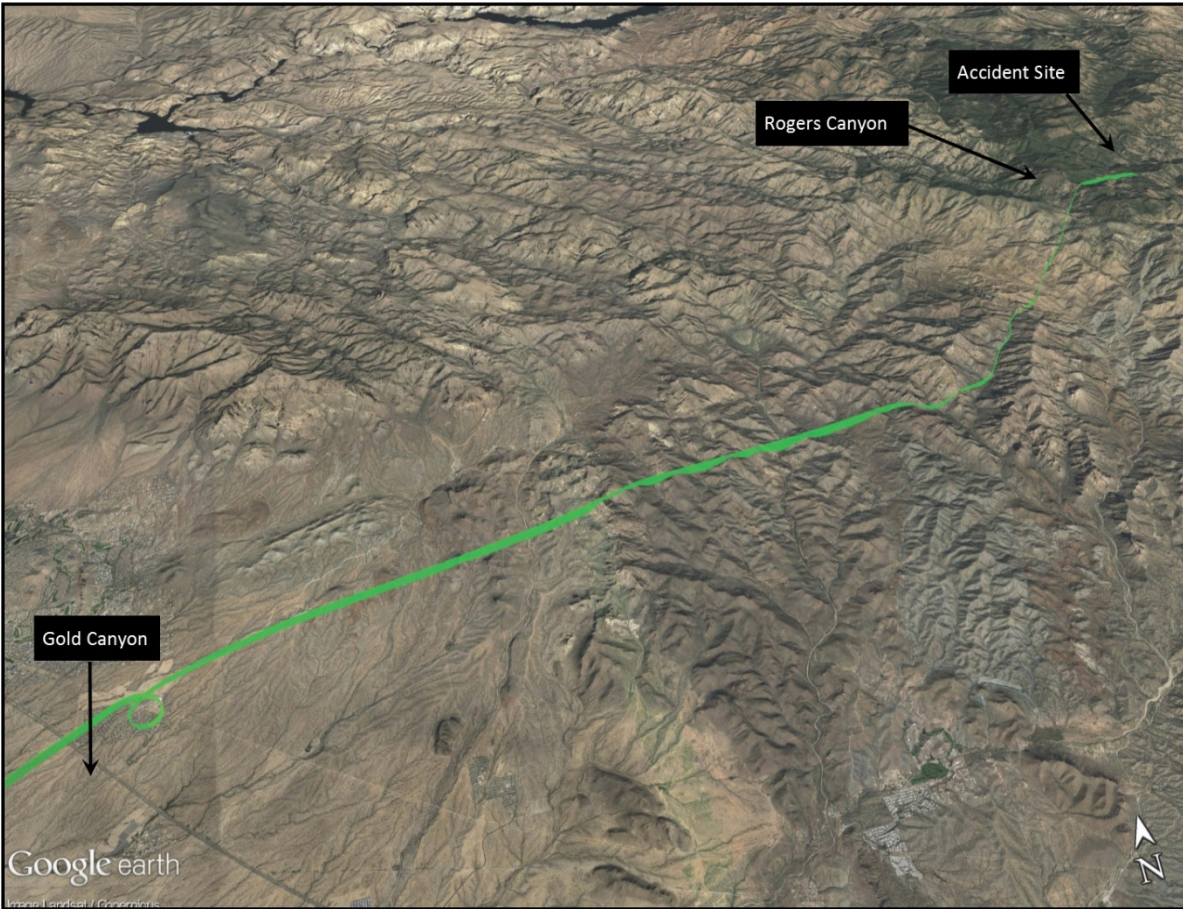
Figure 2-Aerial View of Accident Flight

About 1719, the helicopter entered mountainous terrain, and the height of the helicopter above the terrain began to vary as the terrain elevation rose and fell. Between 1718 and 1720, the altitude varied between 240 ft agl and 1,150 ft agl. Between 1720 and the end of the flight, the altitude varied between 30 ft agl and 770 ft agl. About 1721, the helicopter turned from a heading of about 80° to a heading of about 45° and followed a canyon beneath its ridgelines. (See figure 2)

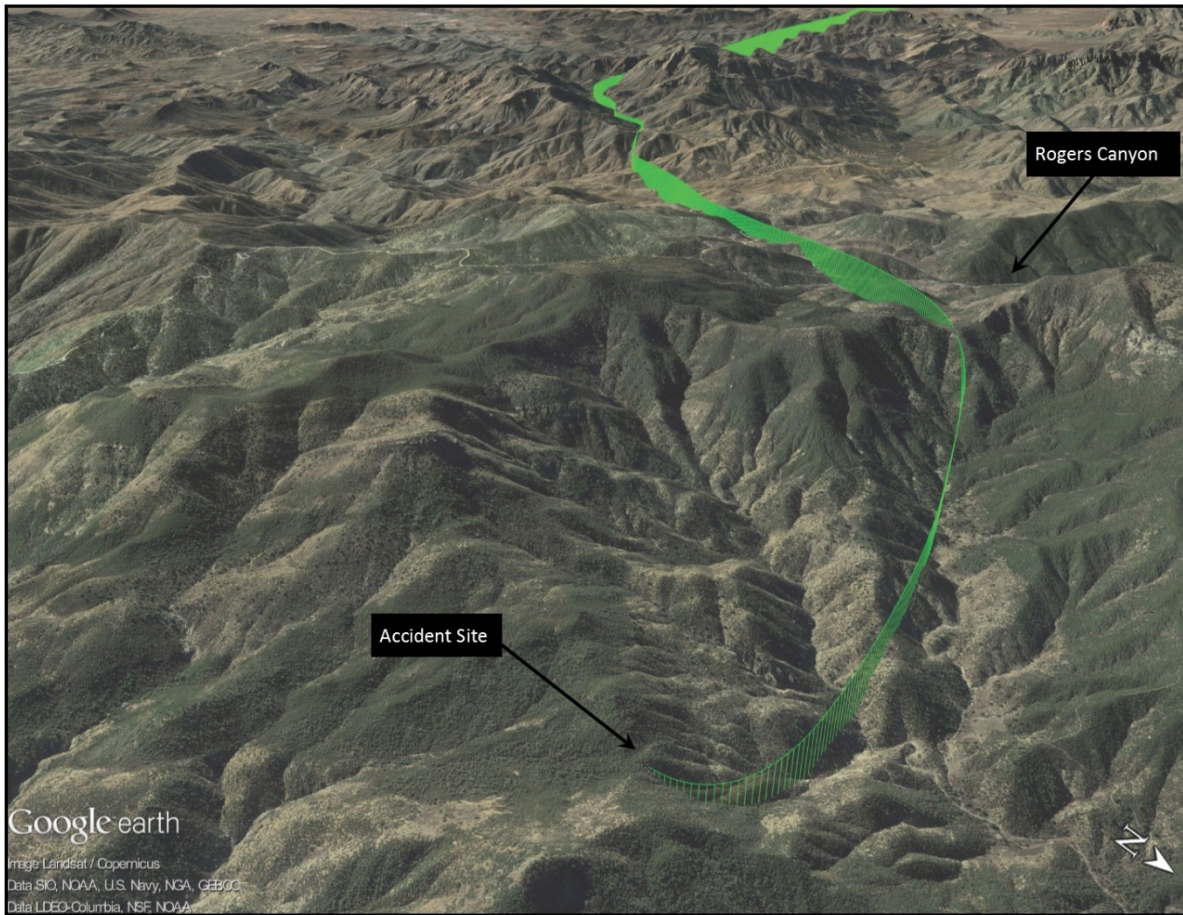
Figure 3-Aerial View of the Accident Flight and Accident Flight

The helicopter flew nearly perpendicularly over the north-south oriented Rogers Canyon, and at 1723:07, it continued through a saddle on the canyon's east wall, clearing the terrain by about 30 ft. As it passed over the eastern ridgeline, the helicopter banked to the right, changing from a ground track of about  $43^\circ$  to  $76^\circ$ , and reached a ground speed of about 120 knots. After the helicopter cleared the ridge, it started to descend and accelerate. The ground speed reached a maximum of 148 knots at 1723:21. The helicopter banked right (about  $5^\circ$  to  $10^\circ$  of roll), and its heading changed from  $76^\circ$  at 1723:18 to about  $90^\circ$  at 1723:32. (See figure 3)

At 1723:32, the GAU2000 recorded an abrupt increase in the helicopter's pitch rate and right roll rate, consistent with right and aft cyclic inputs. According to the paramedic, around this time, the pilot said an expletive in a panicked voice. The paramedic looked up and saw a ridgeline immediately in their flight path and terrain filling up the view. The paramedic described the subsequent motions of the helicopter as a violent hard right bank, and he stated that the pilot did not say anything else but was making jerky fast hand movements. The helicopter impacted terrain on the northwest facing slope of a ridgeline, near a saddle, at an elevation of about 5,035 ft mean sea level.
