Aviation Investigation Final Report

Location:	Gilmer, Texas	Accident Number:	CEN16FA083
Date & Time:	January 12, 2016, 19:54 Local	Registration:	N737EZ
Aircraft:	Cessna 172N	Aircraft Damage:	Substantial
Defining Event:	Fuel exhaustion	Injuries:	1 Fatal, 1 None
Flight Conducted Under:	Part 91: General aviation - Personal

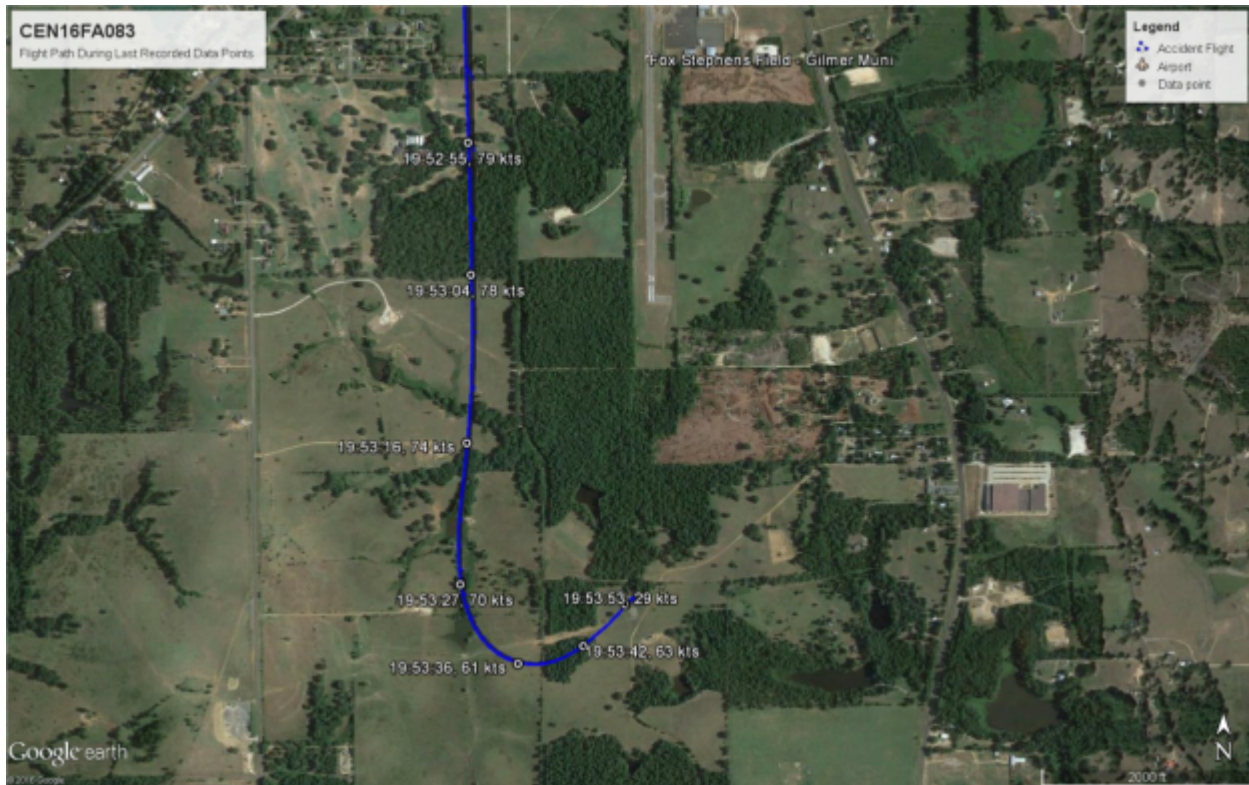
Recorded GPS data showed that the pilot flew the traffic pattern 400-600 ft lower than the recommended 1,000-ft above airport elevation and turned to the base leg of the traffic pattern farther from the runway than recommended. Had the pilot flown the traffic pattern at the recommended altitude and distance from the runway, it may have been possible for the airplane to glide to the runway following the loss of engine power.

During the last minute of flight, the airplane's speed steadily decreased from 79 knots to the last recorded speed of 29 knots. The GPS altitude also steadily decreased from 832 ft to 425 ft. At 19:53:16 the airplane was at 649 ft GPS altitude, 74 kts, and about 35 degrees past and .43 miles from the approach end of runway 36 at JXL. At 19:53:27 the airplane was at 583 ft GPS altitude, 70 kts, and about 55 degrees past and .62 miles from the approach end of runway 36.

Figure 1 shows the flight track the airplane followed, which is consistent with a left downwind and a left base leg for runway 36 at JXI, which had an airport elevation of 415 feet. The GPS track indicated the airplane began a turn for the left base when the airplane reached about 55 degrees past abeam the approach end of runway 36, as depicted in Figure 1.

Plot of recorded data points for the accident flight showing the accident location near JXI.

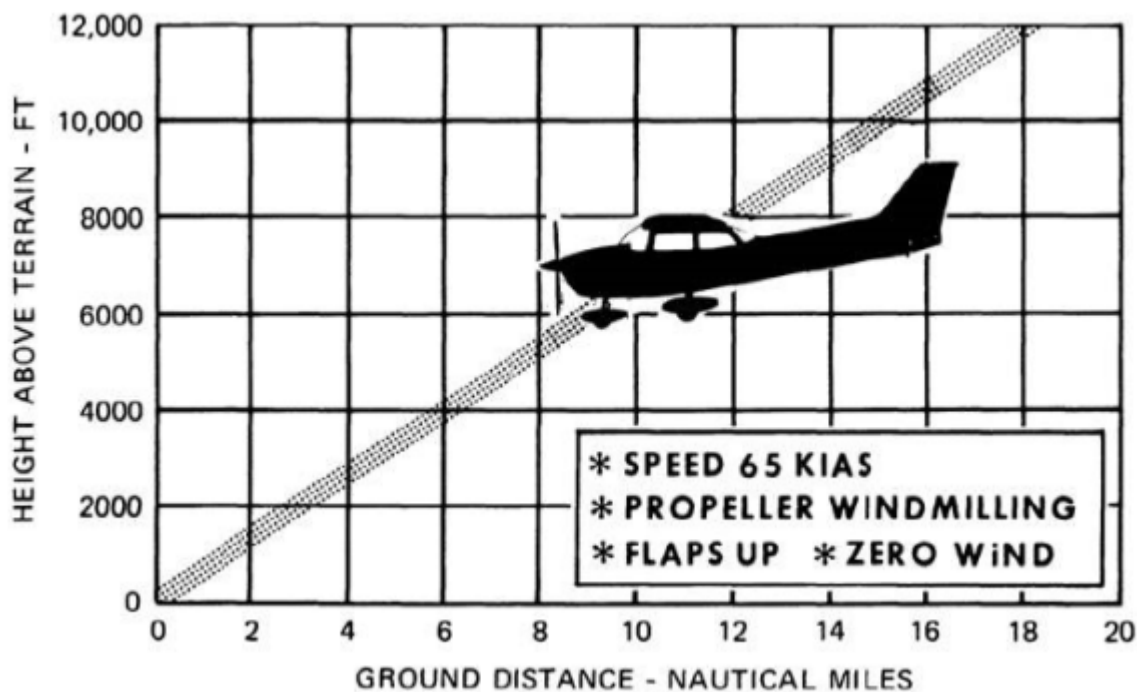
The Cessna 172N airplane flight manual, Section 3, Amplified Emergency Procedures, Engine Failure, contained a chart of maximum glide distance, which is shown in Figure 2.

The Cessna 172N flight manual chart for maximum glide distance shows an approximate glide distance of 1 nautical mile at an altitude of 500 ft above ground level with a speed of 65 knots indicated airspeed, propeller windmilling, flaps up, and zero wind.
