Aviation Investigation Final Report

Location:	Burns, Oregon	Accident Number:	WPR16LA060
Date & Time:	January 31, 2016, 14:59 Local	Registration:	N777PG
Aircraft:	Piper PA46	Aircraft Damage:	Substantial
Defining Event:	Loss of engine power (total)	Injuries:	1 None
Flight Conducted Under:	Part 91: General aviation - Personal

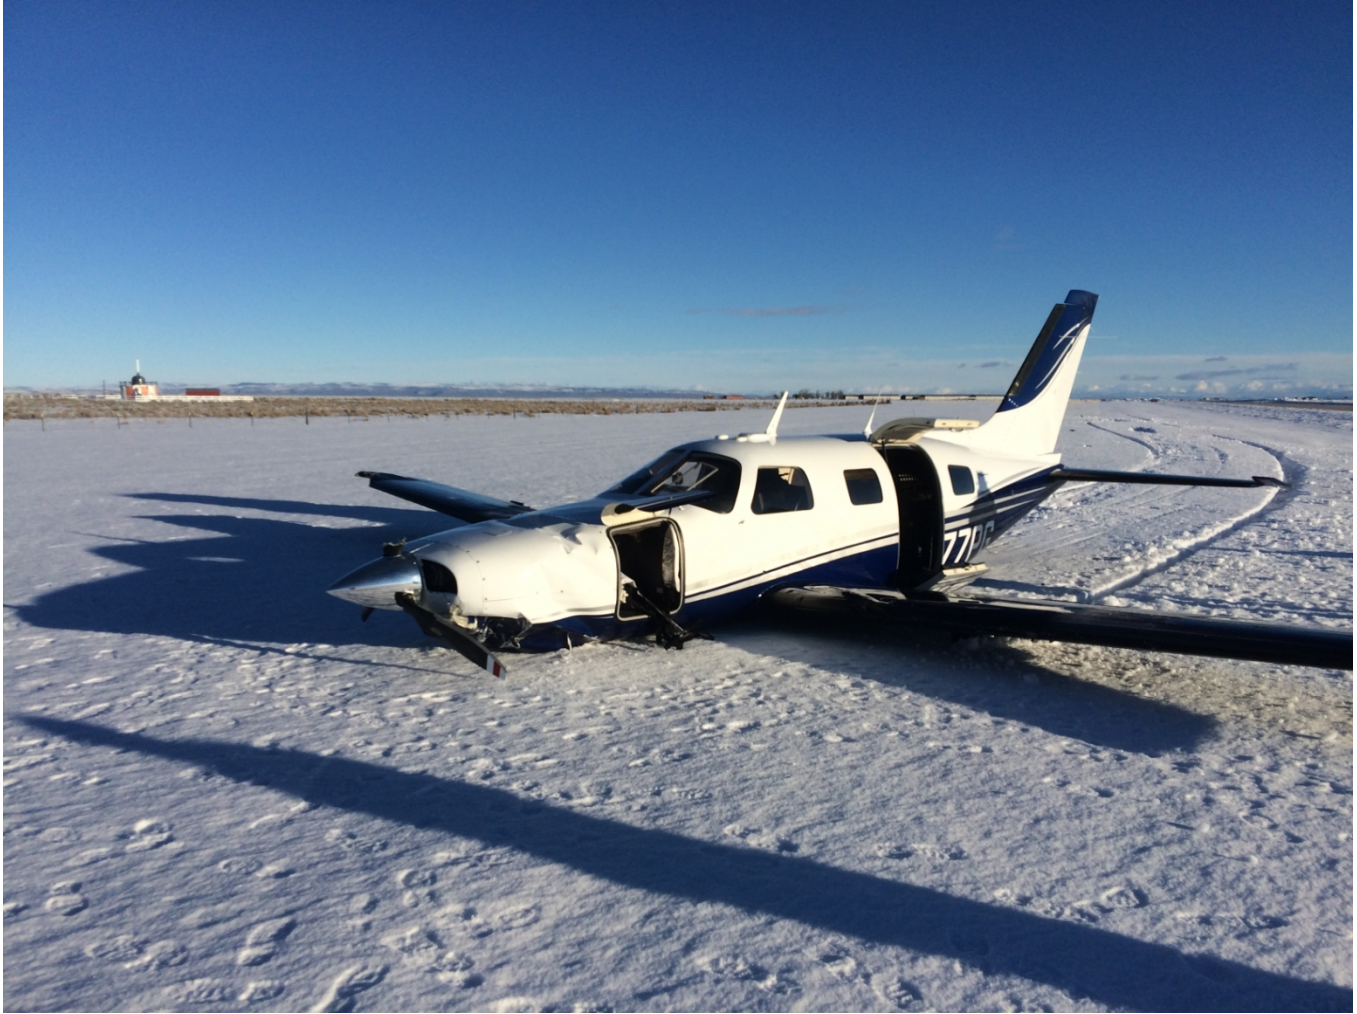
Photo 1 - Airplane at the Accident Site

He reported that just prior to touchdown, when the airplane was about 5 ft above ground level, the landing gear began to extend, and he saw two green lights indicating the main landing gear had locked, but no green light for the nose gear. The airplane touched down, and the nose dug into the snow. The airplane abruptly stopped, sustaining substantial damage to the forward fuselage and both wings (Photo 1).

The airframe sustained wrinkles aft of the firewall, with crush damage to the underside of the engine. Within the cabin, the fuel mixture control was found in the full-forward (RICH) position, the propeller was in the full-forward (INCR) position, and the throttle in the full-aft position (CLSD).
