Aviation Investigation Final Report

Location:	Honolulu, Hawaii	Accident Number:	WPR16FA072
Date & Time:	February 18, 2016, 10:20 Local	Registration:	N80918
Aircraft:	Bell 206B	Aircraft Damage:	Substantial
Defining Event:	Sys/Comp malf/fail (non-power)	Injuries:	1 Fatal, 3 Serious, 1 Minor
Flight Conducted Under:	Part 91: General aviation - Aerial observation

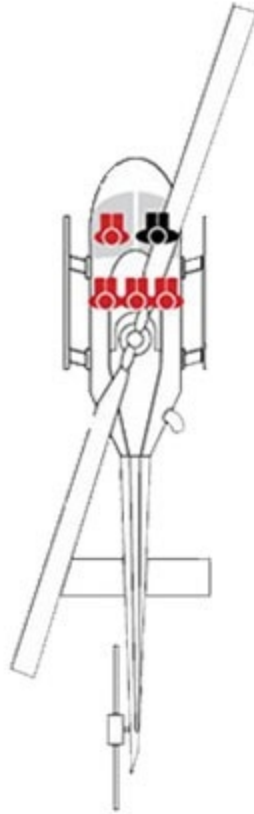
Figure 1: Helicopter Seating Diagram

The helicopter was equipped with 5 seats, two in the front, and 3 in the aft section of the cabin. The helicopter is flown from the front right seat, with passenger seating in the remaining seats as referenced in figure 1.

Three of the passengers reported that they watched the safety video before boarding the helicopter. The passenger who was seated in the front left seat stated they boarded the helicopter with their life preservers on and, one-by-one, were buckled into place by either the pilot or ground crew. The three passengers all stated that the seatbelts were difficult to unlatch following the accident sequence.

Examination of the helicopter revealed that all five seats were equipped with 4-point seatbelt restraints, which included 2 shoulder belts and a left and right lap belt. The front left and right seat restraint buckles were equipped with a rotary buckle, which required rotation of the buckle to release the seat belt clasps. The rotary buckle attached to the shoulder restraints and opposing lap belt by sliding the clasp of the respective belt into the respective port on the buckle. The front right seat was intact. The restraints were intact, remained attached to their respective mounts, and the seat belt latch functioned normally. The inertia reel functioned normally. The front right seat exhibited downward compression damage to the seat frame and structure underneath the seat frame.

The front left seat was intact. The restraints were intact, and the seat belt latch functioned normally. The inertia reel functioned normally. The front left seat exhibited downward compression damage of the seat frame and structure underneath the seat frame.

The aft 3 seats were equipped with standard seatbelt buckles, which required one to lift upward on the tab to release the clasps. The shoulder harnesses were connected to the aft seat restraints by two metal connectors, which slid over the clasp before the seatbelt was buckled.

The aft seats were mostly intact. The aft left seat was missing the seat back cushion. The bottom of the seats exhibited an upward bow in the center, consistent with impact damage to the bottom of the fuselage. All three sets of restraints were intact. The shoulder harness inertia reels functioned normally. All of the aft seat belt latches functioned normally. The seat structure on the aft right side was damaged consistent with downward compression.

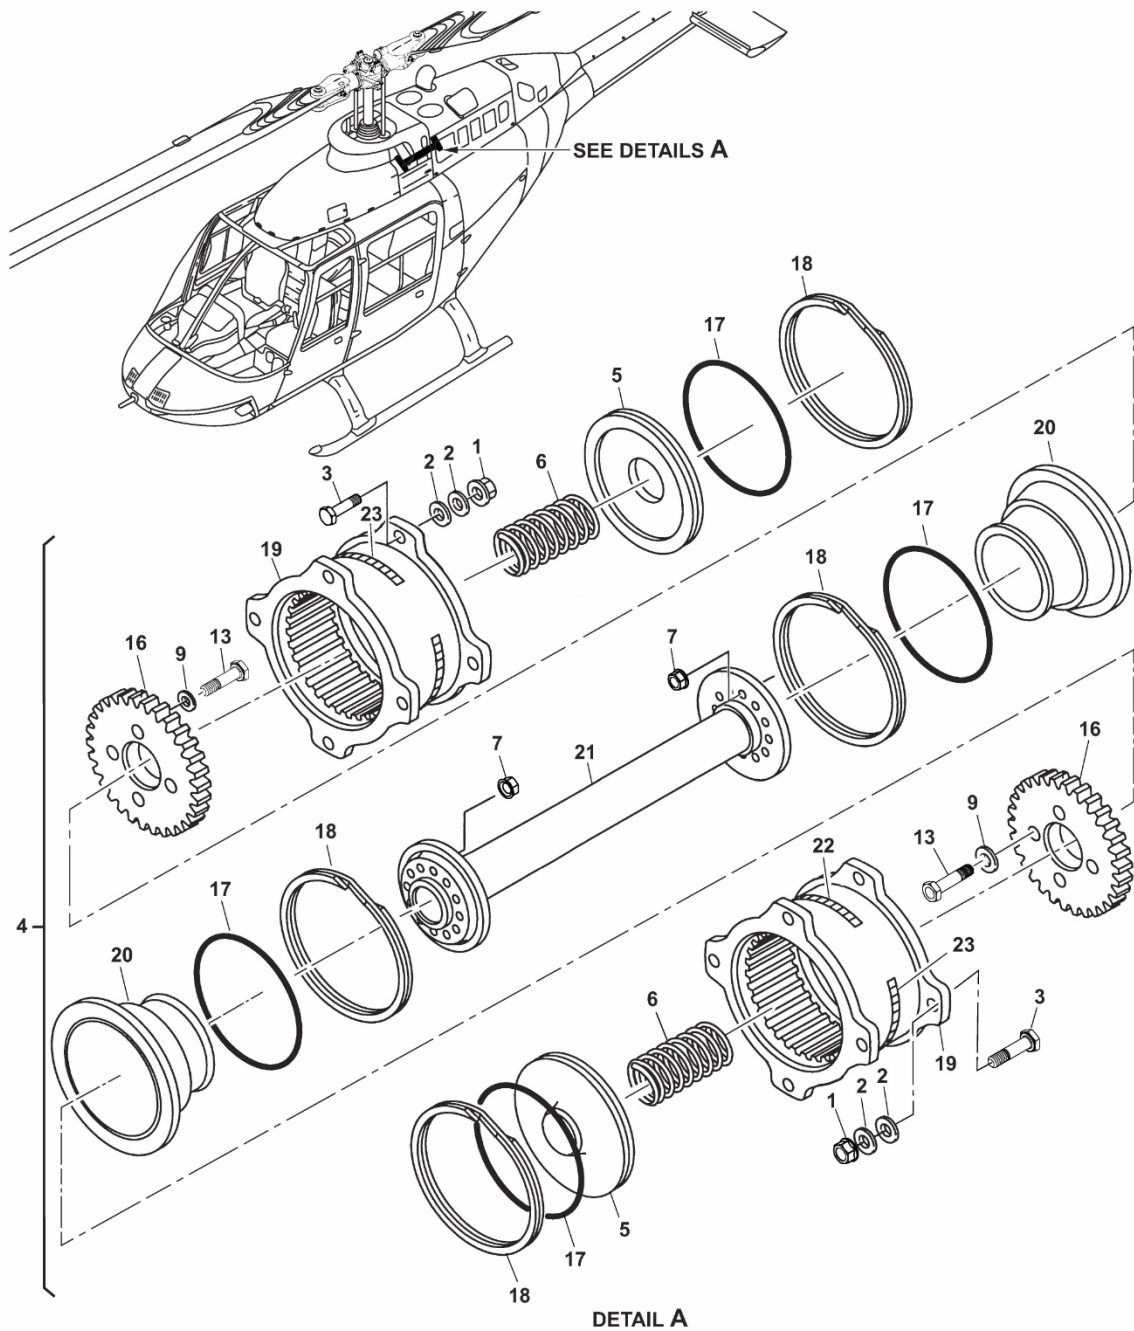
Figure 2: Engine-to-transmission-driveshaft diagram.

The drive shaft contains a gear sprocket affixed to the shaft flange via 4 bolts (bolt heads positioned on the inside of the coupling). The donut-shaped gear has a hollow area in the middle that aligns with the hollow tube situated between the couplings; a slight lip surrounds the hollow area. The outer coupling gear surrounds the drive gear where it is splined, and torque is transmitted. Inside the coupling, the assembly is equipped with a shaft centering spring. The spring (item 6 in figure 2) is positioned between

the lip and the end cap of the coupling (grease retainer plate). A retainer ring and packing seal rest against the back plate.

The BHT maintenance manual recommends that, before reassembly, the engine-to-transmission drive shaft couplings be hand-packed with lubricant (C-015 grease) over the top of the internal spline teeth to a depth of 0.2-0.3 inch.

The spline teeth on the forward (transmission side) spherical coupling were worn down to the bottom landings. Two of the attachment bolts had fractured at the transition from the bolt shank to the bolt head. The forward compression spring and forward cover plate were both fractured into multiple pieces and the spring pieces were deformed from their original shape. A comparison of the spring and cover plate fragments with their respective aft counterparts indicated that only a portion of each item was recovered. The spring and cover plate fragment fracture surfaces were examined visually with the aid of a stereomicroscope and all fractures exhibited features consistent with either overstress or rubbing/smearing due to post-separation damage.

The forward outer coupling had a dark tint consistent with exposure to elevated temperatures, and the temperature plates, which were supposed to be on the forward outer coupling, were missing. The forward end of the forward outer coupling exhibited mechanical damage around the perimeter of the forward opening. The internal spline profile exhibited comparatively minor wear marks near the middle of the spline teeth when compared to the wear on the forward spherical coupling.

Neither the forward spherical coupling nor the forward outer coupling exhibited indications of residual grease lubrication. By comparison, the aft outer coupling and spherical coupling were covered by a lubricant that was brown/black in color and viscous. The aft coupling did not exhibit any notable wear features.

The attachment bolt head fractures were examined in detail and determined to be consistent with cadmium-induced embrittlement of the steel at elevated temperature. The bolts were type NAS 1304-10 and were made of a low alloy steel with a cadmium-plated coating. Both bolt heads were examined using a scanning electron microscope (SEM). The fracture surface had a faceted appearance, consistent with intergranular fracture. Energy dispersive x-ray spectroscopy (EDS) of the fracture surface and a portion of the bolt indicated the presence of oxygen and cadmium in addition to the elements associated with the base metal.
