Aviation Investigation Final Report

Location:	Rome, Georgia	Accident Number:	ERA16LA131
Date & Time:	March 14, 2016, 15:08 Local	Registration:	N465FL
Aircraft:	RAYTHEON AIRCRAFT COMPANY 400A	Aircraft Damage:	Substantial
Defining Event:	Runway excursion	Injuries:	1 Minor, 1 None
Flight Conducted Under:	Part 91: General aviation - Positioning

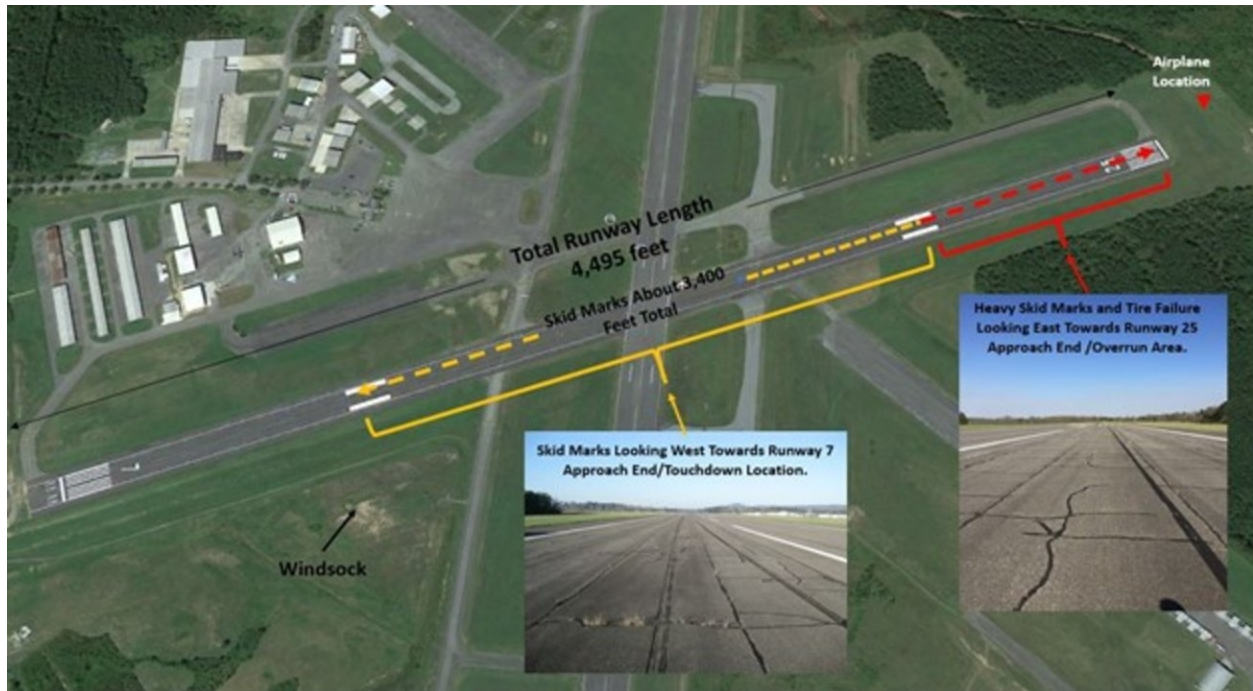
Tire skid marks were found beginning about 1,000 feet from the approach end of runway 7. The PF stated that the airplane touched down "abruptly at Vref+5 and he applied the brakes while the PM applied the speed brakes. Neither pilot felt the airplane decelerating, so the PF applied harder pressure to the brakes with no effect and subsequently applied full braking pressure. When it was evident that the airplane was going to depart the end of the runway, the PM applied the emergency brakes, at which point he felt some deceleration; however, the airplane overran the end of the runway and travelled through grass and mud for about 370 feet before stopping.

During a postaccident examination of the runway, tire skid marks were found beginning about 1,000 ft from the approach end of the runway 7. The tire marks swerved slightly toward the right about 20 ft right of the centerline and then slightly left toward the centerline and extended to the runway end. Further down the runway, the tire marks became increasingly more pronounced, flattened out, and widened. The tire marks continued and veered left through grass and mud for another 370 ft past the departure end of the runway, where the airplane came to rest (see figure 1).

Figure 1 - Overhead view of runway layout showing the approximate measurements of the skid marks and the airplane's final resting location.
