Aviation Investigation Final Report

Location:	Reedsville, Wisconsin	Accident Number:	CEN16FA171
Date & Time:	May 4, 2016, 10:02 Local	Registration:	N629JK
Aircraft:	McDonnell Douglas Helicopter 369E	Aircraft Damage:	Substantial
Defining Event:	Loss of engine power (total)	Injuries:	1 Fatal
Flight Conducted Under:	Part 133: Rotorcraft ext. load

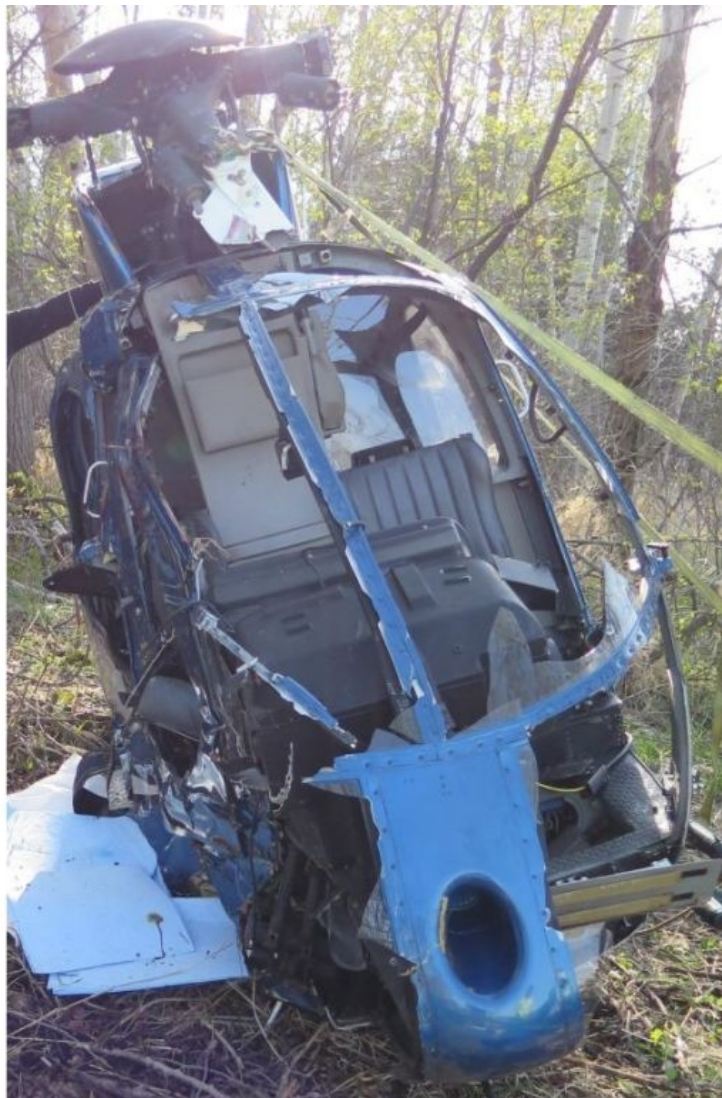
The helicopter came to rest in a wooded area about 125 ft south of tower 9904 (figure 4/5). The surrounding trees were 50 to 75 ft tall, and several of them were broken or showed signs of recent scaring and damage, consistent with the helicopter's impact sequence. All of the major components of the helicopter were found at the accident site. The long line remained attached to the cargo hook and trailed north toward the tower. There was an odor of Jet-A fuel around the main wreckage, and fuel was observed leaking from the helicopter. On-scene documentation was completed, and the wreckage was recovered to a secure examination facility.

Figure 5 – Front view of accident helicopter damage
