Aviation Investigation Final Report

Location:	Reedsville, Wisconsin	Accident Number:	CEN16FA171
Date & Time:	May 4, 2016, 10:02 Local	Registration:	N629JK
Aircraft:	McDonnell Douglas Helicopter 369E	Aircraft Damage:	Substantial
Defining Event:	Loss of engine power (total)	Injuries:	1 Fatal
Flight Conducted Under:	Part 133: Rotorcraft ext. load

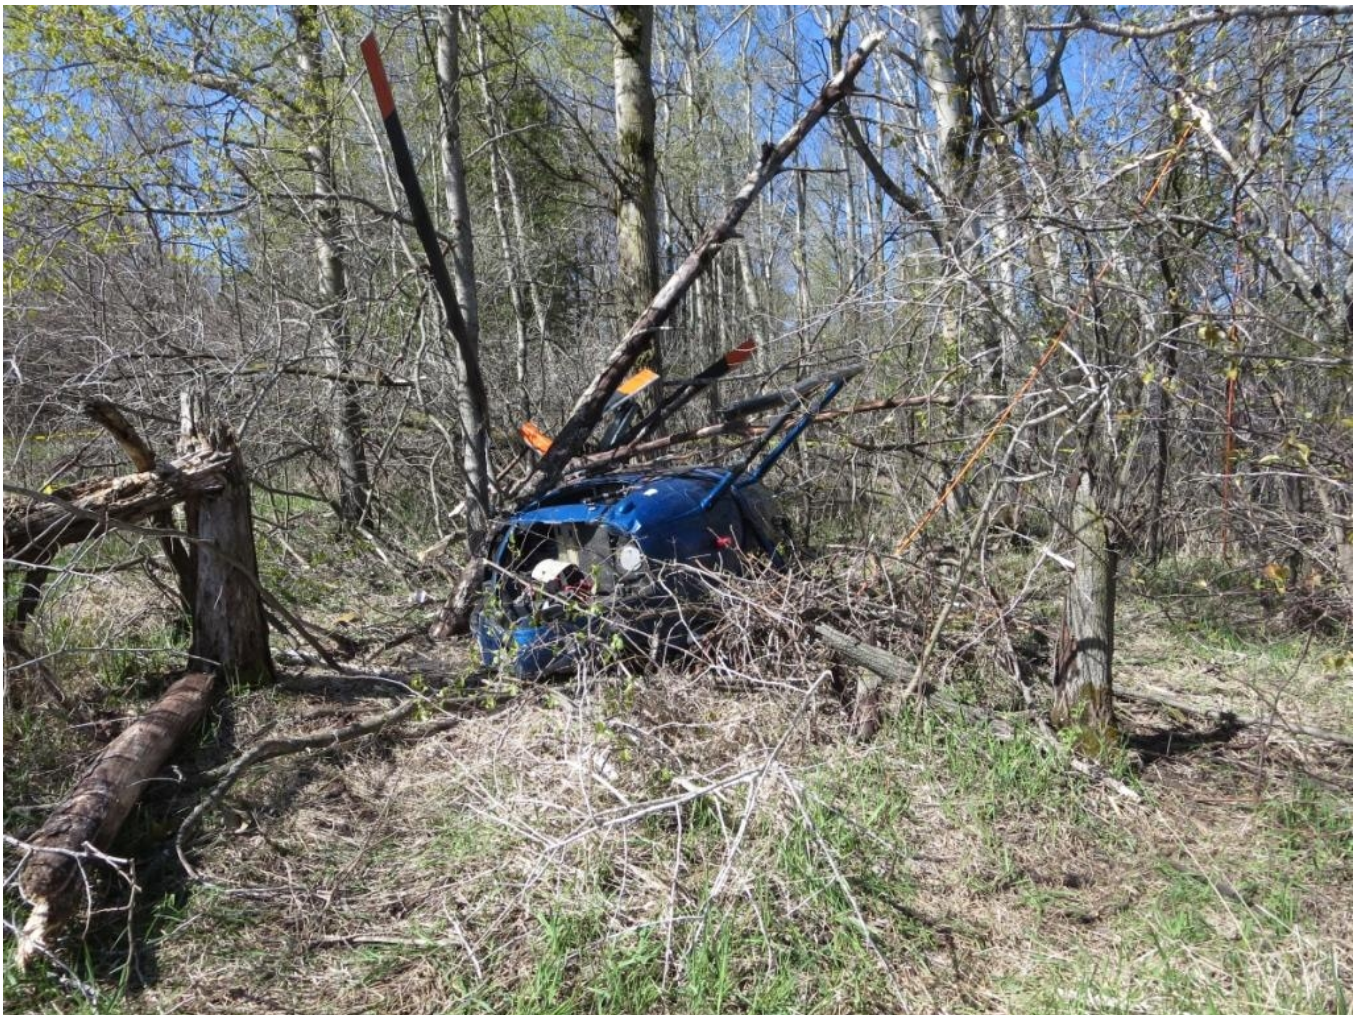
The helicopter came to rest in a wooded area about 125 ft south of tower 9904 (figure 4/5). The surrounding trees were 50 to 75 ft tall, and several of them were broken or showed signs of recent scaring and damage, consistent with the helicopter's impact sequence. All of the major components of the helicopter were found at the accident site. The long line remained attached to the cargo hook and trailed north toward the tower. There was an odor of Jet-A fuel around the main wreckage, and fuel was observed leaking from the helicopter. On-scene documentation was completed, and the wreckage was recovered to a secure examination facility.

Figure 4 – The accident helicopter surrounded by trees

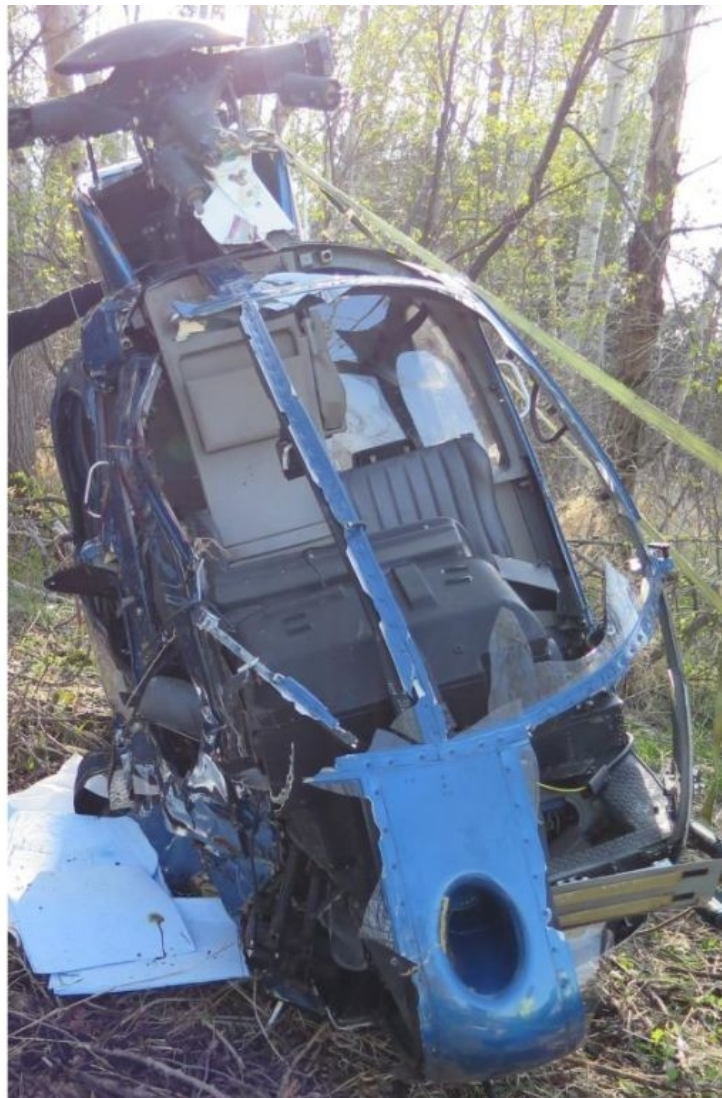
Figure 5 – Front view of accident helicopter damage

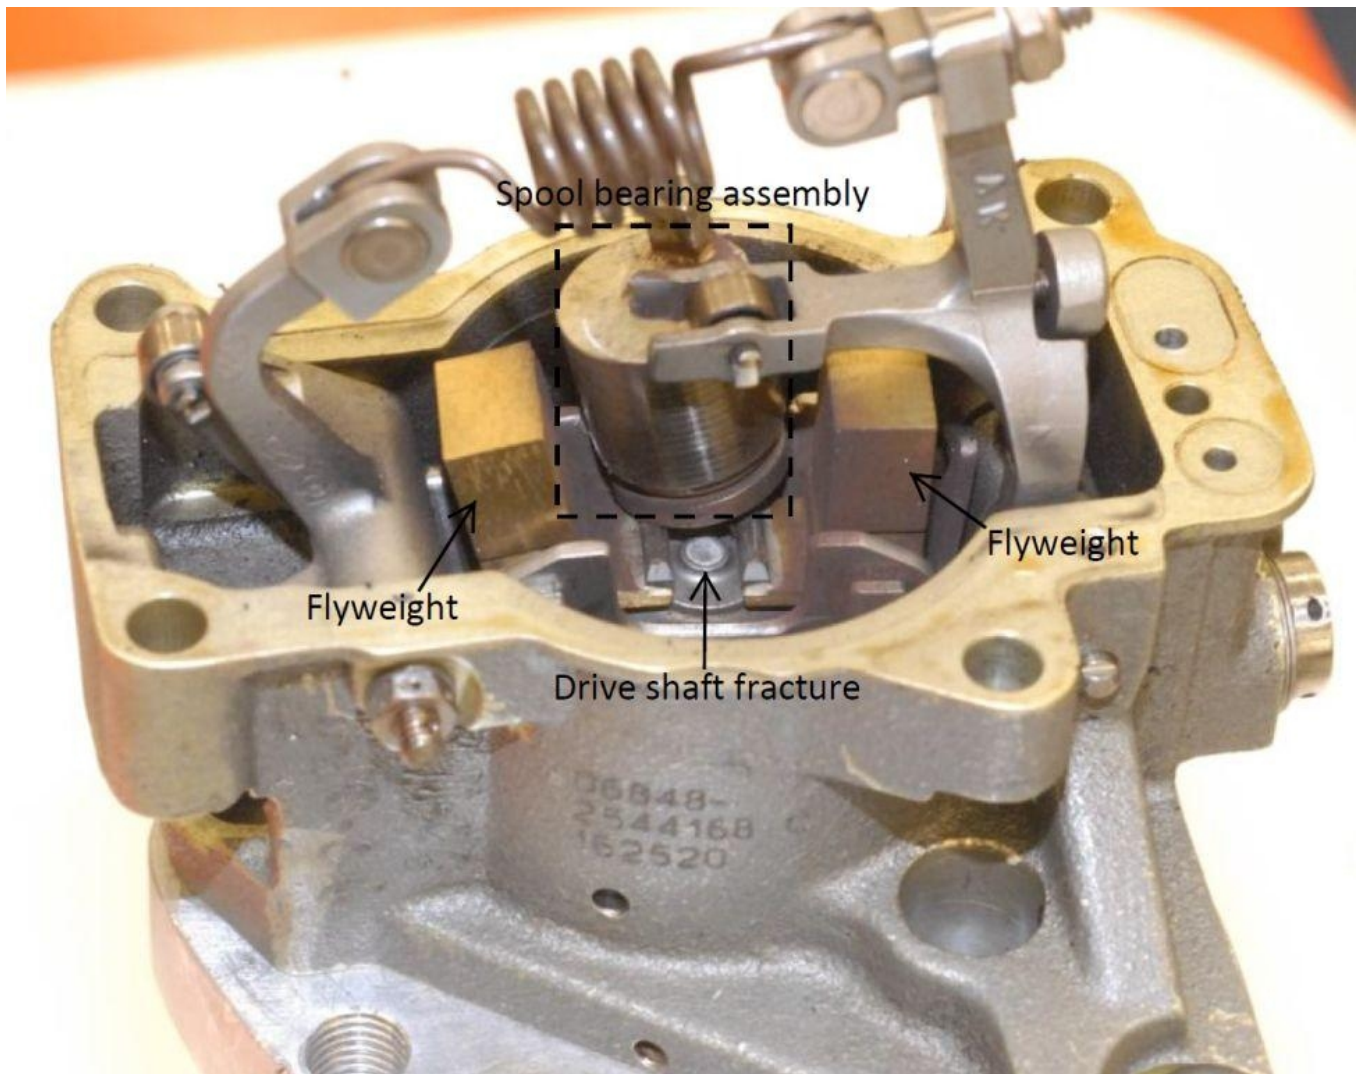
On August 9, 2016, the PTG, which was designed and manufactured by Honeywell, was disassembled and examined at a Honeywell facility under the auspices of the NTSB. A functional performance test could not be performed due to the internal damage. The examination revealed that the governor pressure (Pg) lever clevis fork was bent, and the spool bearing assembly was loose within the drive body cavity (figure 6). The drive shaft guide post was fractured and trapped within the spool bearing bushing. Metallic debris was found within the interior of both the drive body and the drive body cover. The internal bearing elements of the spool bearing assembly were seized and would not rotate. One flyweight was bent and did not pivot freely. The drive shaft was found fractured at the guide post and at the drive spline. The PTG was sent to the NTSB Materials Laboratory, Washington, DC, for further examination.

Figure 6 – Internal view of the PTG

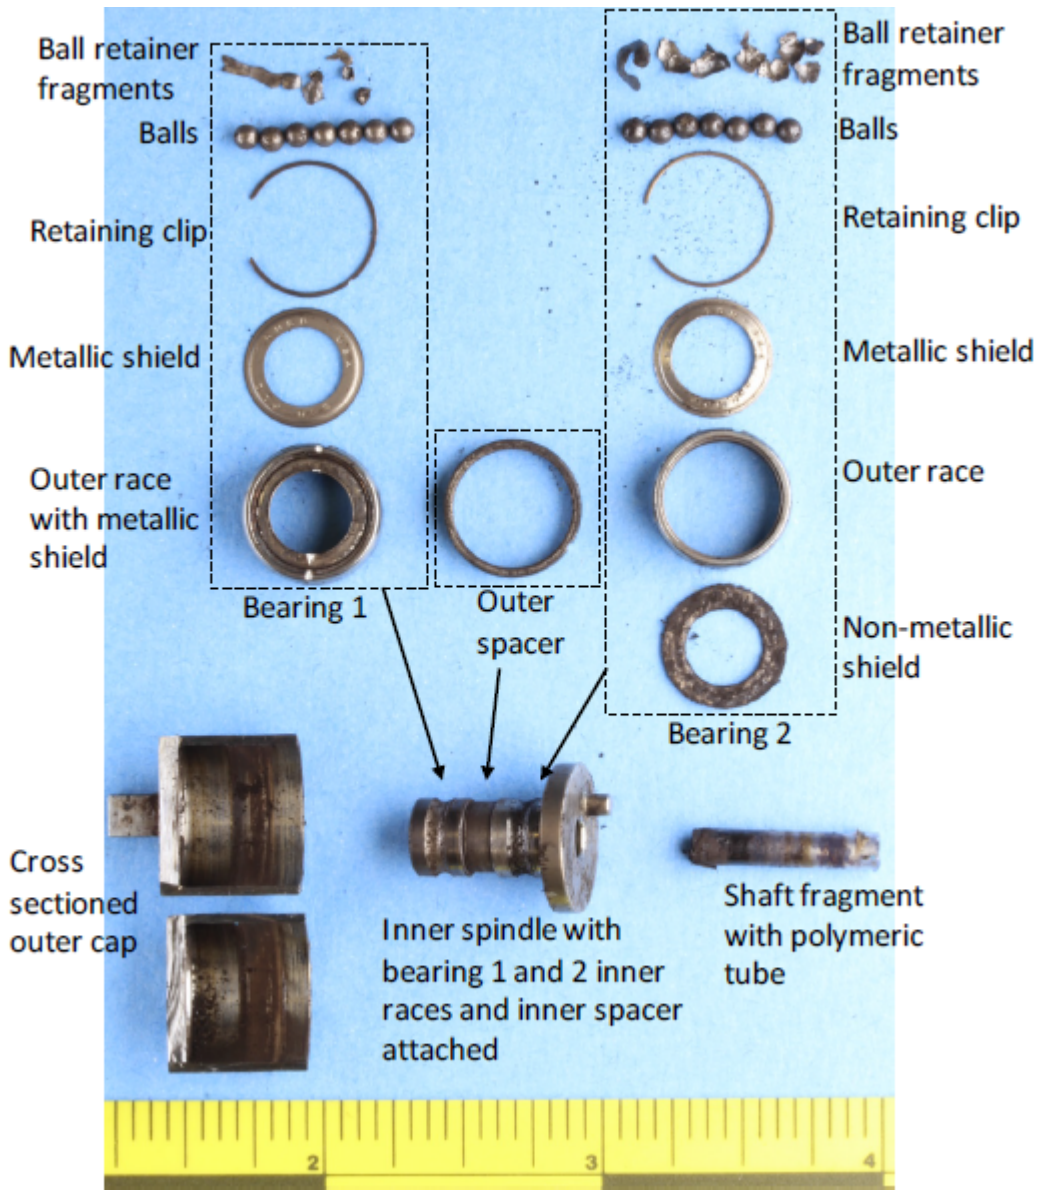
Examination of the PTG revealed that a portion of the drive shaft remained embedded in the spindle of the spool bearing assembly. The fracture surface features of the shaft were consistent with overstress. The internal elements of the spool bearing assembly were seized and would not rotate. The ball bearings and spacers were found coated with voluminous, powdery, black particulate consistent with oxidized metallic wear debris, and no grease was observed. The ball retainers were fragmented, the inner surfaces were found coated with a powdery, black particulate consistent with oxidized metallic wear debris, and no grease was observed. The inner bearing surfaces were rough and frosted, consistent with three-body

abrasive wear. The examination indicated that the fractured PTG drive shaft was the result of a spool bearing that seized due to a lack of lubrication.

On September 16, 2016, the NTSB examination of the PTG revealed that a portion of the fractured drive shaft remained embedded in the spindle of the spool bearing assembly. The fracture surface features of the shaft were consistent with overstress. The outer cap of the spool bearing assembly was removed, and the ball bearings and spacers were found coated with voluminous, powdery, black particulate. Much of the powder fell from the assembly upon removal of the cap. No grease was observed. Disassembly of the bearings revealed that the ball retainers were fragmented, the inner surfaces were found coated with a powdery, black particulate, and no grease was observed. The inner bearing surfaces were rough and frosted. Figure 7 shows the disassembled pieces of the spool bearing.

Figure 7 – Disassembled spool bearing with labels

In 2008, a service bulletin (SB) and commercial engine bulletin (CEB) were issued by PTG and engine manufacturers, respectively, that called for replacement of the dual-spool bearing, the type installed in the accident PTG, with a single-spool bearing. The dual-spool bearing had experienced 23 previous failures that had led to either engine oscillations, uncommanded engine acceleration, or a loss of engine power. Although the SB and CEB called for replacement of the accident PTG's dual-spool bearing not later than 750 hours after the PTG was installed new, the accident PTG had accumulated 1,048.7 hours since new when the accident occurred, and the SB and CEB had not been completed. As stated in the operator's Federal Aviation Administration (FAA) approved operations specifications, the operator was required to comply with FAA Airworthiness Directives but was not required to comply with manufacturer's service bulletins. It is likely that had the SB and CEB been completed, the PTG would not have failed and the engine would not have lost power.
