Aviation Investigation Final Report

Location:	Altadena, California	Accident Number:	WPR16FA111
Date & Time:	May 15, 2016, 08:29 Local	Registration:	N133BW
Aircraft:	Cessna R182	Aircraft Damage:	Destroyed
Defining Event:	Controlled flight into terr/obj (CFIT)	Injuries:	1 Fatal
Flight Conducted Under:	Part 91: General aviation - Personal

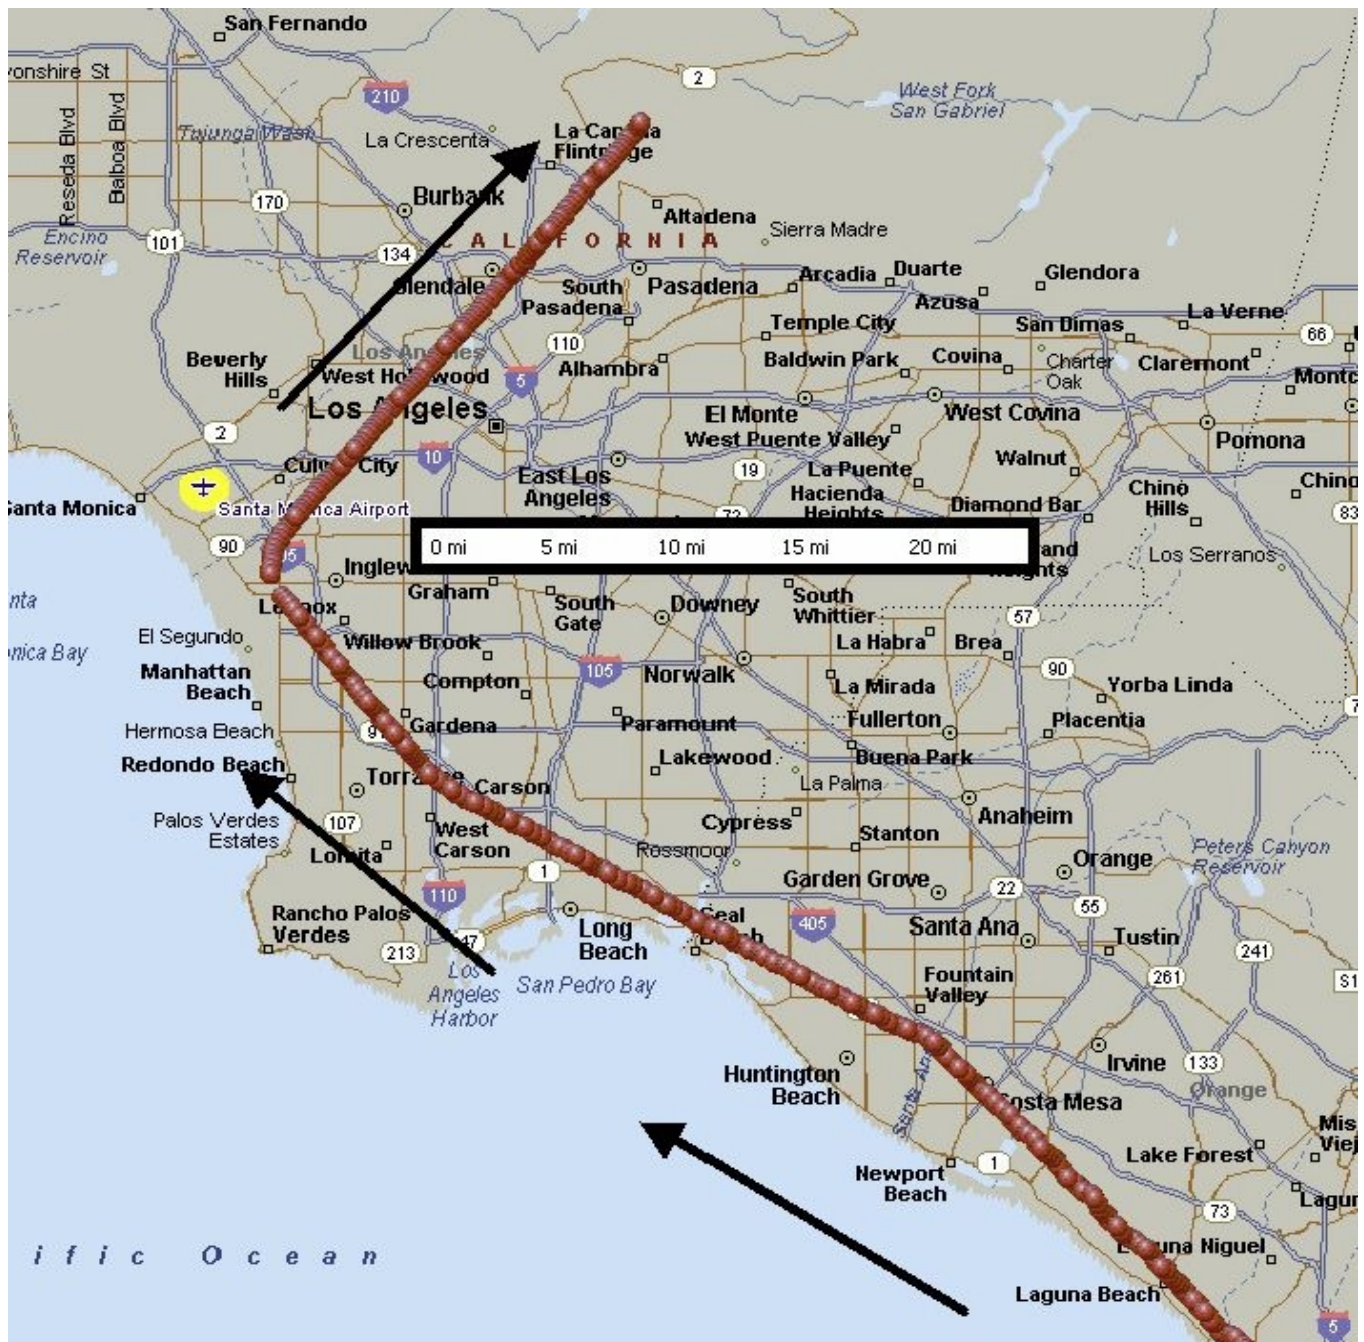
Review of recorded radar data revealed that the flight proceeded on a northwest heading after takeoff and paralleled the coast until nearing Torrance, California. The airplane then turned slightly right toward SMO. As the flight neared SMO, the airplane turned about 90° right to a northeast heading of about 30°. The airplane remained on this heading and maintained an altitude of 4,000 ft msl for about 19 miles until radar contact was lost.

Flight path of the accident airplane, with direction of travel noted by the black arrows.
