Aviation Investigation Final Report

| Location: | Altadena, California | Accident Number: | WPR16FA111 |
| Date & Time: | May 15, 2016, 08:29 Local | Registration: | N133BW |
| Aircraft: | Cessna R182 | Aircraft Damage: | Destroyed |

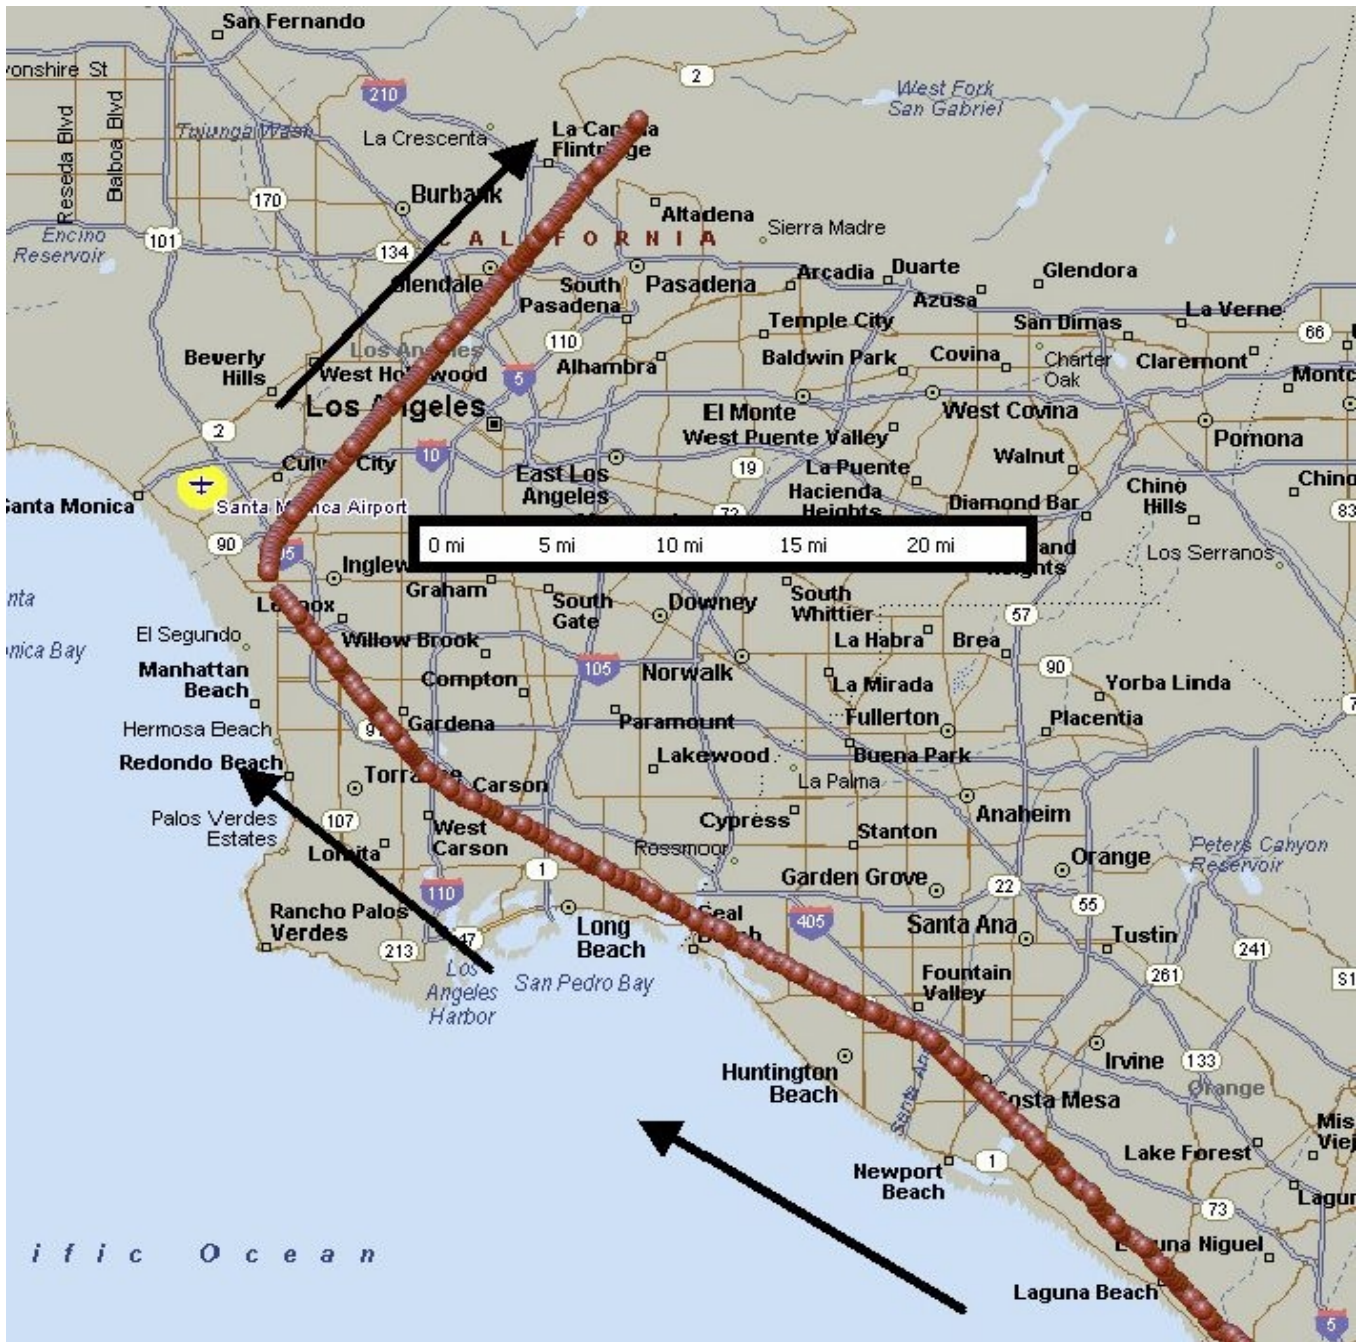
Review of recorded radar data revealed that the flight proceeded on a northwest heading after takeoff and paralleled the coast until nearing Torrance, California. The airplane then turned slightly right toward SMO. As the flight neared SMO, the airplane turned about 90° right to a northeast heading of about 30°. The airplane remained on this heading and maintained an altitude of 4,000 ft msl for about 19 miles until radar contact was lost.

Flight path of the accident airplane, with direction of travel noted by the black arrows.
