Aviation Investigation Final Report

Location:	Sheridan Lake, Colorado	Accident Number:	CEN16FA188
Date & Time:	May 18, 2016, 09:01 Local	Registration:	N6609P
Aircraft:	Cessna P210N	Aircraft Damage:	Substantial
Defining Event:	Loss of control in flight	Injuries:	1 Fatal
Flight Conducted Under:	Part 91: General aviation - Personal

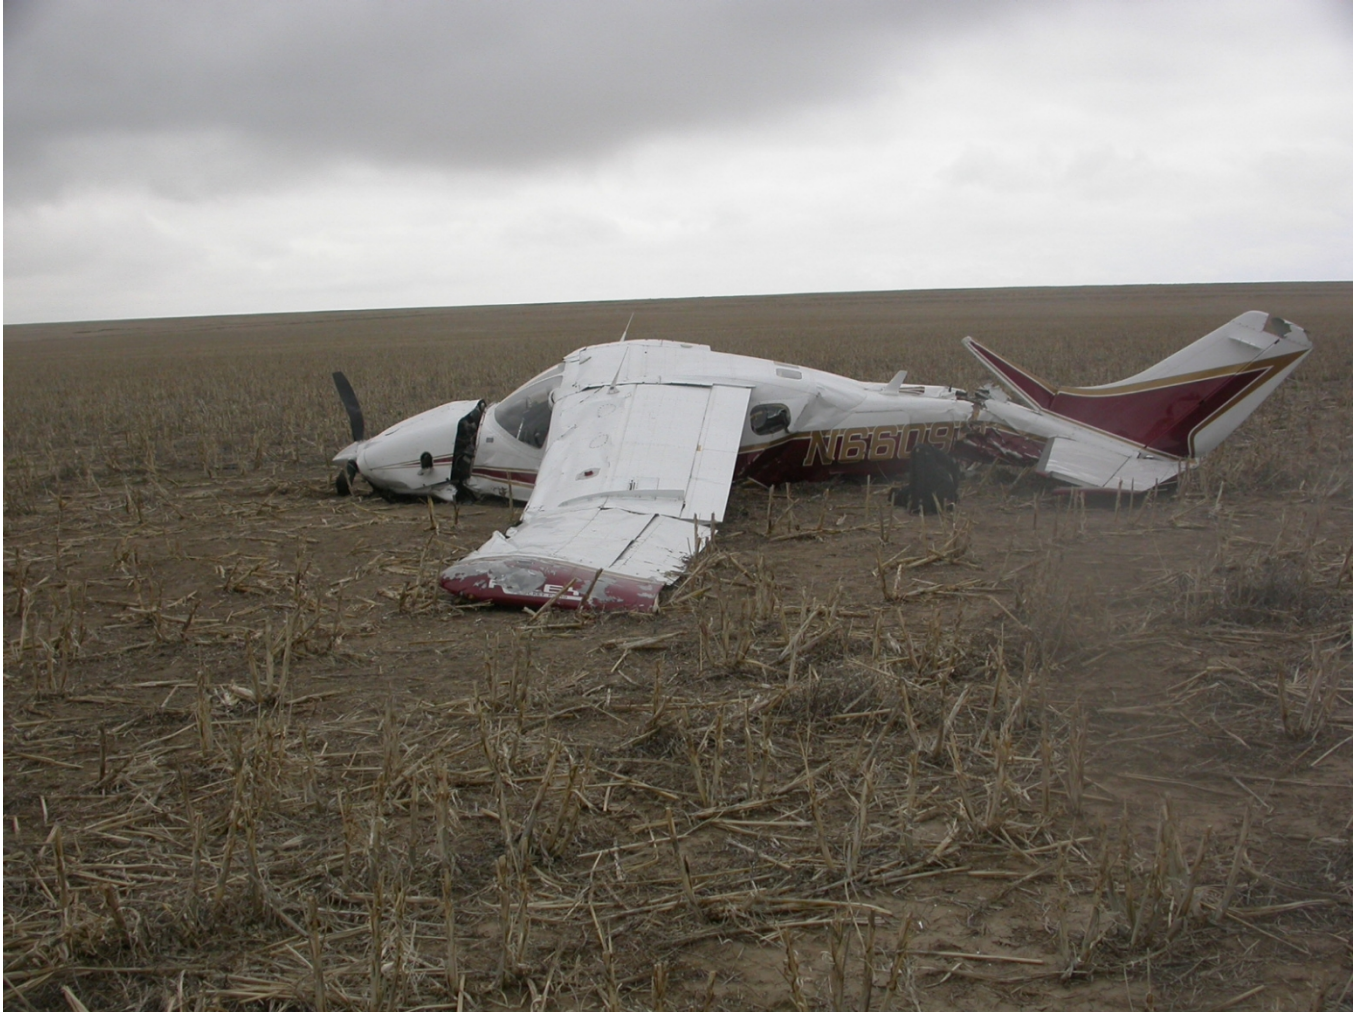
Fig. 1 View of the airplane at the accident site

The airplane impacted an open, harvested agricultural field in a wings-level, flat pitch attitude. The left wing was canted aft and the right wing was canted forward, consistent with the airplane being in a left spin at impact. The tail was bent slightly to the left of the fuselage and the engine was displaced slightly to the right. The fuselage was leaning slightly to the left. The landing gear was found in the retracted position.

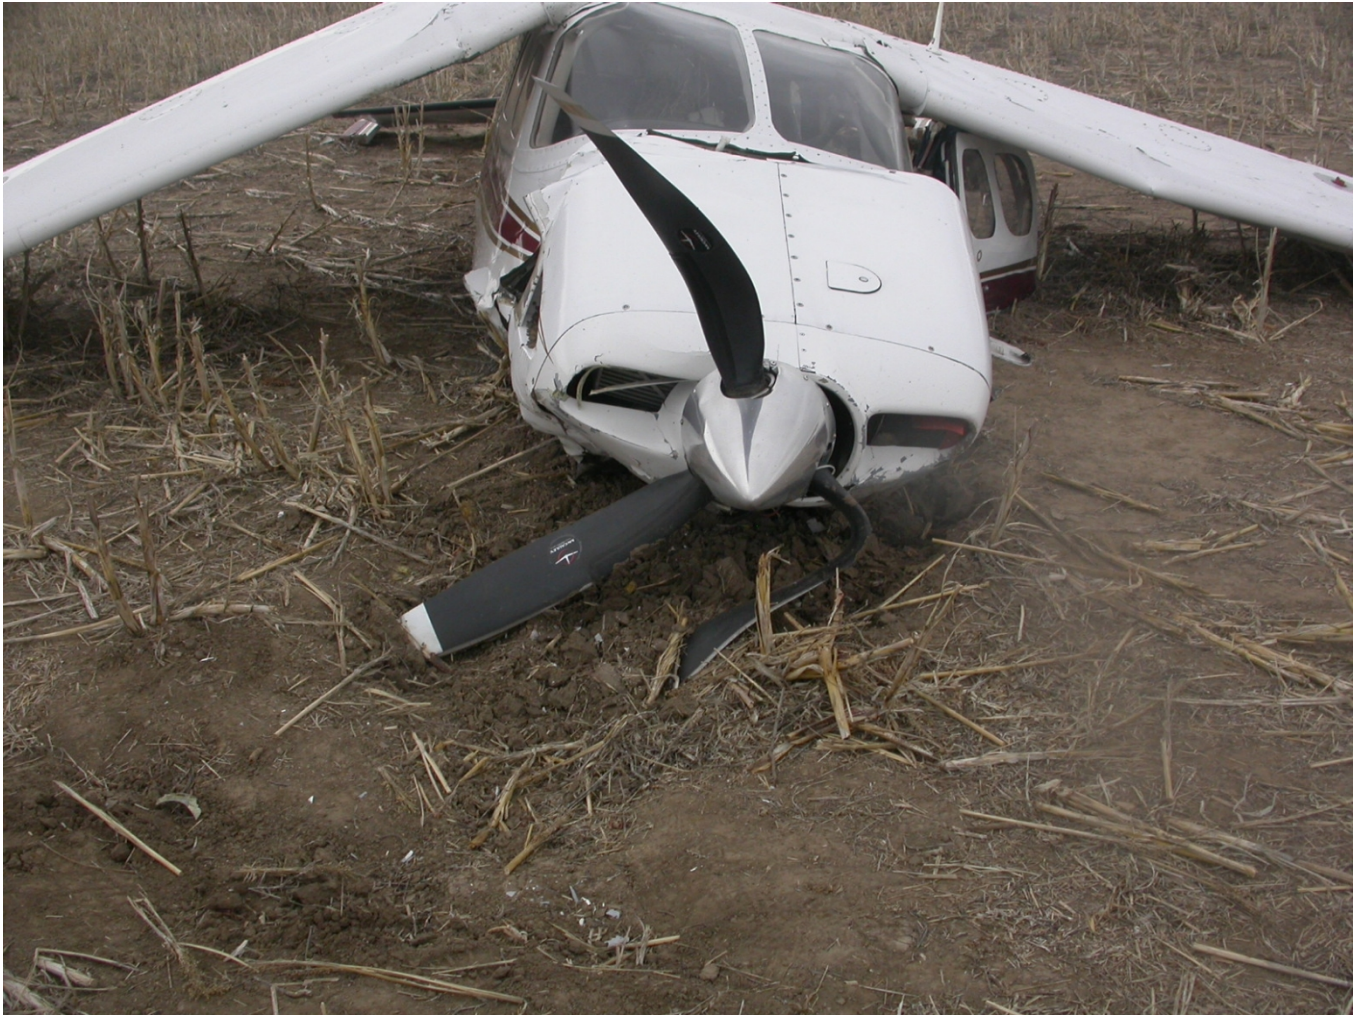
The 3-blade propeller remained attached to the crankshaft propeller flange. Examination of the propeller revealed all 3 blades were loose in the hub. The propeller blade marked No. 1 was bent forward about 90° about 6 inches from the hub. The outboard 10 inches of the blade exhibited a slight blade twist. The No. 2 blade exhibited a curved bend in the entire length of the blade. The No. 3 blade was bent slightly forward about 12 inches from the hub and exhibited a curved bend along the remaining length of the blade. All three blades exhibited burnishing of the leading edge; however, none of the blades exhibited nicks, gouges, or chordwise scratching of the blades.

Fig 2. View of the front of the airplane and propeller

The propeller manufacturer examined 25 digital photographs of the propeller that were provided by the National Transportation Safety Board's investigator-in-charge. According to the propeller manufacturer, the propeller sustained damage that appeared to be a result of impact and subsequent recovery of the airplane. There were no indications of propeller failure or malfunction before impact. Also, the propeller exhibited damage consistent with low rotational energy absorption during the impact sequence, which generally indicates low to no engine power at impact.
